Conservation Area Character Appraisal and Management Plan

East Meon

November 2015

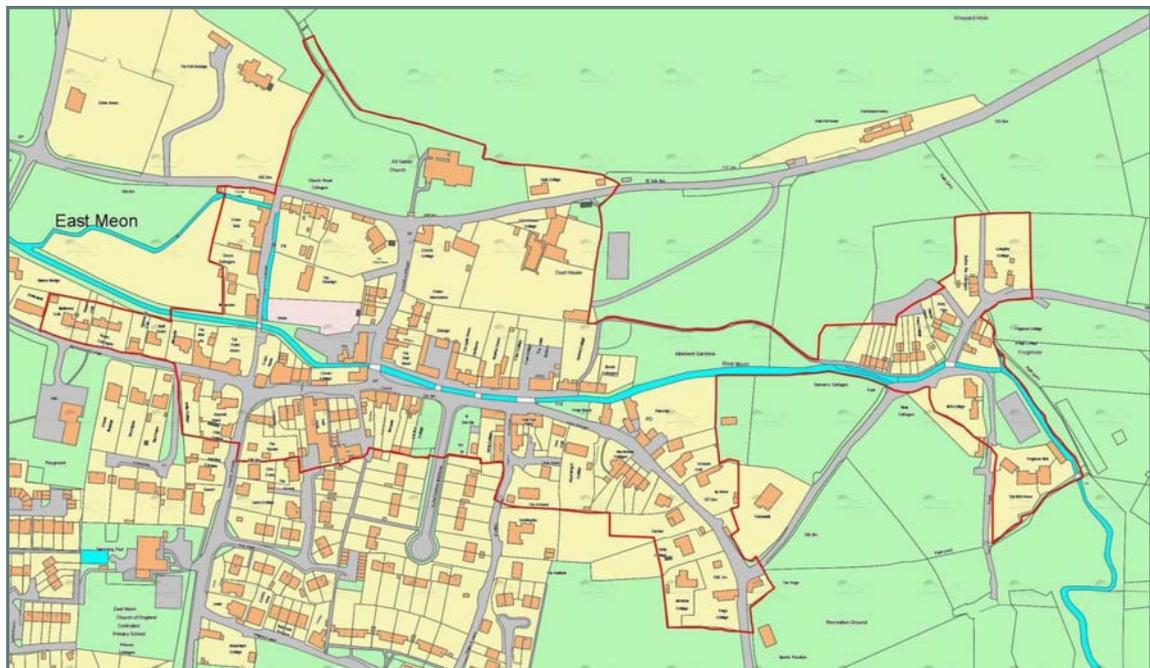
Figure 7: Boundaries of the Conservation Area

4.1 The boundary of the Conservation Area is shown on figure 7. It encompasses the developed areas which appear on the tithe map and early Ordnance Survey mapping. The modern development to the south of the village, although inserted within an earlier pattern of lanes, is excluded.

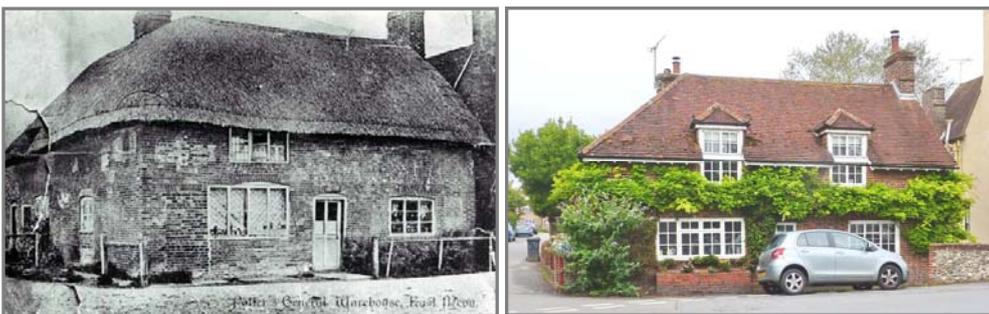
4.35 Comparing the old photograph of the building once known as 'Potters General Warehouse', with the same building today, *Corner Cottage*, illustrates this change and the ways in which this and other buildings have evolved, including the loss of thatch, the creation of dormers and the insertion of modern joinery.

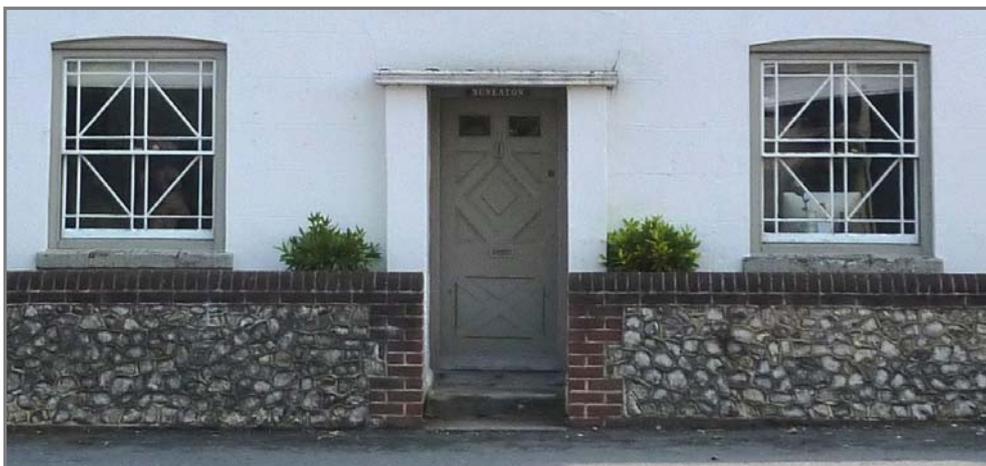
4.36 Where traditional joinery survives, it is the typical range of sliding sash and casement windows and board or panel doors. A very attractive departure from the norm is presented by the windows of *Nuneaton House*, which have a most unusual arrangement of margin panes combined with diagonal glazing bars, and the equally unusual panelled door.

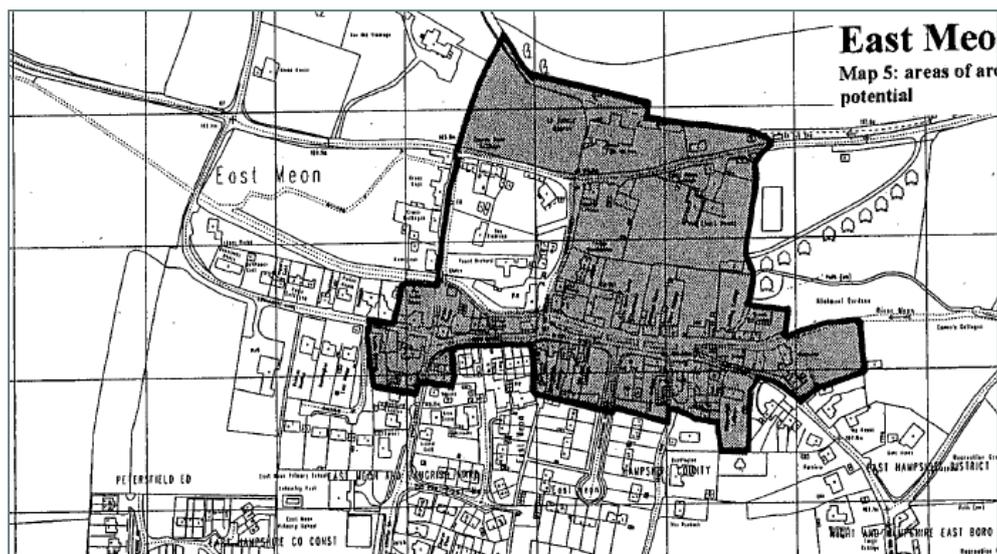
Figure 8: Areas of Archaeological Potential

5.11 As an historic settlement, all of East Meon has archaeological potential for below ground archaeological remains as well as historic buildings and structures. The East Meon Historic Rural Settlement publication identifies some areas of high archaeological potential and these are shown on figure 8 below.

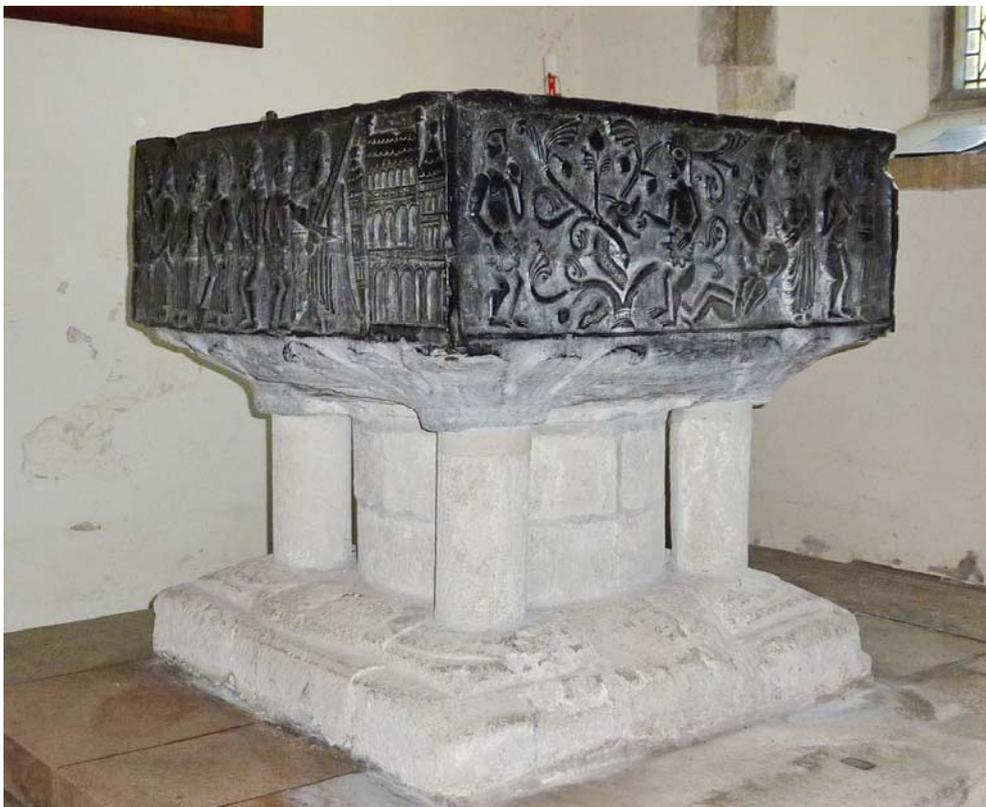
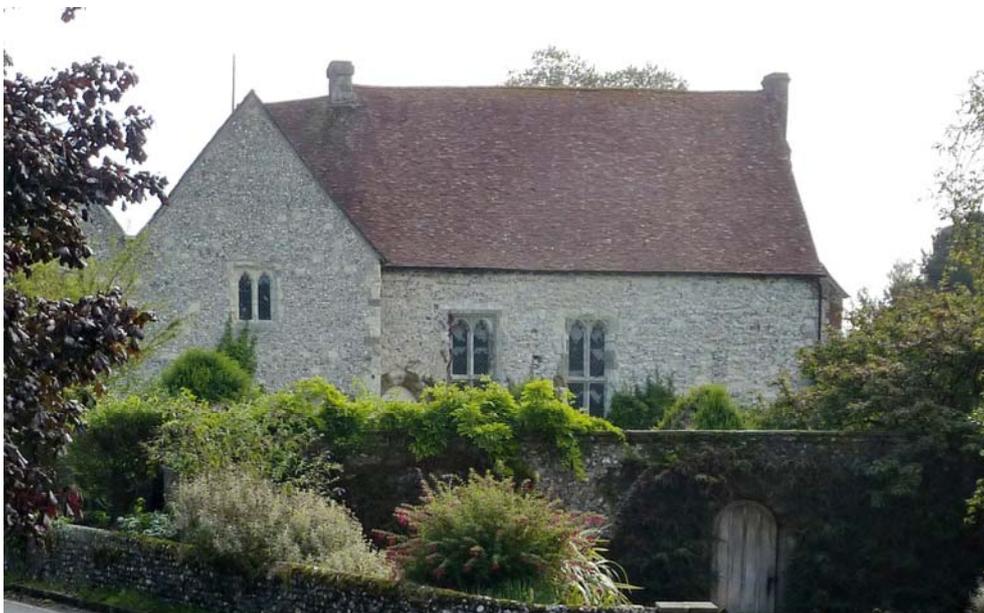
Figures 23 and 24 : The Court House

4.19 *The Court House* (figures 23 and 24) on Church Road can be documented through detailed building accounts to 1395-7, during the incumbency of William of Wykeham. William built a three-bay stone hall with a two-bay cross wing containing buttery and pantry on the ground floor and solar on the first floor. This probably stood on the footprint of an earlier building, parts of which were retained at the southern end where they formed a private suite of rooms for the bishop. A link between the old and new was created by a small projecting room off the dais end of the main hall, sometime referred to as an 'oriel' although this word carries a number of architectural meanings.

4.20 William's house is largely built of flint, incorporating irregular blocks of sandstone and malmstone, with sandstone ashlar used for quoins and window dressings. It cost a little over £110.

4.21 William was succeeded as Bishop by Henry Beaufort and in the 1430s and 1440s he repaired William's buildings, rebuilt or remodelled the private suite, and added a timber-framed gatehouse; neither of the latter survive. The kitchen, because of the associated fire hazard, would have been a freestanding building to the east. A timber-framed farmhouse was built against the east wall of the main hall in the early 17th century.

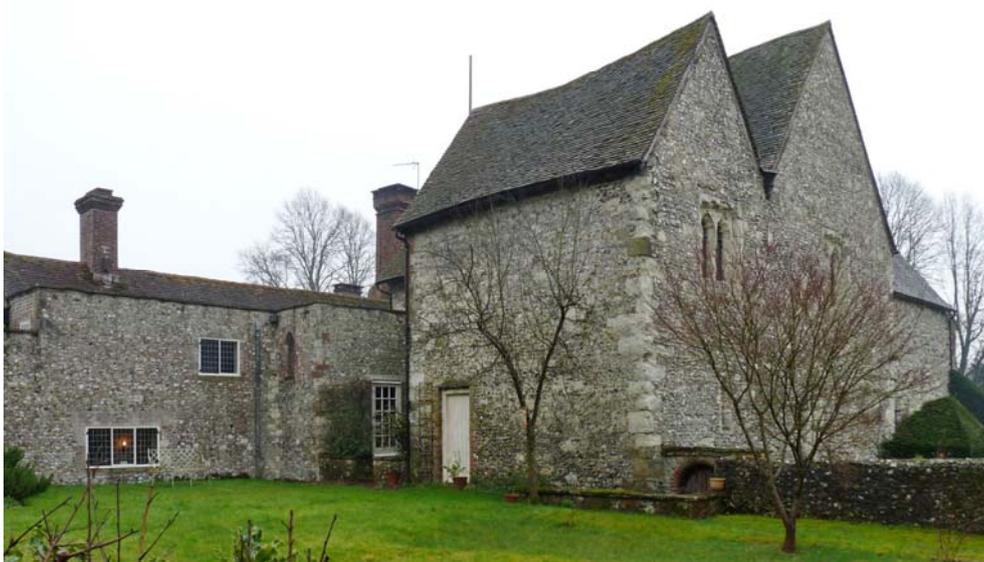
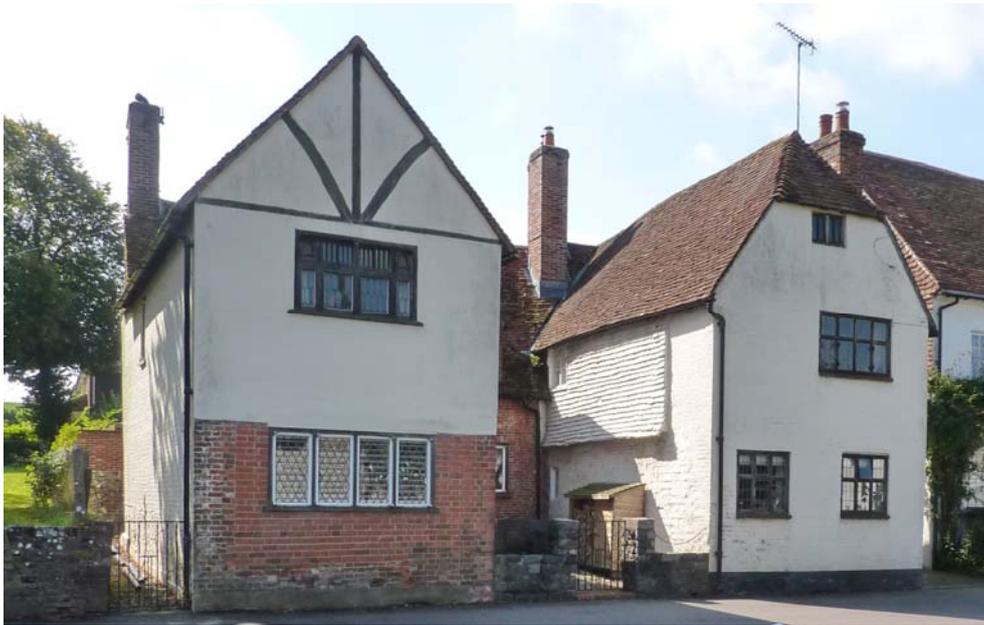
Figure 25 and 26: Bell Cottage (above) and Forge Sound (below)

4.25 The early examples include *Old Bell Cottage* (figure 25) and *Forge Sound* (figure 26), both on High Street. Beneath later cladding and extensions, the former is a late-medieval timber-framed hall with cross-wings whilst the latter is a three-bay aisled hall dating to about 1350.

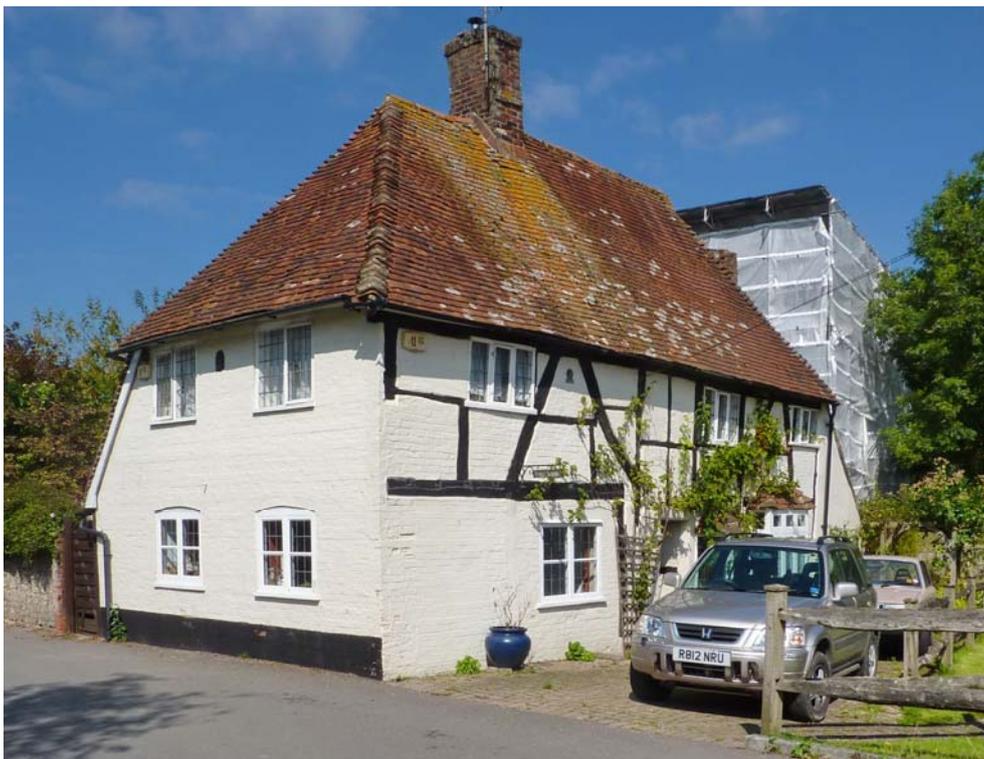
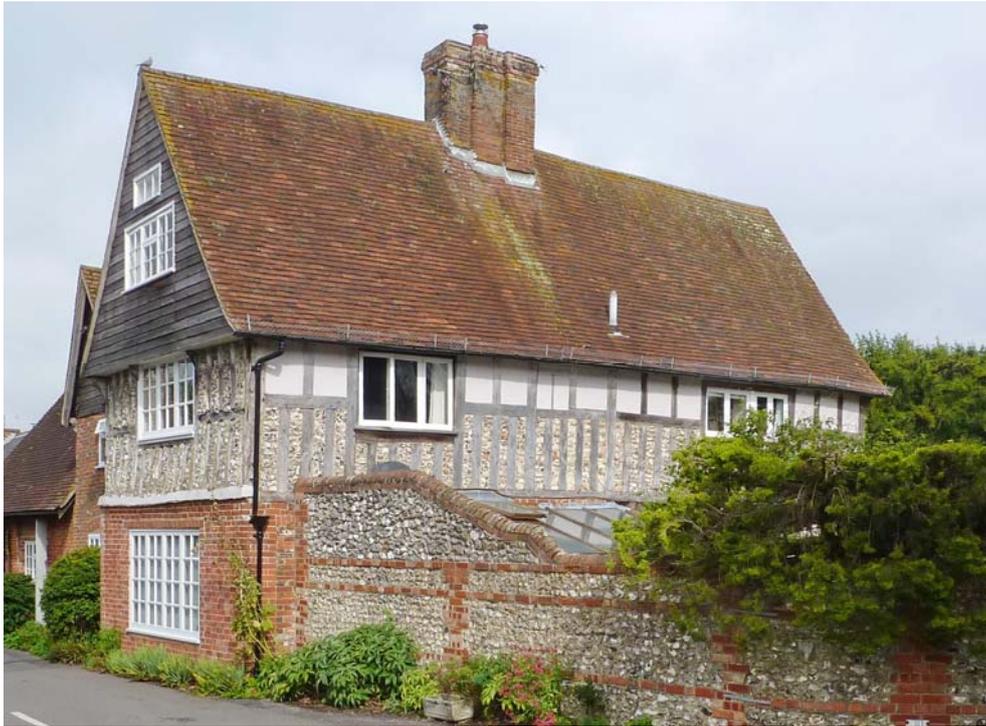
Figures 27 and 28: Tudor House (above) and Heycroft House (below)

4.26 Impressive examples of timber-framed construction are the *Tudor House* (figure 27) and *Heycroft House* (figure 28), both on The Square and both 16th century in origin, and the timber-framed farmhouse forming part of *The Court House*.

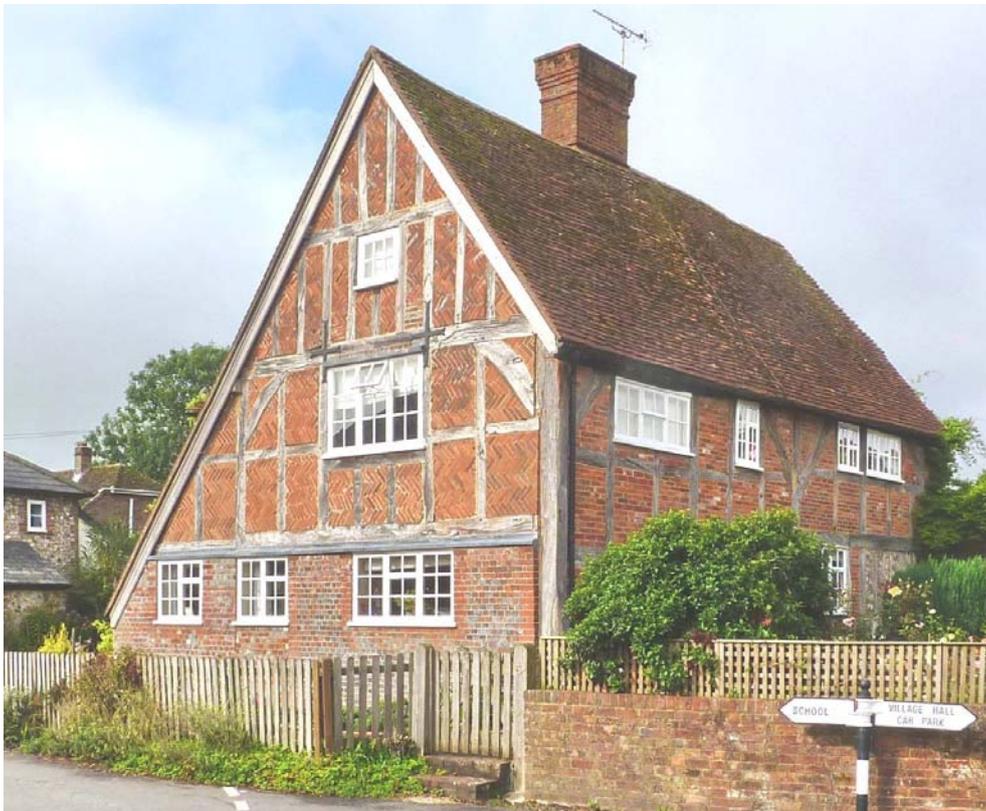
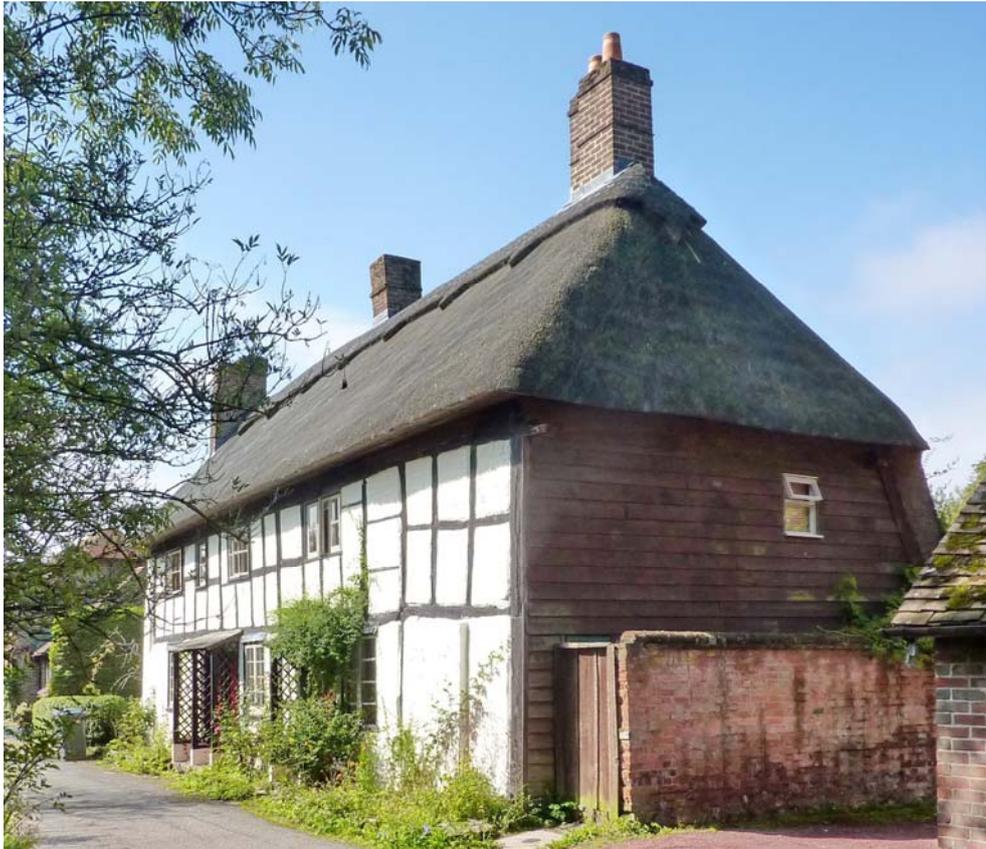
Figure 29 and 30: Cross Cottage, The Cross (above) and Forge Cottage, High Street (below)

4.27 Other timber-framed buildings include a number spread throughout the village all with apparent 17th century origins, including *Cross Cottage*, *Forge Cottage*, *Riverside*, *White Cottage*, *Hockley Cottage* and *Brook Cottage* (figures 29 – 34 respectively)

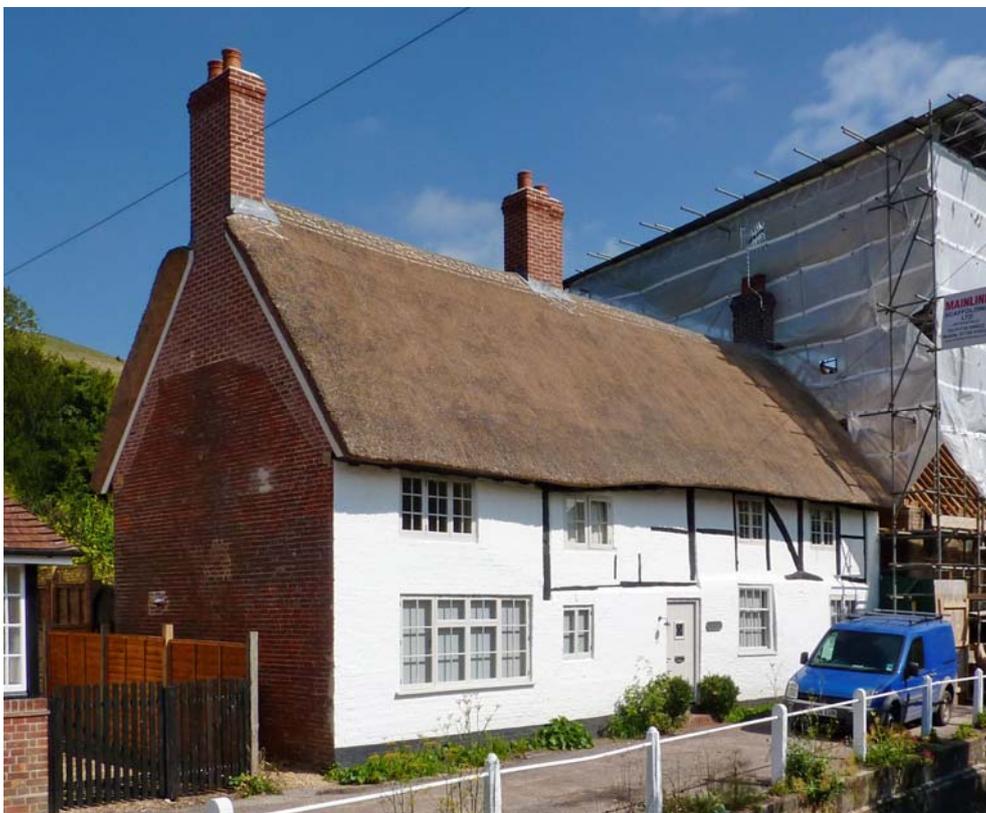
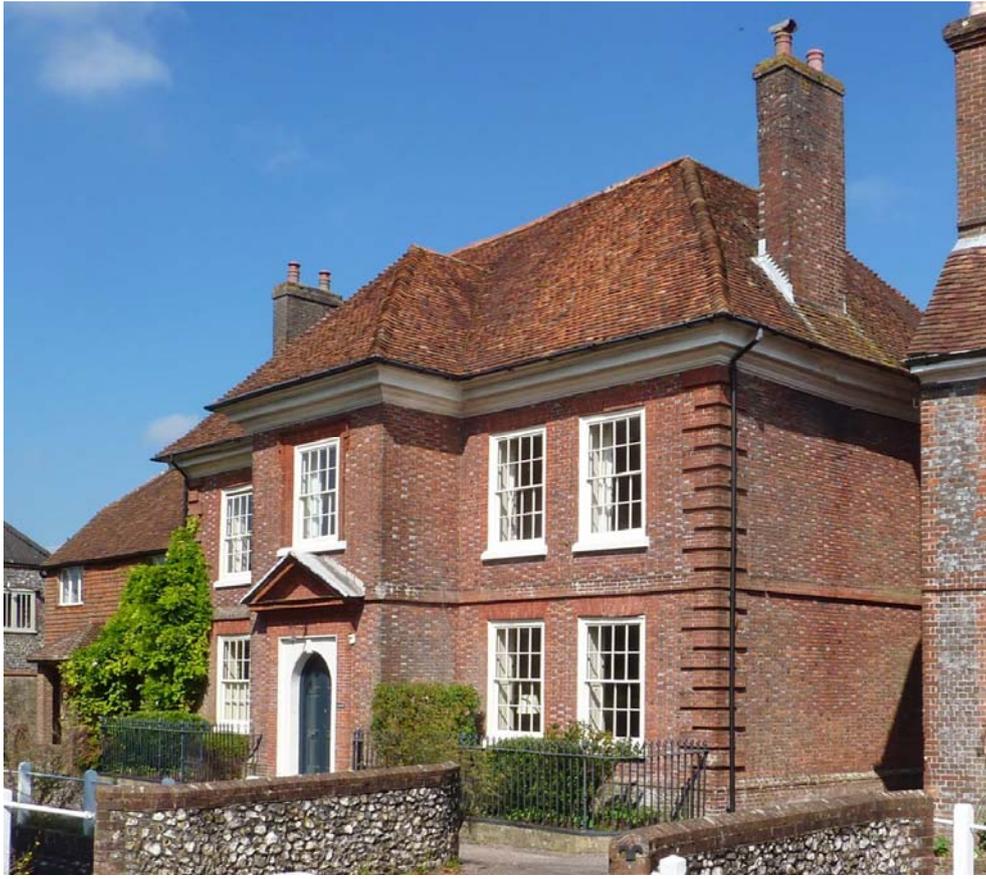
Figures 35 and 36: Glenthorne and its front railings

4.28 Brick begins to replace timber framing in the later 17th century with a particularly striking example in *Glenthorne*, built in 1697 and now Grade II* listed (figure 35); this listing specifically includes the fine railings in front of the house. The transitional nature of this building is demonstrated by the use of timber framing in the north elevation.

House. 1697. Red brickwork in Flemish bond with blue headers, red dressings; plinth, rubbed flat arches, 1st floor band, rusticated quoins, eared architrave to centre with cut brick ornament to mouldings. Hipped tile roof, fully-moulded wood cornice. A notable example of William and Mary style, with a symmetrical south front, having a projecting centre, of two storeys, 2.1.2 windows. Sashes in exposed frames. The classical doorcase is of fine cut brickwork, with pediment, dentilled cornice, cut decoration to some of the mouldings, rubbed flat arch, the inner framework being rendered and containing an arched opening with key, and double (three panelled) doors. Within the porch is an arched entrance with a decorative fanlight. The east elevation is plain, with the plinth, 1st floor band, and moulded cornice continued. The rear (north) elevation is an unusual exposed timber frame (of the same date) with painted brick infill: there are five windows (of irregular spacing) with a middle tall staircase light with an arched head. Sashes. The ground-floor contains outshots, mostly of the C20 with glazing and flat roofs; the hipped roof continues from the other elevations, but with a large plaster cornice of cyma form. The interior contains the original staircase, some Georgian plaster work and some Victorian renovation (in matching style). In front of the house, on each side of the entrance, there is a wrought-iron forecourt rail, resting on a stone base.

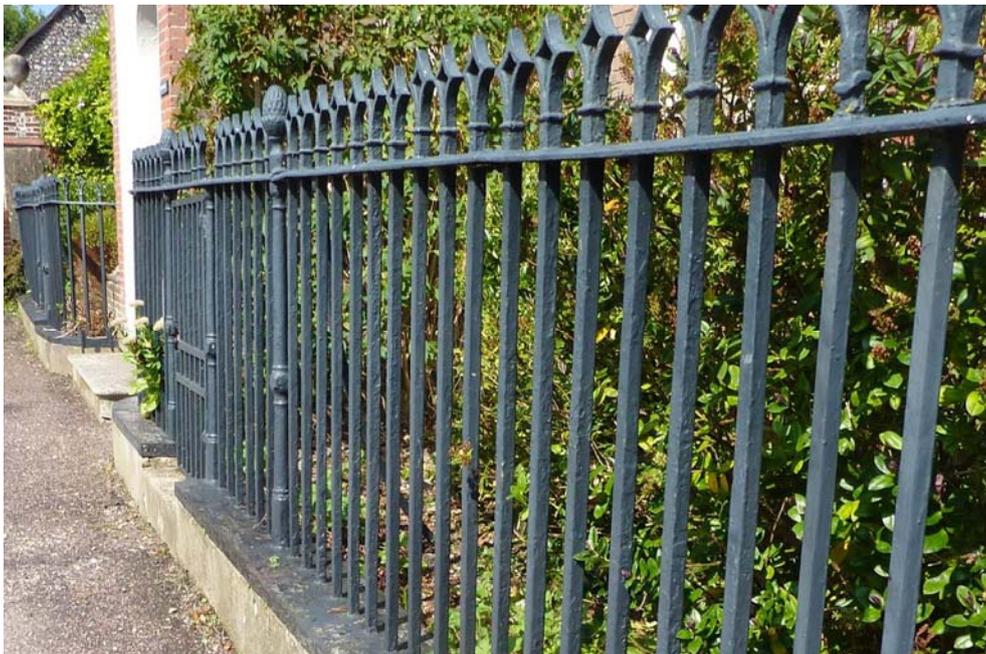
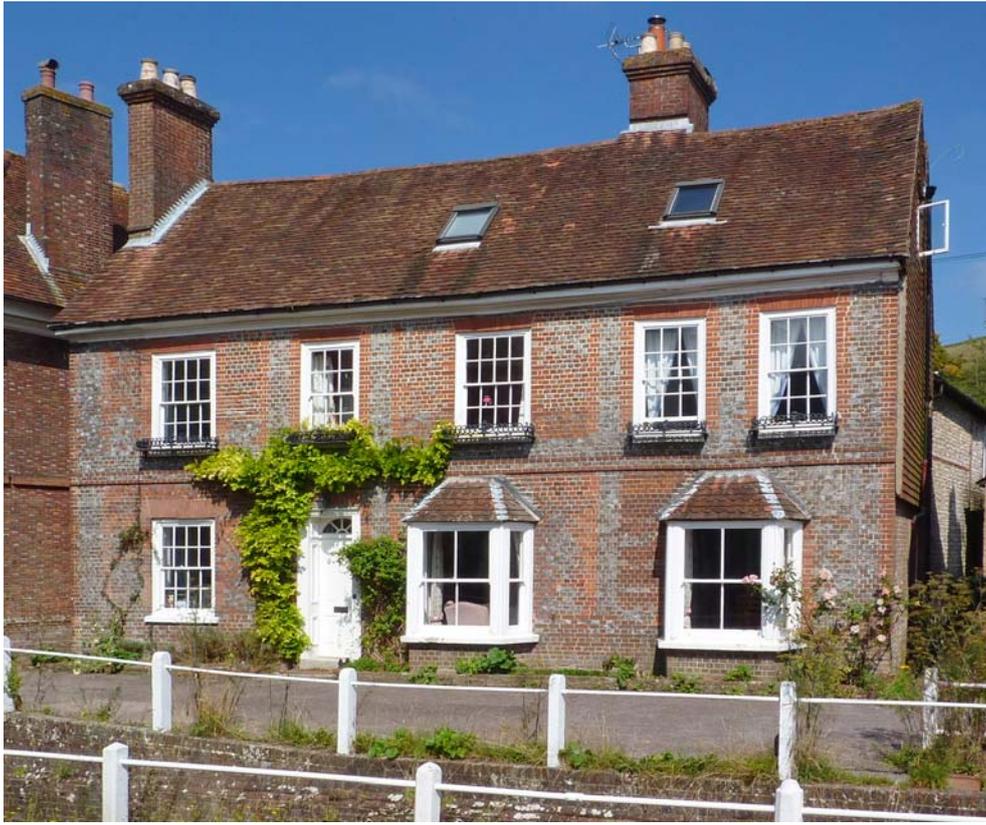
Figures 37 and 38: Brooklyn Cottage (above) and Clare Cottage / 11 High Street (below)

4.29 *Brooklyn Cottage* (figure 37) and *Clare Cottage/No. 11* (figure 38) are immediate neighbours to *Glenthorne* and both present 18th century brick front elevations combining blue headers with red brick detailing; a combination found quite frequently in Hampshire.

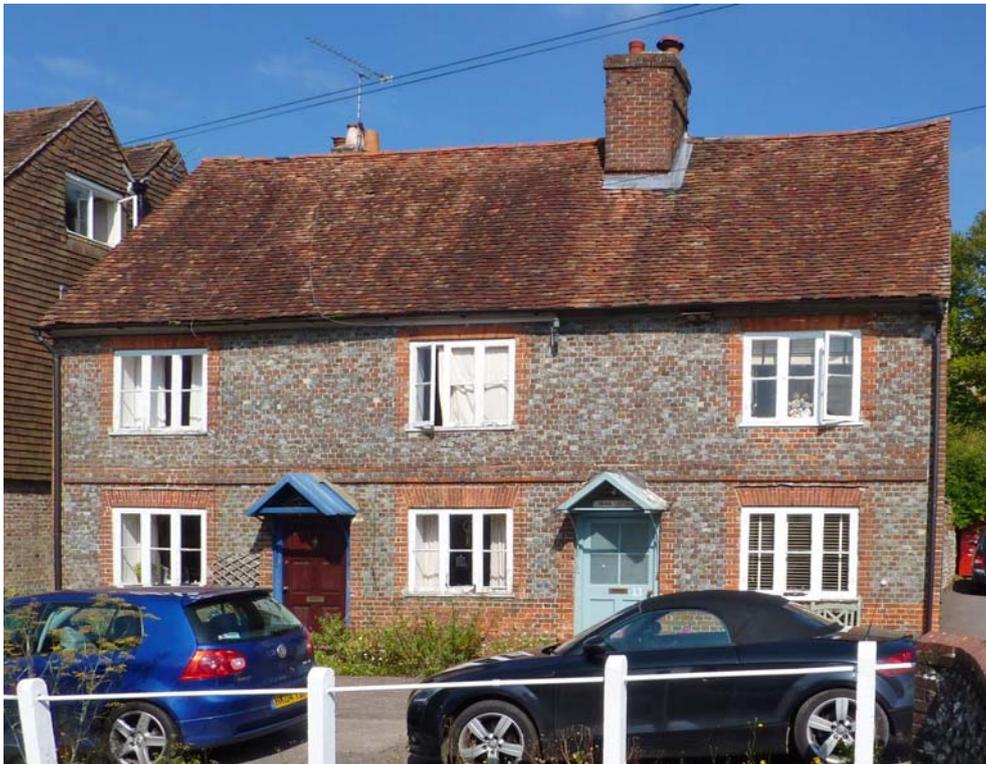
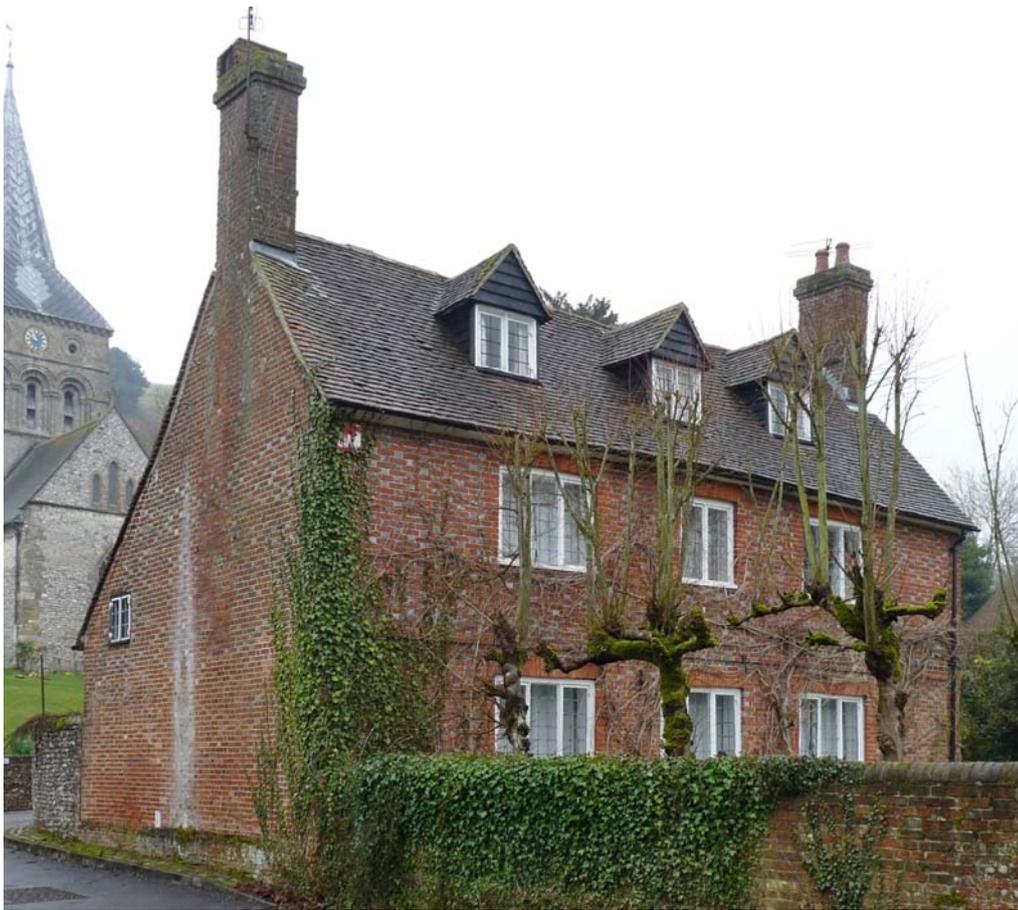
Figures 39 and 40: Church Cottage (above) & Wheelwrights Cottage (below)

4.30 The emergence of brick as the favoured building material in the 18th century is demonstrated by a number of other buildings, including *Church House*, *Wheelwrights Cottage*, *Court House Cottage* and *Cross Keys* (figures 39 – 42 respectively).

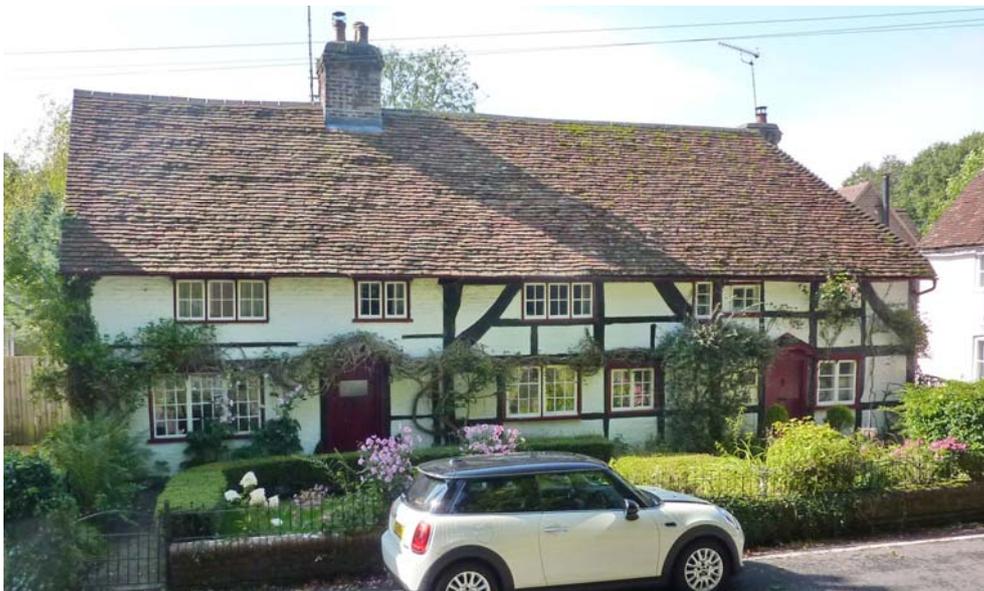
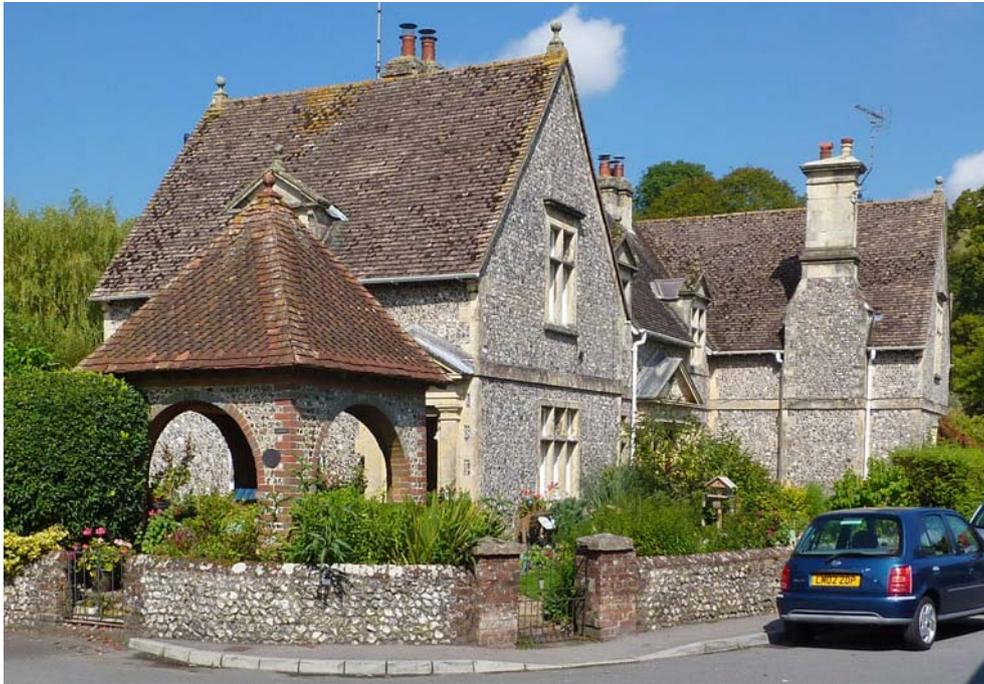
Figures 49 and 50 : Forbes Almshouses

4.33 Flint is often used for boundary walls within the village and these make an important contribution to the character of the conservation area. It is used rather more sparingly for buildings, however, with the notable exceptions of *The Court House*, the *Forbes Almshouses* (figures 49 and 50), and *Flint Cottage* (figure 51).

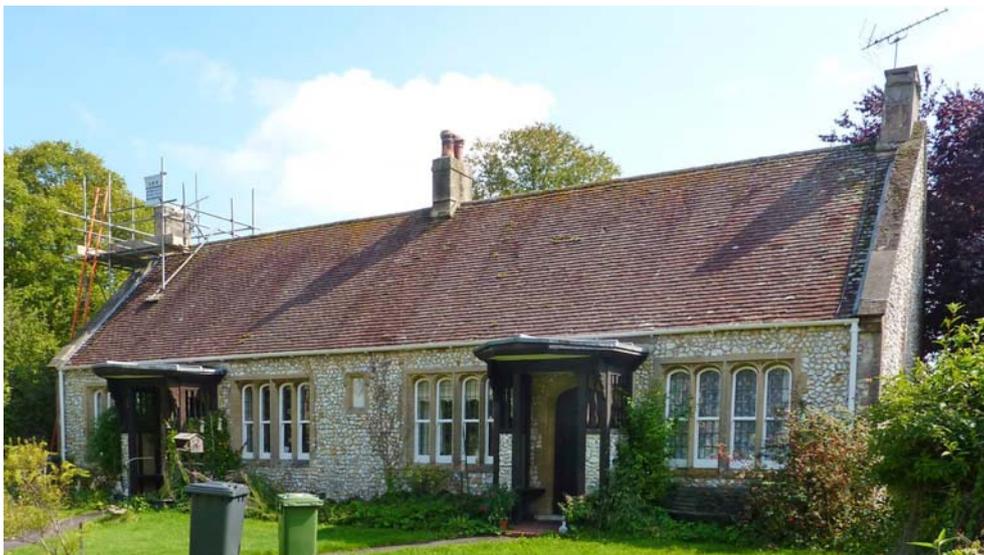
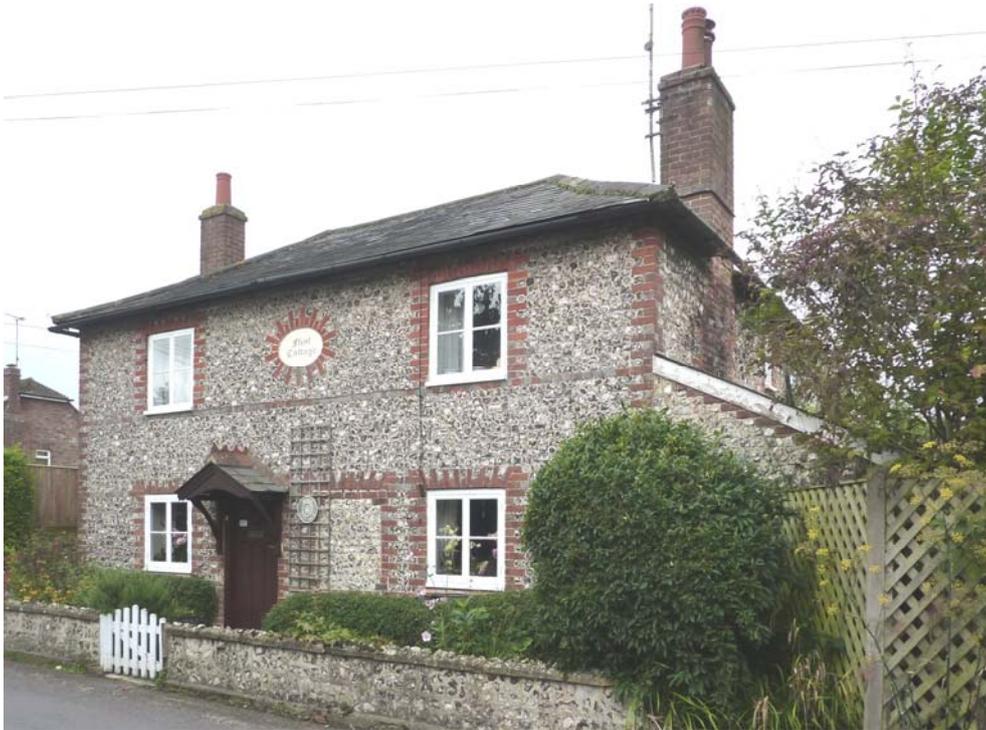
Figures 51 and 52: Flint Cottage (above) and Nuneaton House (below)

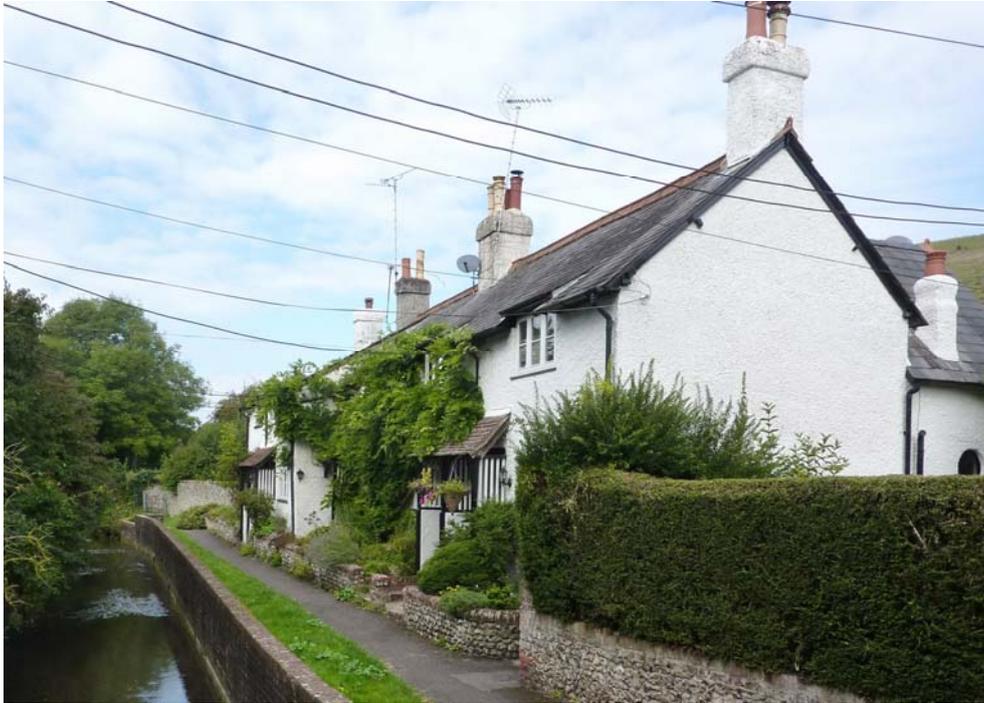
Figures 56 and 57: Frogmore – Eames Cottages (above) and New Cottages (below)

4.39 The buildings in Frogmore form a distinct spatial group but otherwise present a similar range of forms and building materials as the main part of the village (figures 56 – 63).

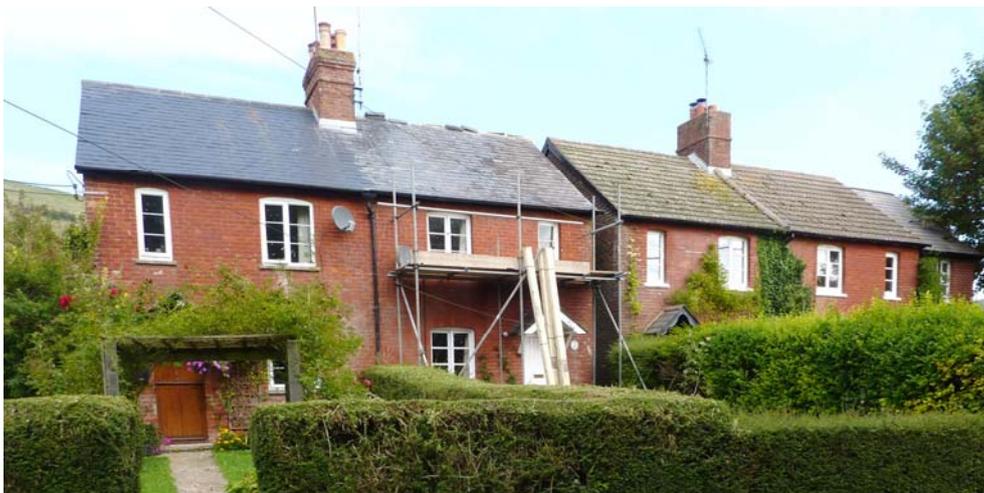
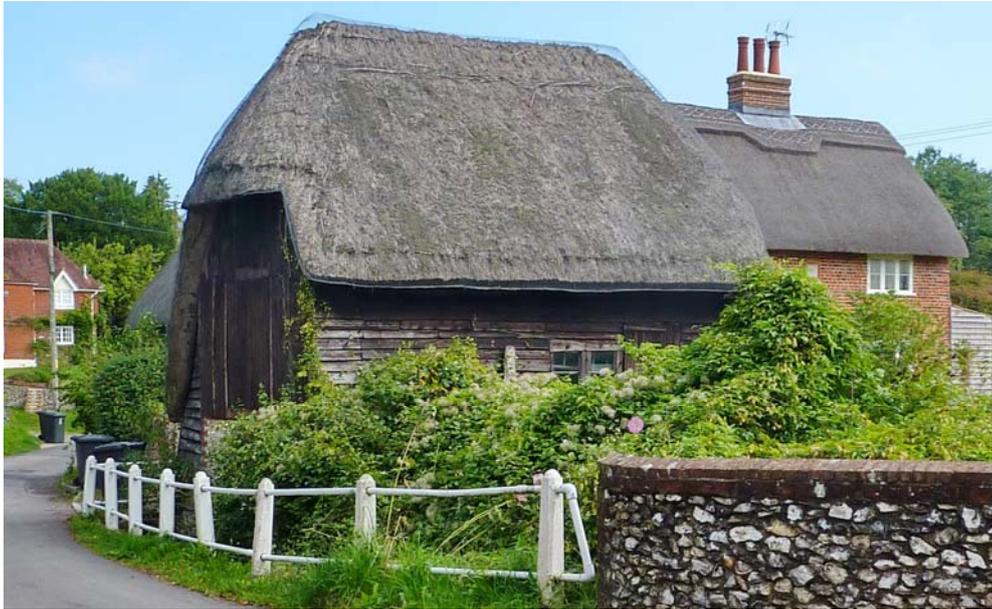
Figures 58 and 59: Frogmore – Stable south west of Bridge Cottage (above) and Mill Cottage (below)

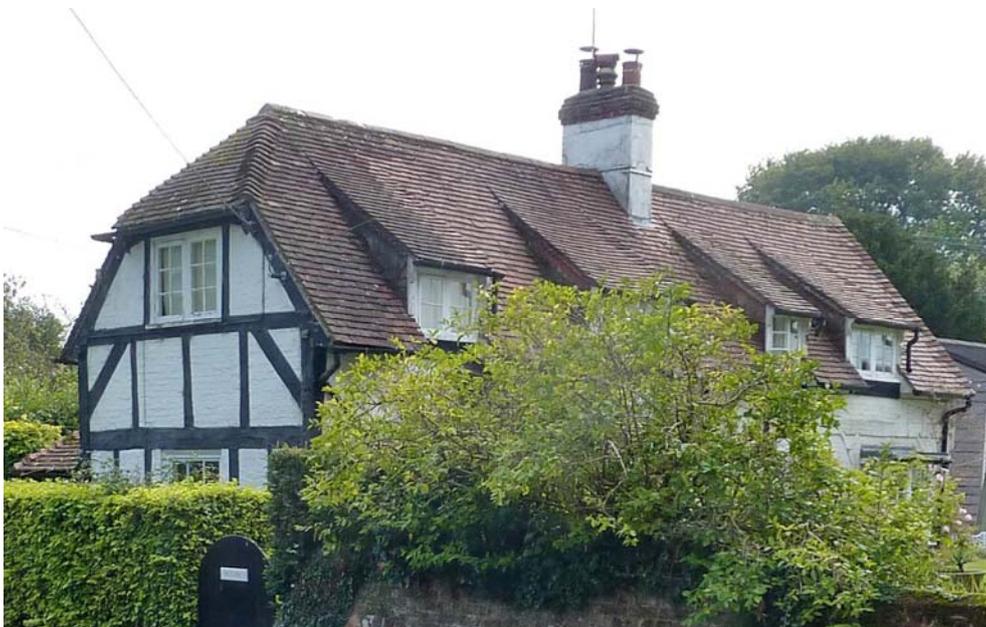
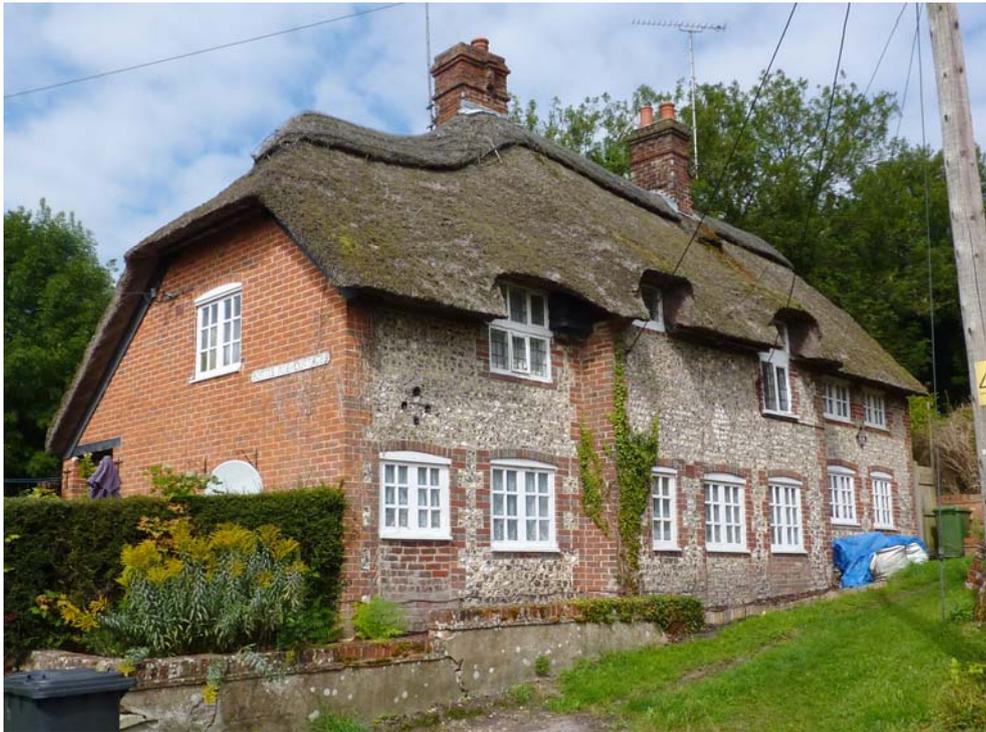
Figure 60 and 61: Frogmore – Bottle Ale Cottage (above) and Compton Cottage (below)

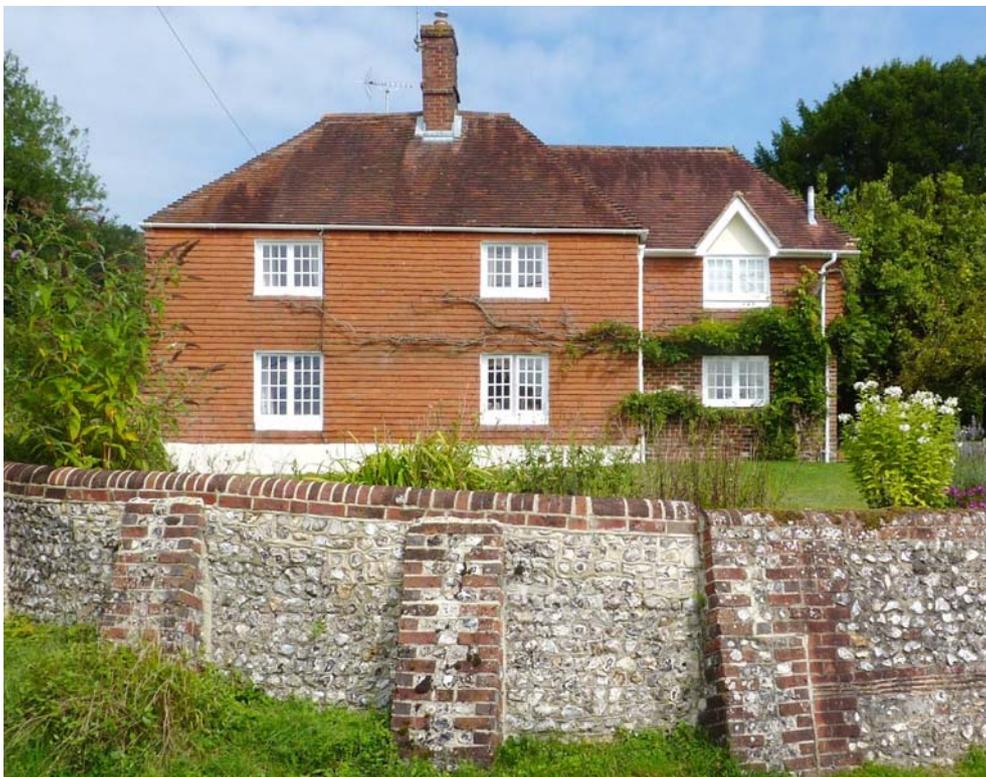
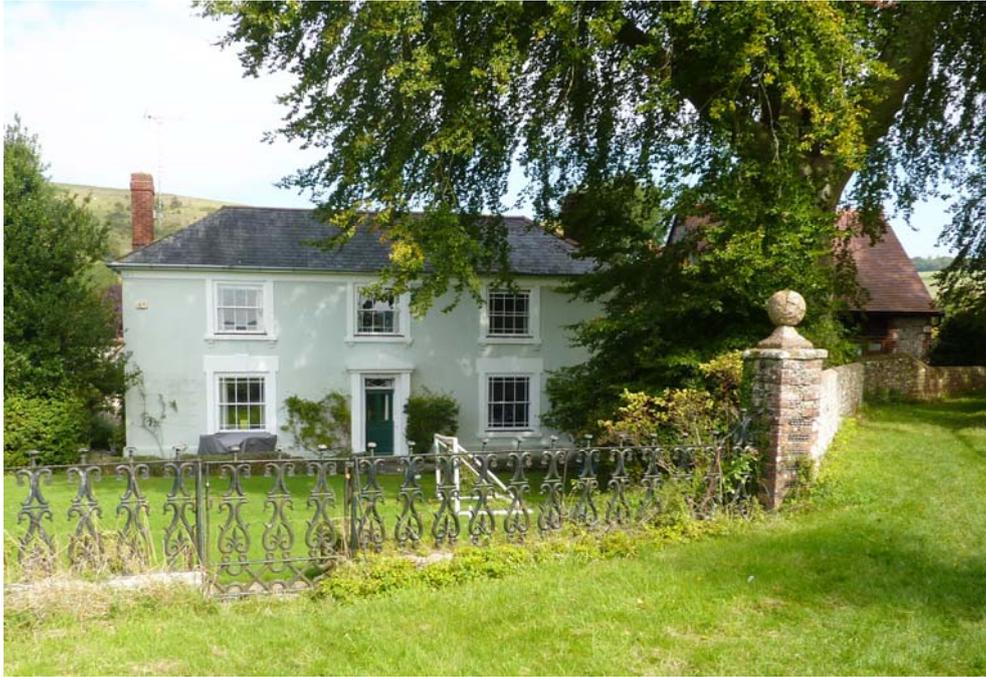
Figures 62 and 63: Frogmore – The Mill House (above) and remains of the water race (below)

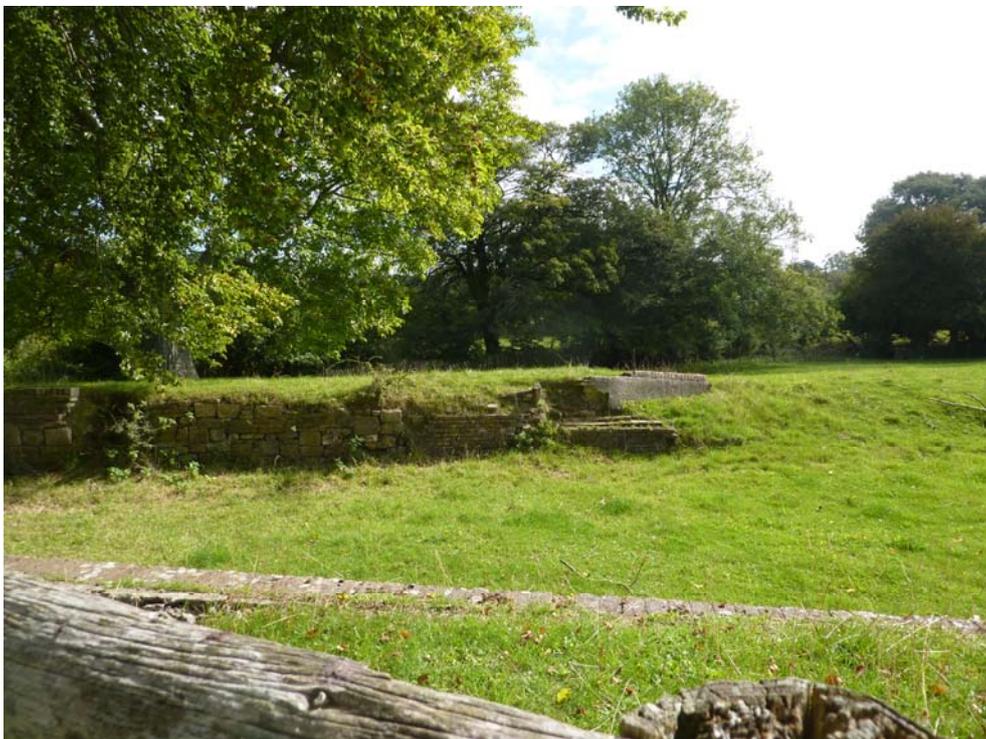
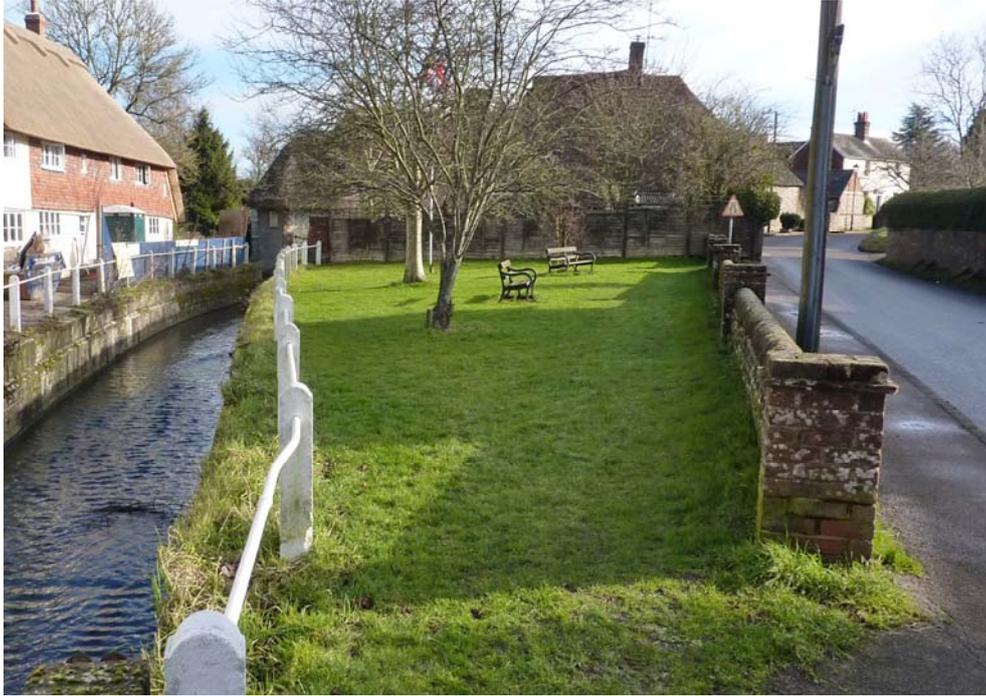
Figures 64 and 65: Washers Triangle (above) and Glenthorne Meadow (below)

4.42 Within the Conservation Area, the main open areas of green space are Washers Triangle, at the eastern end of High Street where it diverts from the line of the river (figure 64), the land to either side of Glenthorne Meadow where it joins High Street (figure 65), and most impressively, the Churchyard.
