Conservation Area Character Appraisal and Management Plan

East Meon

November 2015

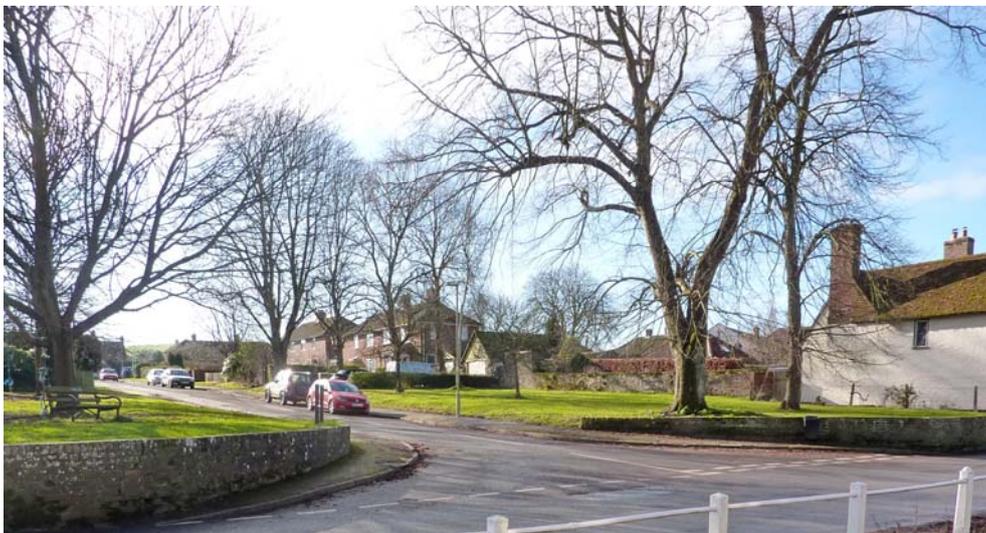
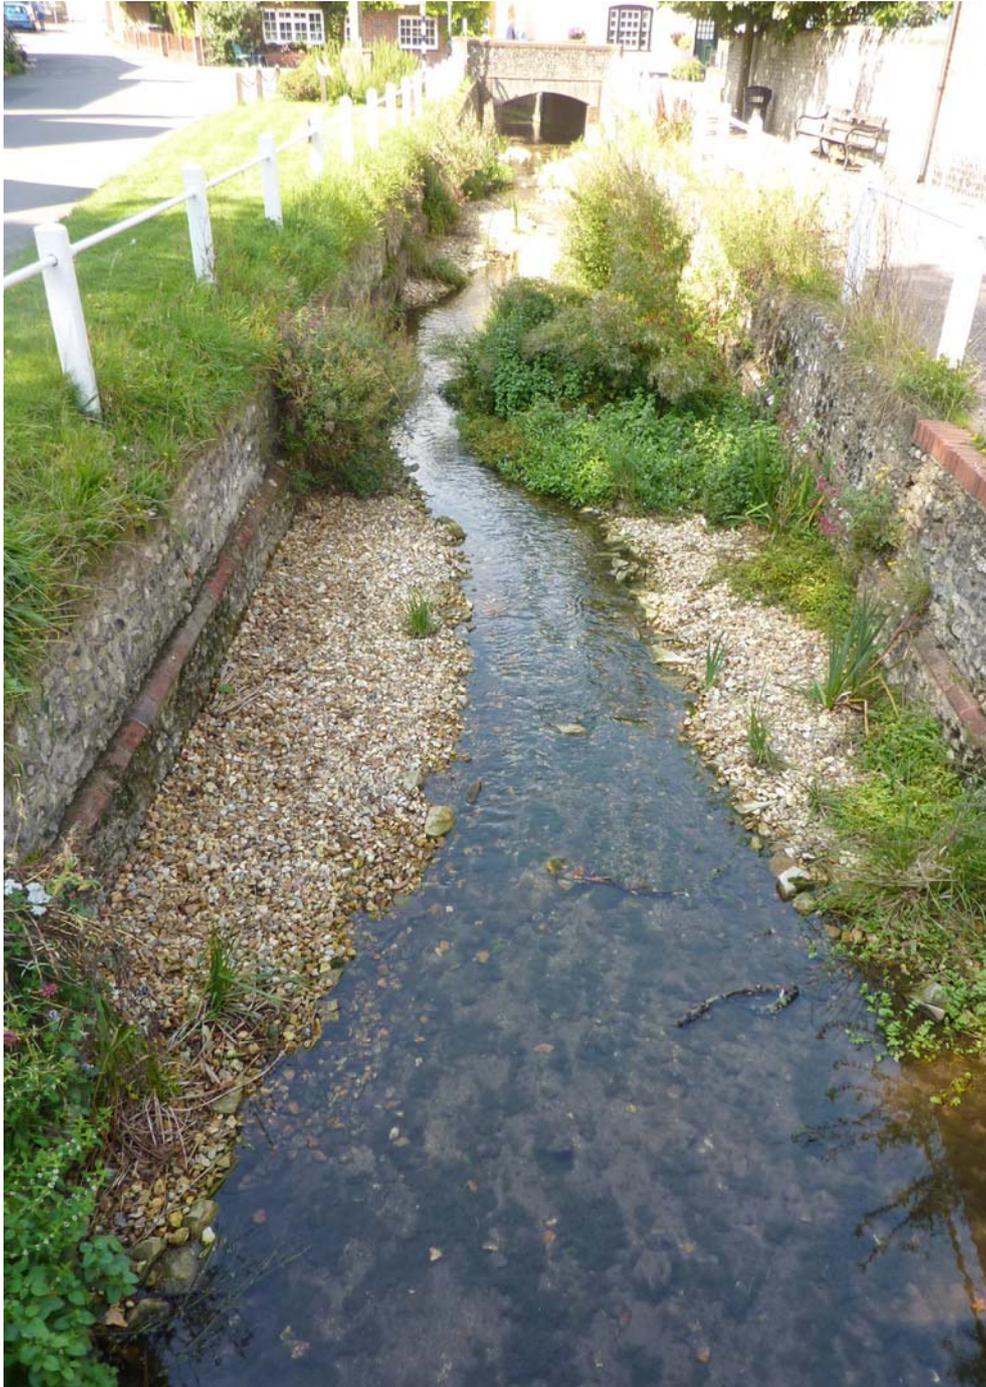
Figure 66: Enhancement of the river as it passes through the village

4.45 An enhancement scheme for the central section of the river has addressed this situation by recreating a more naturalistic river-scape which has produced a significant visual improvement (figure 66).

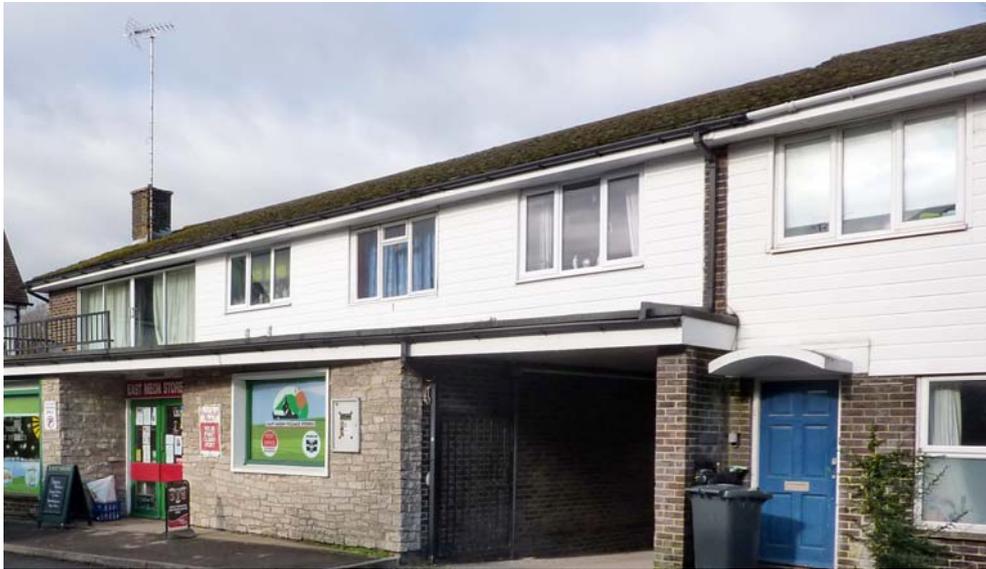
Figures 67 and 68: Inappropriate modern development within the village

5.2 The western end of High Street has been affected by the loss of traditional buildings and their replacement by much less sympathetic modern development. The village store undoubtedly performs a valuable function but the building it occupies is quite inappropriate in the street scene (figure 67). Likewise, the modern housing which sits in the gap created by the fire of 1910 does not respect the form of traditional development within the village (figure 68). Should either site ever come forward for redevelopment, replacement buildings of more sympathetic form have potential to enhance this part of the Conservation Area.

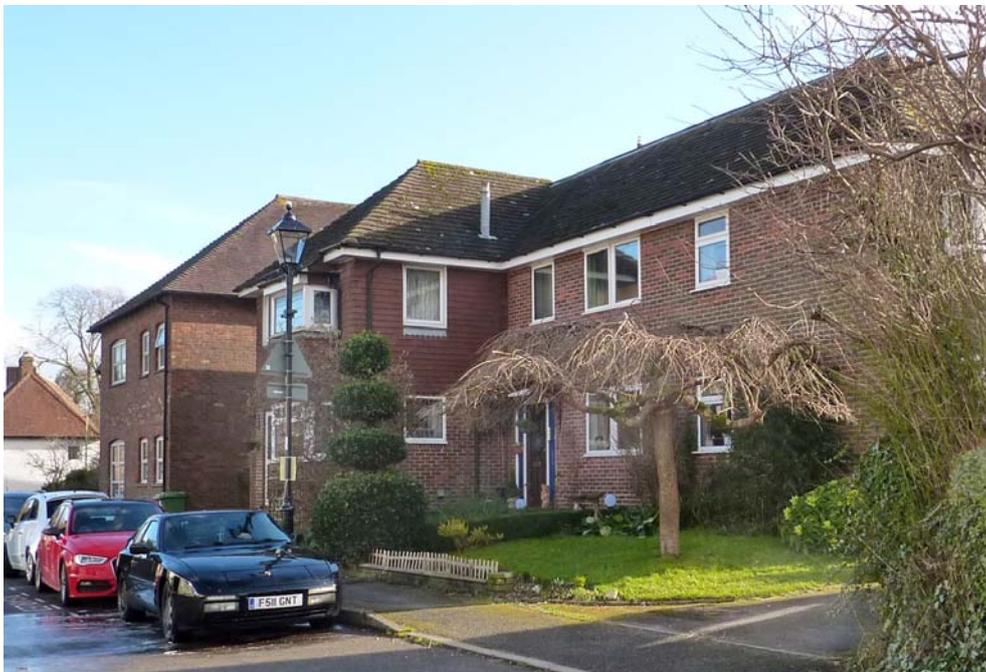
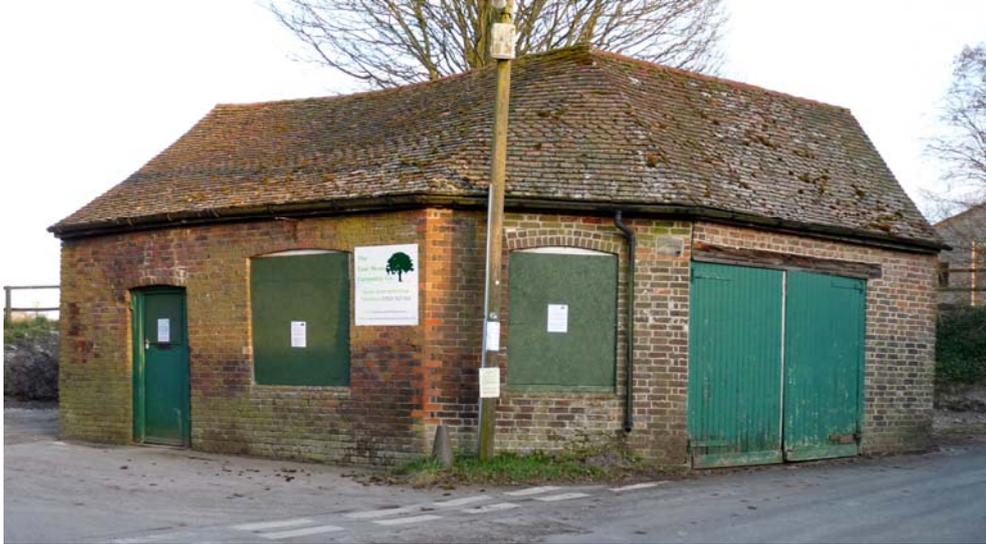
Figures 69 and 70: The old Forge (above) and the Stables, 10 metres south of Riverside and Gateway. The Stables were actually the slaughterhouse for a former butchers shop to the north. The building may originally have been thatched

5.4 The National Park Authority commissioned a Building at Risk survey in 2012-2013 which looked at both listed and unlisted buildings within the Conservation Area. Of the 109 buildings surveyed, none were found to be at risk and only two were identified as 'vulnerable', these being *The Forge* and the Stables and gateway 10 metres south of *Riverside*.

6.19 As reported in paragraph 5.4, the historic building stock in East Meon is generally in good condition. Of 109 buildings surveyed, none were found to be at risk and only two were considered to be vulnerable – the Forge and the Stables and Gateway close to Riverside

ACTION 3 – that the National Park Authority monitors the condition of the Forge and the Stables and Gateway close to Riverside

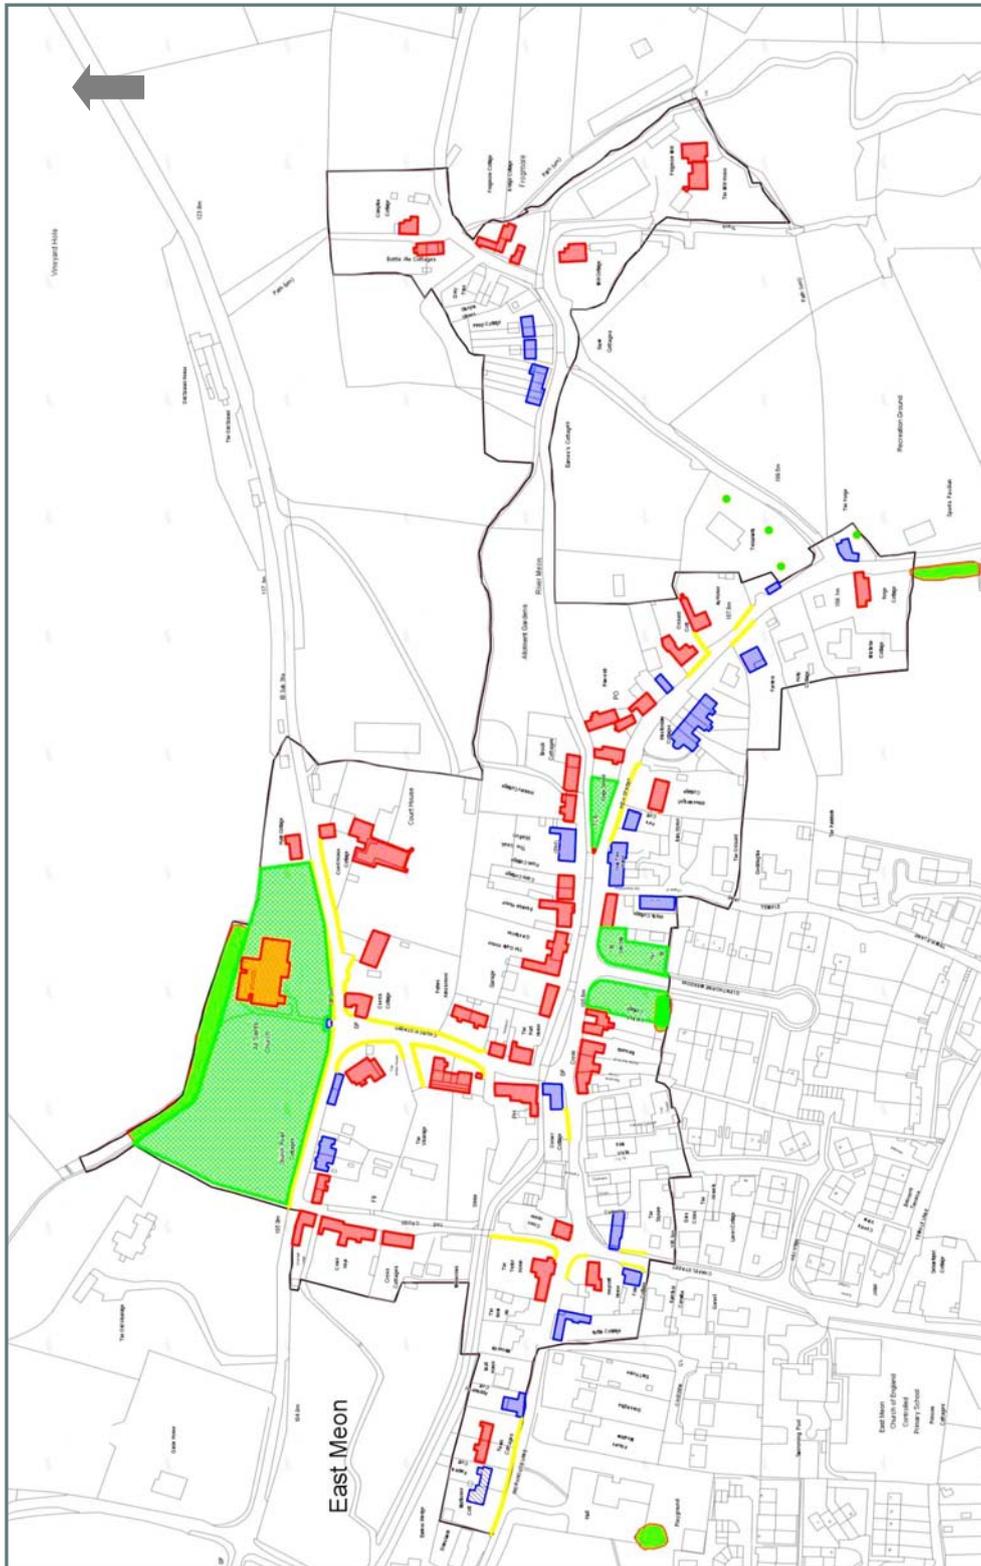
Figure 71: **Conservation Area Analysis Map**, showing listed buildings (red), locally listed buildings (blue shading), other buildings making a positive contribution to character (blue), significant boundaries (yellow), important green spaces (green), and tree preservation orders (green with red edges).
