ROPLEY CONSERVATION AREA
CONSERVATION AREA APPRAISAL AND MANAGEMENT PLAN: CONSULTATION DRAFT
ISSUE 02
APRIL 2025

ROPLEY: CONSERVATION AREA APPRAISAL AND MANAGEMENT PLAN

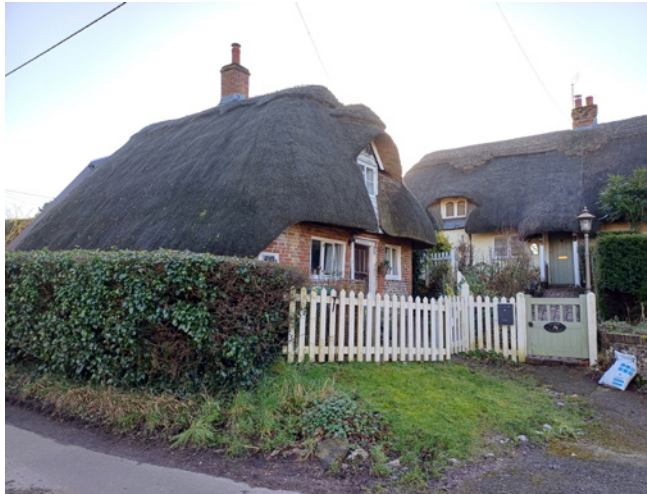
Archbishop's Cottage, Church Street, which dates from the late 18th century. Typical characteristics which identify it as a vernacular structure include the steeply pitched thatched roof, use of local brick and flint, timber weatherboarding to the upper storey and window openings of irregular shapes and sizes.

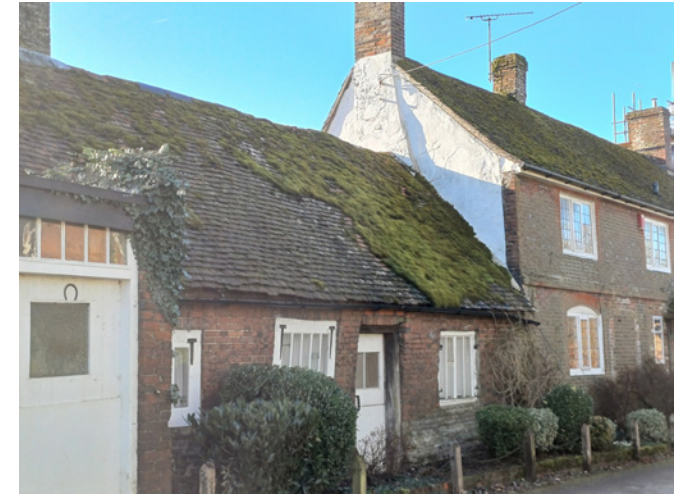
The Forge on Church Street, with elements spanning from the 15th to the early 19th century. As is typical with vernacular structures, this building has been extended and adapted many times.

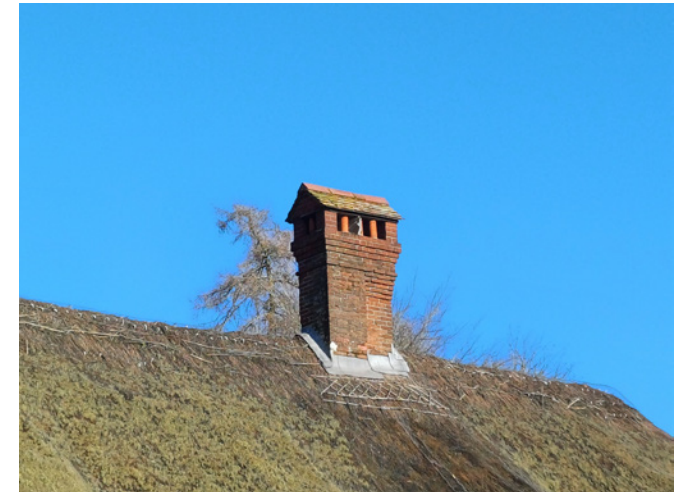
Detail of a brick chimney stack to the building known as The Old Manor House on the corner of Petersfield Road and Hammonds Lane.

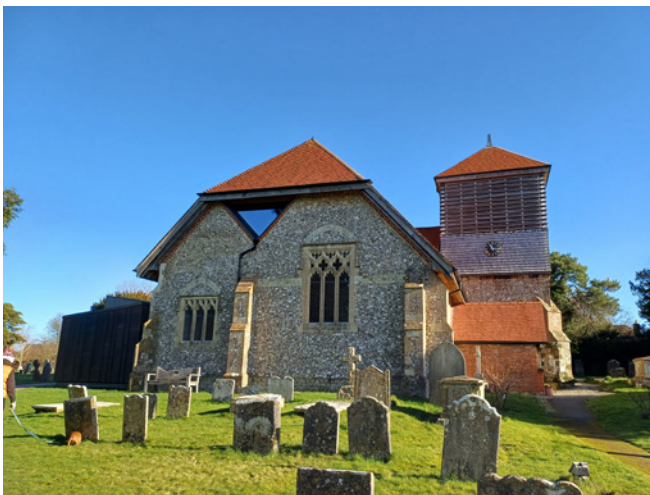
The delicate tracery and leaded lights to the Church of St Peter's are typical of the Gothic style.

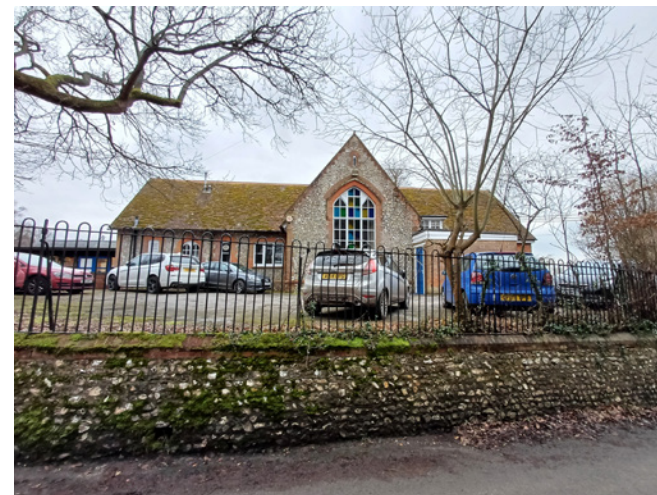
Ropley Primary School, built as a national school during the Victorian era, displays the Gothic style which was popular at this time.

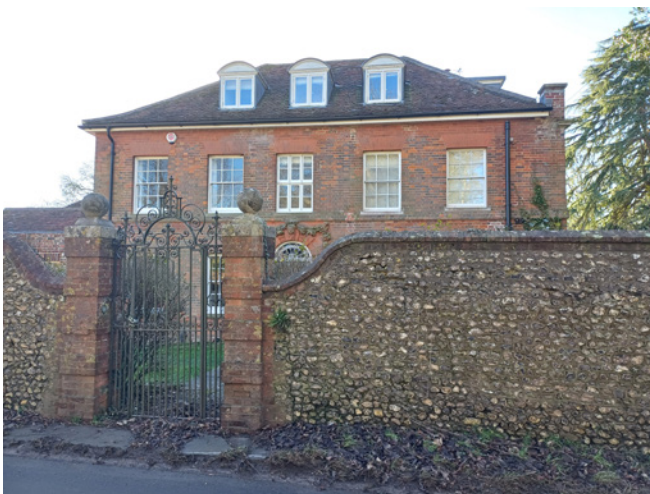
Ropley Grove, Petersfield Road. An 18th-century Georgian building, easily identifiable as such through its highly symmetrical façade, shallow hipped roof and regularly arranged sash windows.

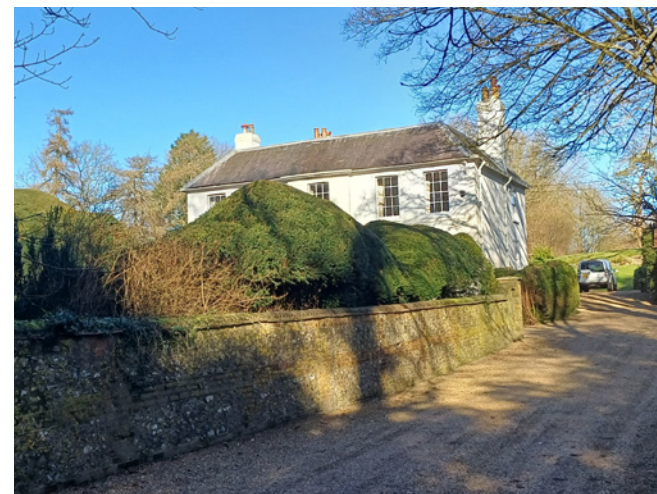
Hall Place, a substantial Georgian residence constructed on Petersfield Road around 1790. Typical Neo-Classical features include the regular sash windows, moulded eaves cornice and pale stucco finish.

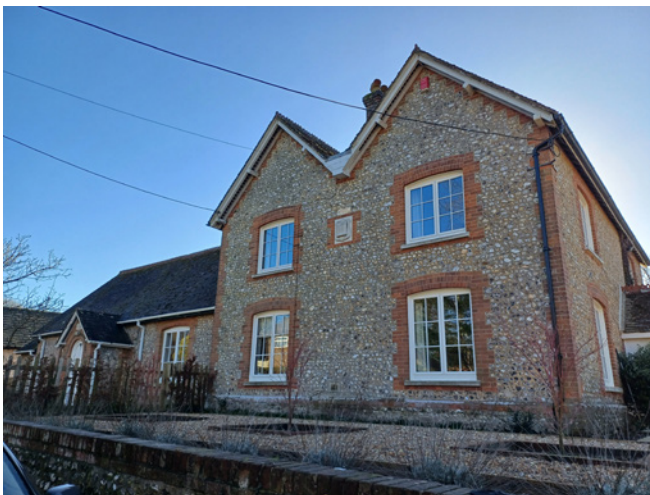
Meadowside, a Victorian residential property adjoining the Reading Rooms on Church Road, constructed in the 1880s. The building has a Victorian domestic style, featuring large street-fronting gables, brick detailing and decorative ridge tiles.

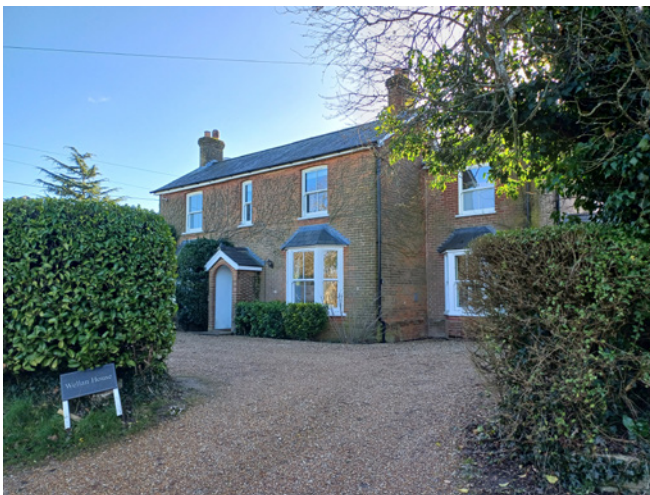
Wellan House, an Edwardian structure with typical features including sash and bay, with plain architectural treatment.

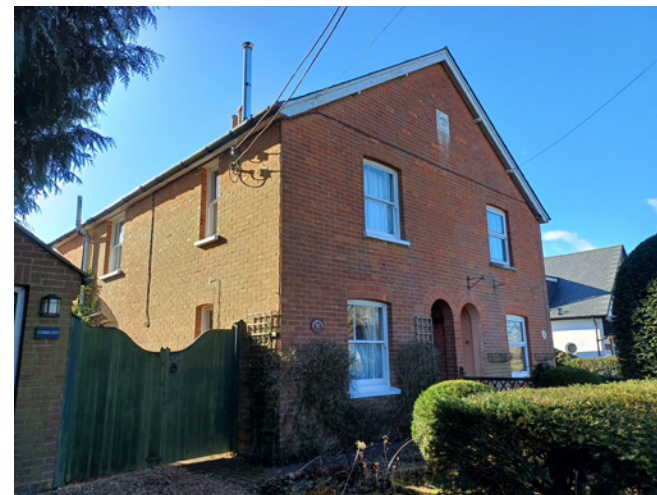
Cobblers and Homeside, a semi-detached pair of Edwardian houses. The simple architectural detail is typical for modest Edwardian dwellings, and the round-headed arches to the alleyways illustrate the wider influence of Neo-Classical architecture at this time.

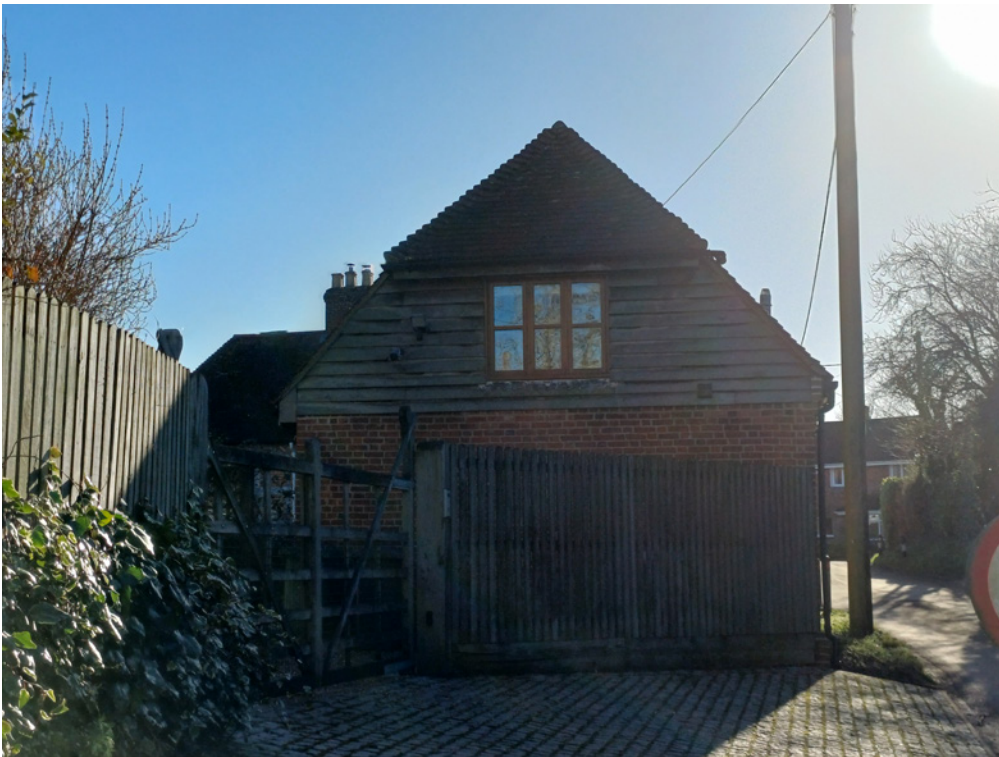
A former cartshed associated with Town Street Farm, which once occupied this site off Dunsell's Lane. It is a single storey rectangular building with an agrarian character, enhanced by the historic weatherboarding to the gable end.

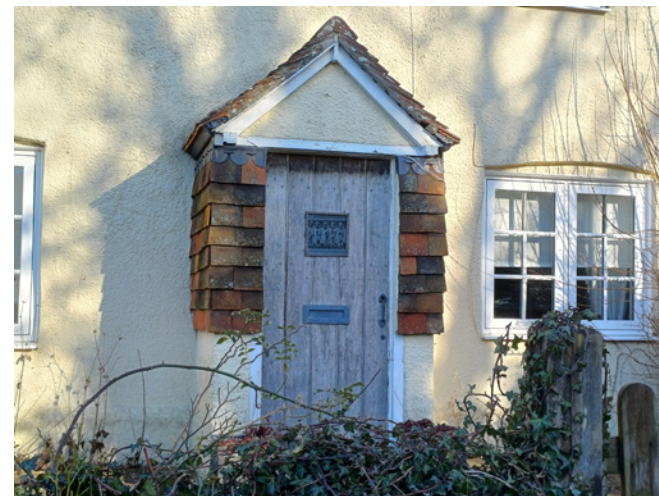
Hand-made clay tiles are a characteristic feature of vernacular architecture in Hampshire and can be found throughout the conservation area, like this example to a porch on Church Street.

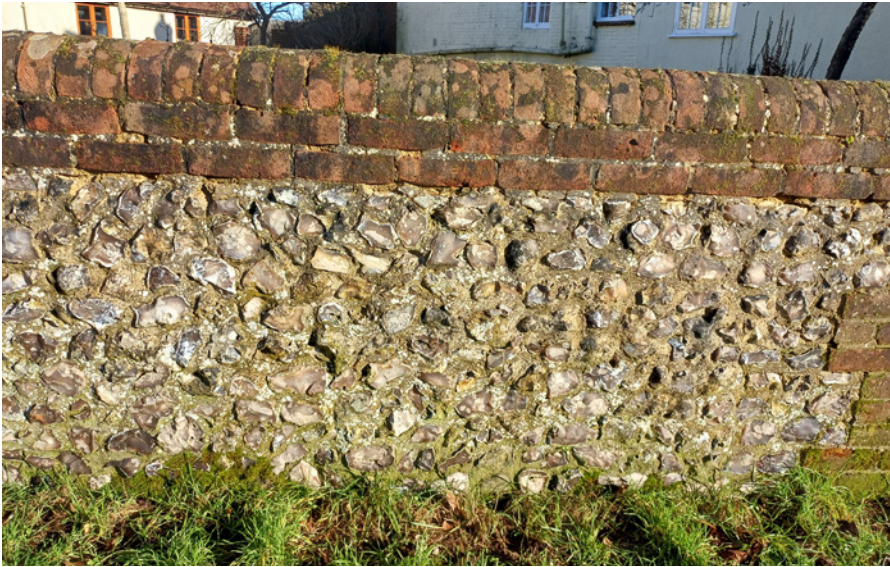
Detail of a knapped flint and brick boundary wall enclosing Town Street Farmhouse, on the corner of Dunsell's Lane.

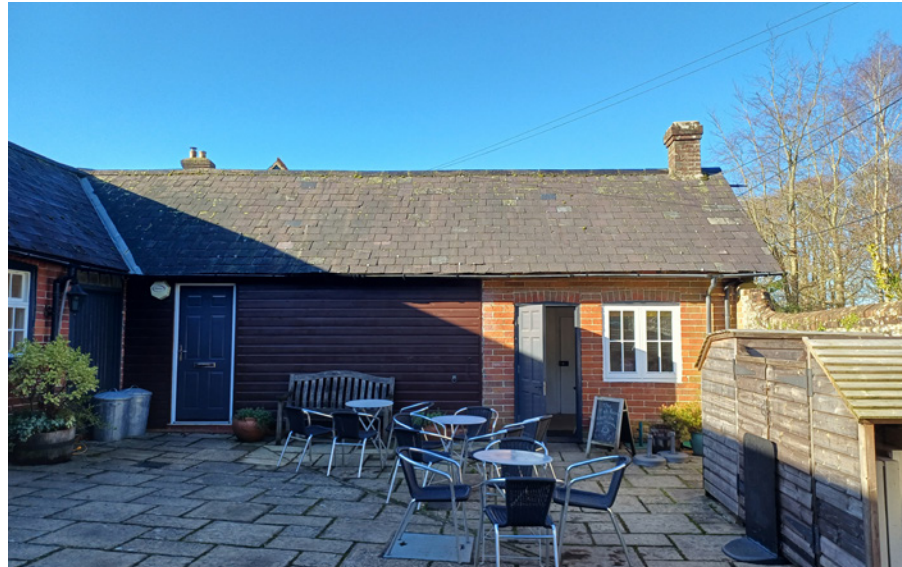
Traditional slate roof to a historic building on the south side of Church Street.

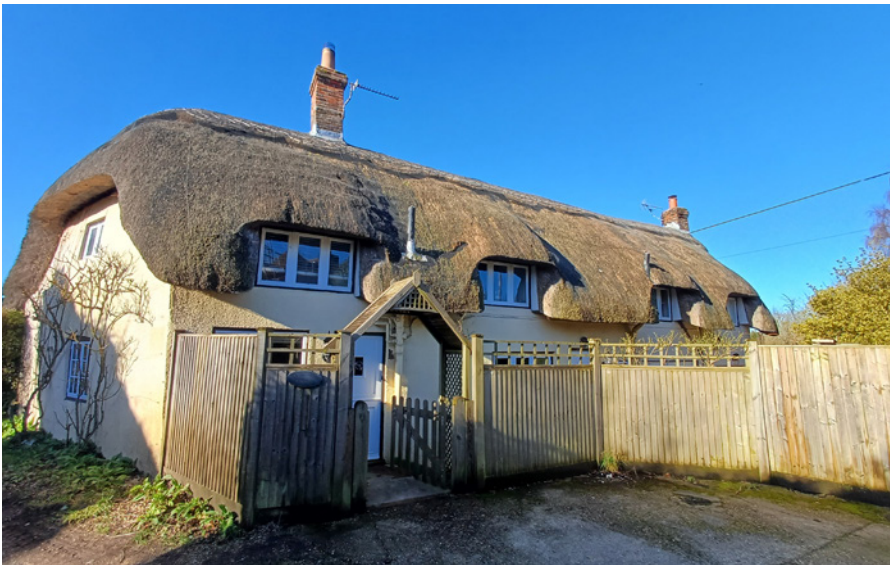
The 17th-century Cromwell Cottage, between Church Street and Church Lane, featuring a thatched roof as is common for the older buildings within the conservation area.

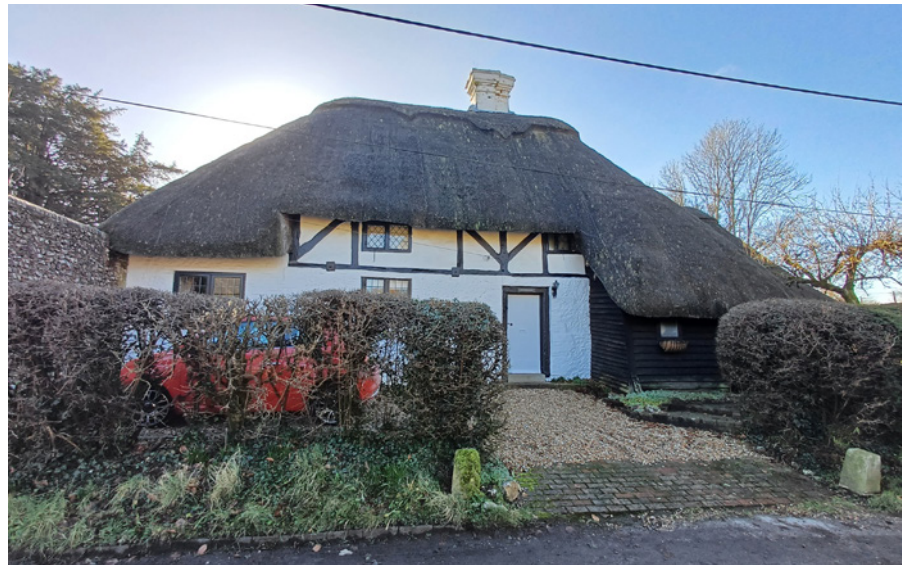
The timber frame to Fairways, on South Street, is partially visible at the upper storey.

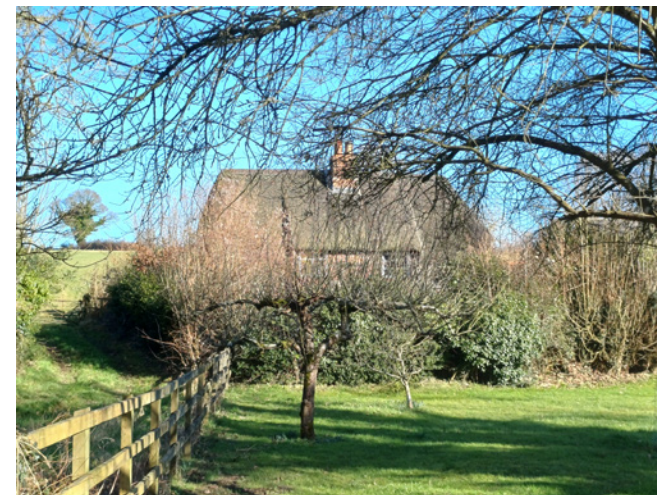
View 18: The prevalence of intervening vegetation in views of this humble vernacular dwelling on the north side of Petersfield Road enhances the rural character of the settlement.

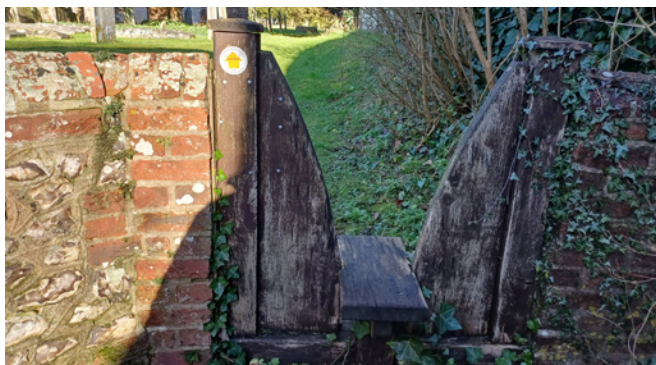
A traditional timber stile providing a pedestrian route into St Peter's churchyard.

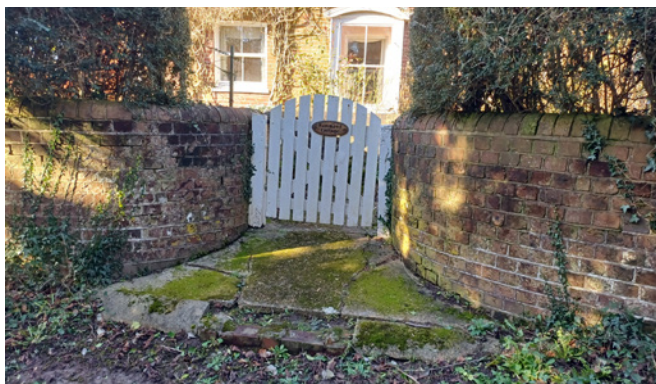
This historic boundary wall and traditionally styled timber gate enhance the public realm.

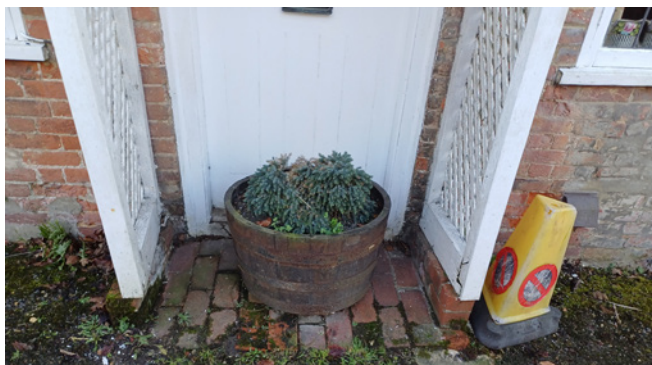
A historic brick threshold outside the front door of a cottage on Church Street, which lends visual interest and historic character.

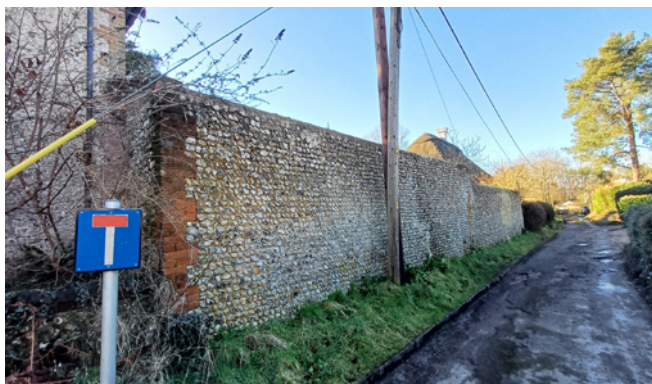
A tall flint boundary wall on South Street.

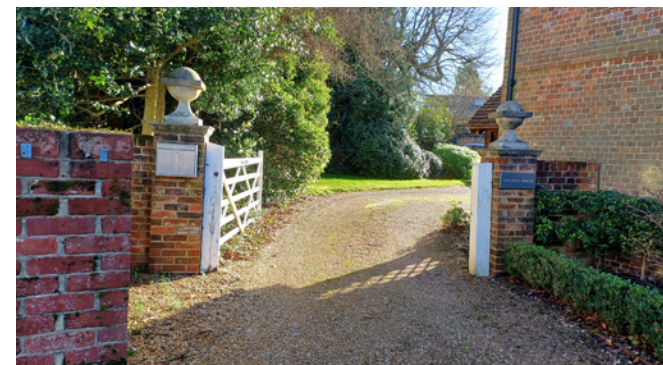
Brick gate piers announce the entrance to The Post House on Church Street. Note the permeable surface finish to the driveway, which is a more sympathetic alternative to modern hard standing.

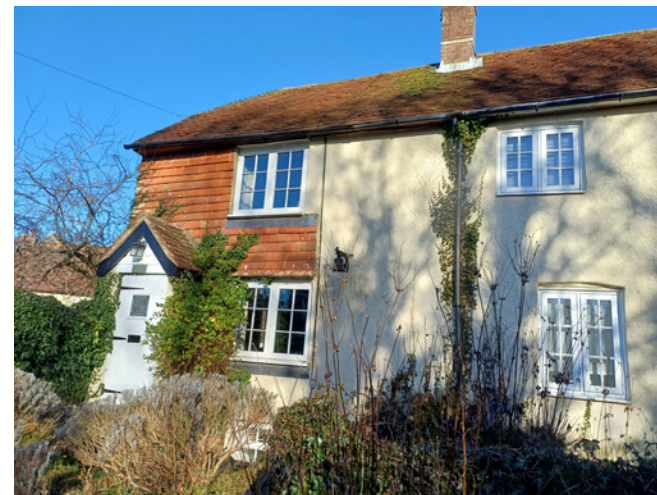
Vegetation growth. A small number of buildings are affected by climbing plants such as ivy, which have the potential to cause damage where roots disturb and displace historic fabric. Similarly, allowing moss to build up on roofs can cause damage by holding moisture against tiles and slates, and blocking gutters and downpipes. There are several instances where vegetation growth is taking place on boundary walls. This can also cause problems; plants rooted in mortar joints can force themselves deeper over time and push built fabric out of position.

Climbing plants such as ivy have the potential to disturb and displace historic fabric. Vegetation growing around downpipes can indicate the presence of moisture caused by leaks or blockages.

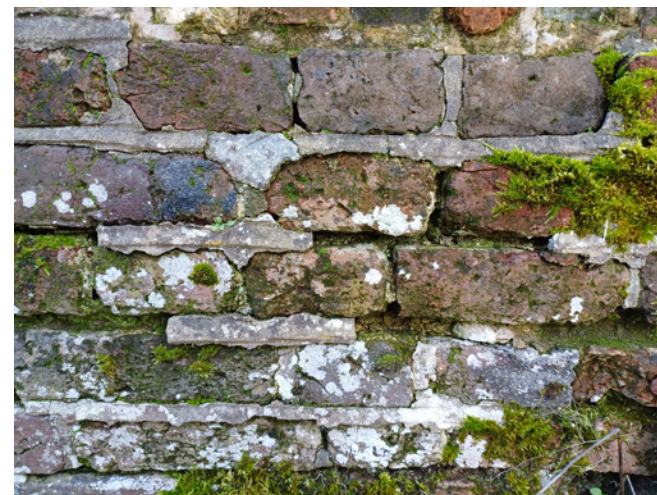
Maintenance of boundary walls. There are several instances throughout the conservation area where boundary walls are suffering from a lack of maintenance which manifests in missing joints, vegetation growth, lost sections of flint and spalling or crumbling brick and in some instances the loss of whole sections of wall. This could be remedied through the replacement of sections of brick/flint and lime mortar repairs.

Inappropriate repairs. Issues with condition are often initiated or exacerbated with the use of modern non-breathable materials such as cementitious mortar/ render and plastic-based paints, and there are some examples of this within the conservation area. Traditional buildings (generally those built before 1919) utilised 'breathable' materials which facilitate the free passage of moisture through a structure. Although older buildings absorb more moisture than modern structures, this moisture should be able to evaporate in dry conditions. Modern cement-based renders and mortars are not breathable and prevent the evaporation of moisture from a traditional building, thereby causing issues with damp and deterioration. Non-breathable paint applied over historic solid walls and timber windows can have a similar impact.

This section of boundary wall has been subject to inappropriate repairs with cement-based mortar. As moisture cannot escape through the mortar, it instead moves through the bricks, causing them to degrade over time. Failed pointing has not been replaced, leaving large gaps in the wall where plants can take root.

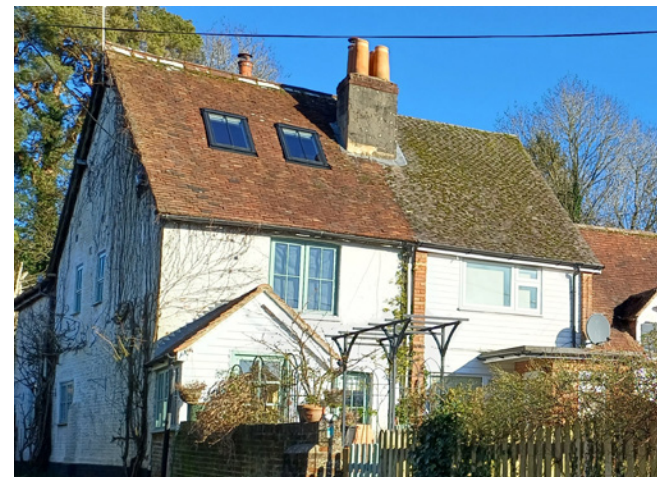
The proportions and materiality of the modern uPVC window lighting the upper floor of the property on the right detract from the historic character of the conservation area.

uPVC windows. Whilst the majority of windows within the conservation area are either historic or modern timber sash/casement units, some traditional units have been replaced with uPVC. The materials, style and position within the window reveal (i.e. flush with the elevation, rather than set back) of the uPVC replacements are detrimental to the character of historic elevations and collectively detract from the special interest of the conservation area. Although they are often perceived to offer environmental benefits, the lifespan of uPVC windows is also considerably shorter than that of well-maintained timber windows and the units cannot be easily recycled. The introduction of slim-profile double glazing or secondary glazing can offer improved thermal performance within older buildings, whilst retaining the appearance of traditional window units.⁰¹

Although many of the uPVC windows which have already been installed are unlikely to require replacement in the near future, there is scope for any further replacement windows and doors to be carried out using styles, materials and methods that are better suited to enhancing the special interest of the conservation area. It would be especially beneficial for first-generation uPVC double-glazing, which is generally coming to the end of its life cycle, to be replaced with more suitable alternatives.

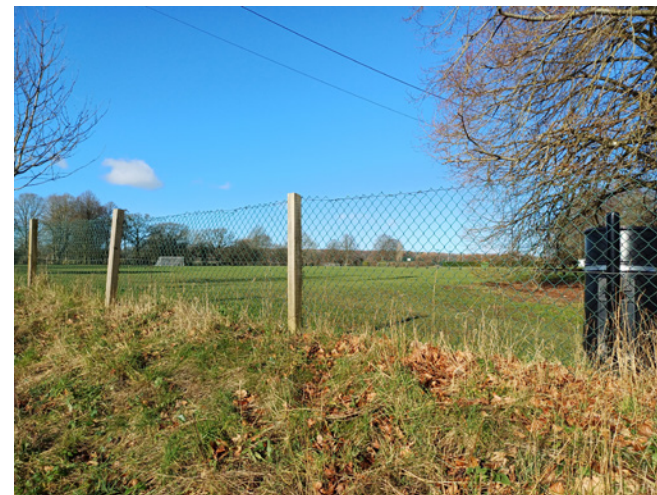
Inappropriate boundary treatments. There are several areas throughout the conservation area where modern shiplap fencing has been installed. Traditional picket or post-and-rail fencing is more appropriate in style and is in keeping with the historic character of the conservation area. The municipal chain link fencing bounding the south side of the recreation ground could be beneficially replaced.

Municipal style chain link fencing to the south of the recreation ground.

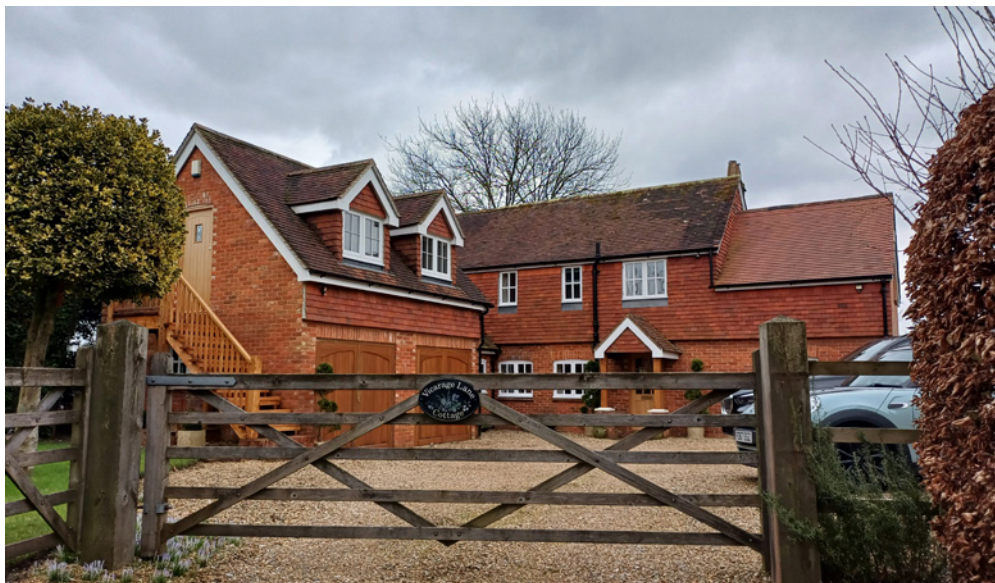
Vicarage Lane Cottage, Church Street. This is an example of modern development which is sensitive to the established character and materials palette within the conservation area, and enhances its setting.

Future development within or in the setting of the conservation area has the potential to contribute positively to its established character. Vicarage Lane Cottage for example, which lies just outside the western boundary of the conservation area, is a modern building sympathetic in scale, style and materiality to the special character of the historic core.

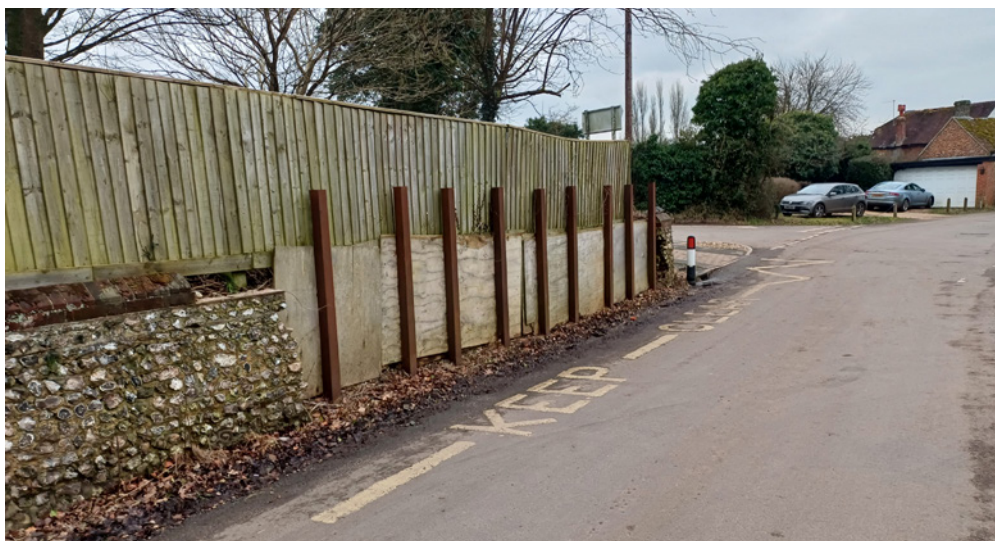
This temporary repair to a missing section of flint boundary wall on Church Street detracts from the character of the streetscape and provides an opportunity for enhancement.

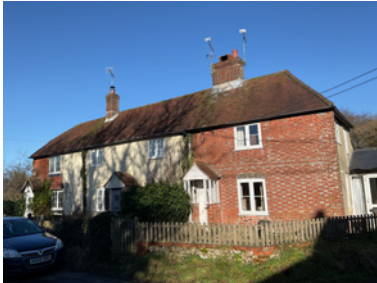
1-3 Church Street	Positive Contributor	Historic proportions, boundary treatments incorporating flint and brick and architectural details including hung tiles to Nos.1 and 2, exposed brickwork to No.3 and chimney stacks enhance the historic character of the streetscape.	N/A

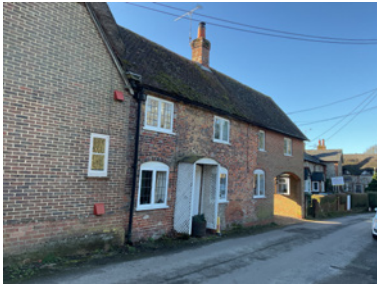
Dover Cottage (western extension)	Positive Contributor	Historic proportions and architectural details including exposed brickwork, timber window units and historic chimney stack enhances the historic character of the streetscape and contributes to the setting of the adjacent listed building.	N/A

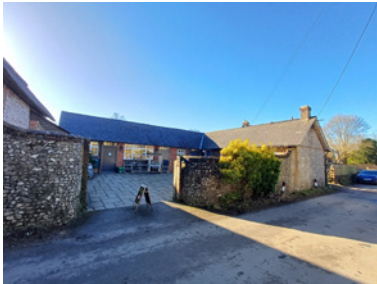
A photograph of a historic building with a thatched roof and a mix of knapped flint and brickwork. It features a prominent chimney and is situated on a street corner.
The Courtyard Buildings (includes surrounding wall)	Positive Contributor	Comprises former stable block and caretaker's house for the adjacent Reading Rooms. Derives historic and architectural interest through survival of historic courtyard plan and traditional materiality (brick and flint construction with slate covered roof). Substantial flint boundary wall also enhances the historic vernacular character of the streetscape.	N/A

A photograph showing a courtyard area with a stone wall on the left and a building with a slate roof on the right. The area is paved and has some greenery.

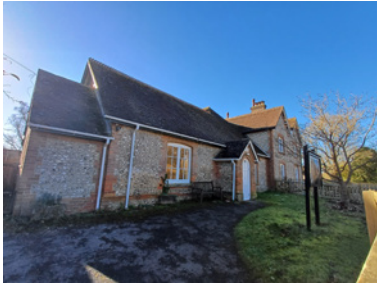
Reading Rooms	Positive Contributor	Historic proportions and architectural details including characteristic combination of knapped flint and brick detailing, timber windows/door and decorative ridge tiles enhance the historic character of the streetscape.	N/A

A photograph of a historic building with a steep gabled roof and a mix of knapped flint and brickwork. It has a small porch and is surrounded by a low wall.

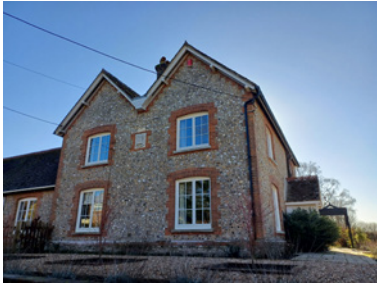
Building Name/ Number	Status	Reason for Inclusion (Positive Contributors)	List Entry (Where Applicable)	Photo/Brief Description
Meadowside	Positive Contributor	Historic proportions and architectural details including characteristic combination of knapped flint and brick detailing, decorative ridge tiles and surviving chimney stacks enhance the historic character of the streetscape.	N/A

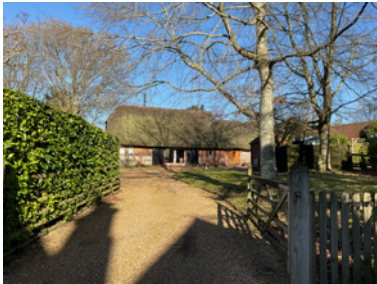
Old Parsonage Tithe Barn	Positive Contributor	Architectural details including characteristic combination of knapped flint and brick detailing and thatched roof enhance the historic character of the streetscape. Despite later conversion the original proportions of this agricultural building are still appreciable.	N/A

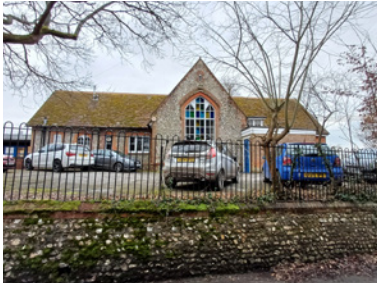
Building Name/ Number	Status	Reason for Inclusion (Positive Contributors)	List Entry (Where Applicable)	Photo/Brief Description
Ropley Primary School (excludes 20th-century extensions)	Positive Contributor	Traditional flint boundary treatments and architectural details including characteristic combination of knapped flint and brick detailing, historic Gothic Revival style windows and typical Victorian proportions enhance the historic character of the streetscape.	N/A

A photograph of Ropley Primary School, a historic building with a gabled roof, a prominent arched window, and a mix of brick and flint construction. Several cars are parked in front of the school.
The Forge	Grade II Listed Building	N/A	https://historicengland.org.uk/listing/the-list/list-entry/1179655

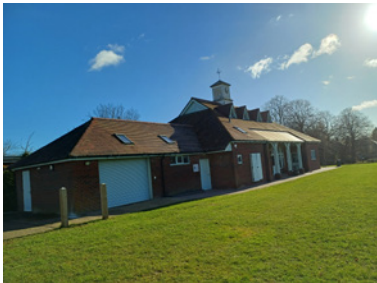
Sports Pavilion	Positive Contributor	Although a modern building, the traditionally styled sports pavilion enhances the historic recreational character of the adjacent sports ground, which was first laid out at the end of the 19th century.	N/A

A photograph of the Sports Pavilion, a modern building with a traditional design, featuring a gabled roof and a small cupola. It is located on a grassy area under a clear blue sky.

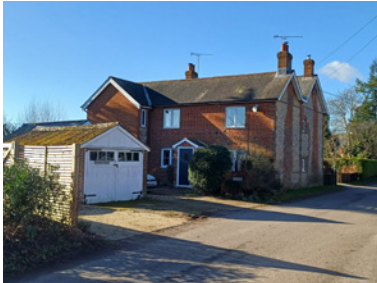
Building Name/ Number	Status	Reason for Inclusion (Positive Contributors)	List Entry (Where Applicable)	Photo/Brief Description
Ivy and Ashley Cottage (including later extension to Ashley Cottage)	Positive Contributor	Historic proportions and architectural details including characteristic combination of knapped flint and exposed red brick, slate roof covering and surviving chimney stacks enhance the historic character of the streetscape.	N/A

A photograph of Ivy and Ashley Cottage, a two-story red brick building with a slate roof, multiple chimneys, and a white garage door. The house is set back from the road with some landscaping.
Wellan House	Positive Contributor	Historic proportions and architectural details including exposed red brick, slate roof covering, sash windows and surviving chimney stacks enhance the historic character of the streetscape.	N/A

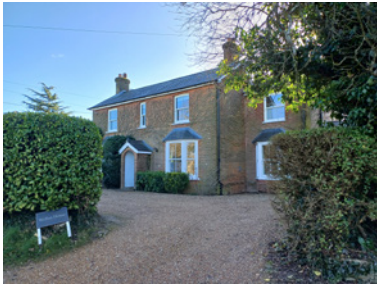
A photograph of Wellan House, a two-story red brick building with a slate roof, sash windows, and a small white porch. The house is surrounded by mature hedges and trees.

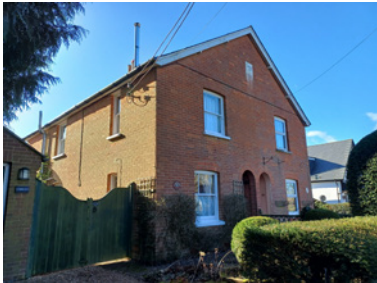
Cobblers and Homeside	Positive Contributor	Historic proportions and architectural details including exposed red brick, slate roof covering, sash windows and surviving chimney stacks enhance the historic character of the streetscape.	N/A

A photograph of Cobblers and Homeside, a two-story red brick building with a slate roof, sash windows, and a small white porch. The house is surrounded by mature hedges and trees.

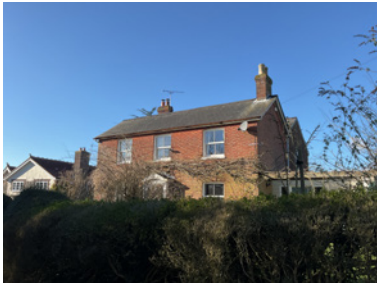
Building Name/ Number	Status	Reason for Inclusion (Positive Contributors)	List Entry (Where Applicable)	Photo/Brief Description
Hammonds Lane				
Hammond Cottage	Positive Contributor	Historic proportions and architectural details including exposed red brick, slate roof covering, sash windows and surviving chimney stacks enhance the historic character of the streetscape.	N/A

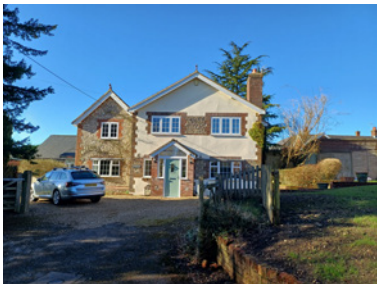
Yewstead (south range only)	Positive Contributor	Derives historic interest as site of former public house known as The Star Inn. Large bow window to ground floor illustrates former commercial usage. Historic proportions and traditional materiality (knapped flint with brick dressings) enhance the historic character of the conservation area.	N/A

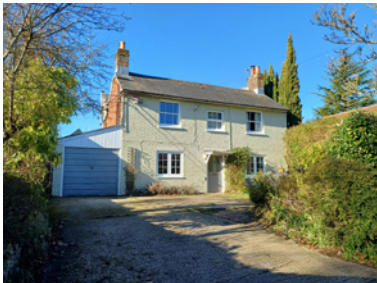
Laurel Cottage	Positive Contributor	Historic proportions and architectural details including slate roof coverings, hung tiles to south gable end, sash windows to upper storeys and surviving chimney stacks enhance the historic character of the conservation area.	N/A

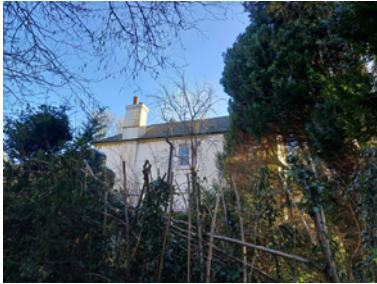
Building Name/ Number	Status	Reason for Inclusion (Positive Contributors)	List Entry (Where Applicable)	Photo/Brief Description
Winton Cottage	Positive Contributor	Historic proportions and architectural details including slate roof coverings, sash windows and surviving chimney stacks enhance the historic character of the conservation area.	N/A

A photograph of Winton Cottage, a white building with a slate roof, partially obscured by trees and a fence.
Outbuilding in grounds of Winton Cottage	Positive Contributor	Now utilised as garage, this single-storey structure incorporates fabric from an earlier outbuilding. The roof coverings, timber cladding and timber-framed extension are modern but complement the rural vernacular character of the conservation area.	N/A

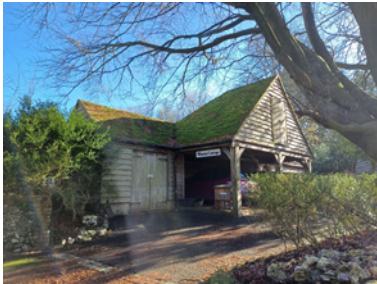
A photograph of a single-storey outbuilding with a green roof and timber cladding, situated in a garden.
Petersfield Road

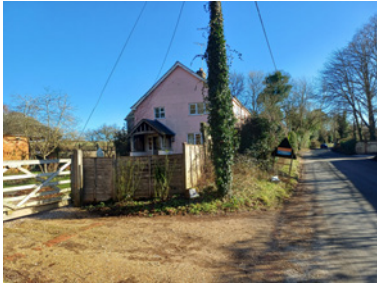
Building Name/ Number	Status	Reason for Inclusion (Positive Contributors)	List Entry (Where Applicable)	Photo/Brief Description
Hall Place Cottage	Positive Contributor	Historic proportions, slate roof finish and survival of brick chimney stack enhance the historic character of the streetscape.	N/A

A photograph of Hall Place Cottage, a small, light-colored building with a dark roof, situated on a dirt path next to a wooden fence. A tall, thin tree stands to the right of the building.
Little Grove Farmhouse	Positive Contributor	Built in a neo-vernacular style around the turn of the 20th century, the materiality of this dwelling (including exposed red brick and hung tiles) contributes to the characteristic material palette found throughout the conservation area.	N/A

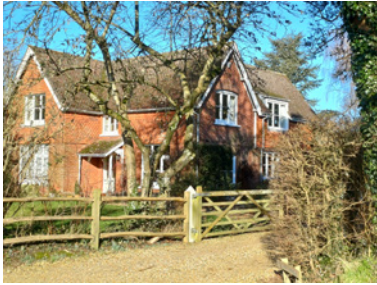
A photograph of Little Grove Farmhouse, a large, two-story red brick building with a gabled roof and multiple windows, surrounded by trees and a wooden fence.

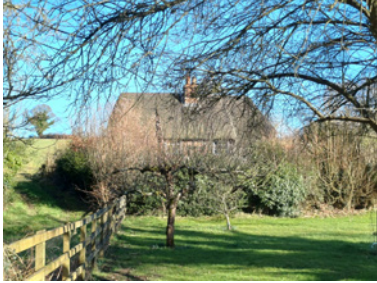
Thatched Cottage at Cowgrove Farm	Positive Contributor	The historic proportions and traditional materiality of this building (including a highly visible thatched roof) enhance the rural vernacular character of the conservation area.	N/A

A photograph of the Thatched Cottage at Cowgrove Farm, a small, dark building with a prominent thatched roof, situated in a grassy field with trees in the background.

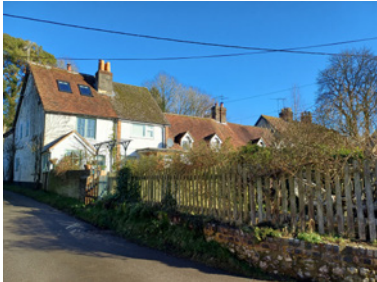
Building Name/ Number	Status	Reason for Inclusion (Positive Contributors)	List Entry (Where Applicable)	Photo/Brief Description
South Street				
1 and 2	Positive Contributor	Historic proportions, boundary treatments and architectural details including clay roof tiles, timber windows to No.1 and surviving chimney stacks enhance the historic character of the conservation area.	N/A

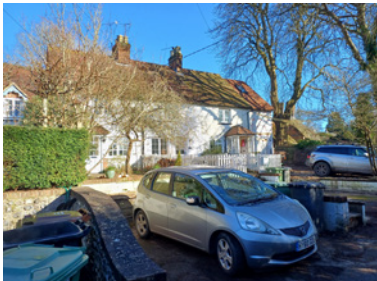
5 to 7	Positive Contributor	Historic proportions and architectural details including clay roof tiles and surviving chimney stacks enhance the historic character of the streetscape.	N/A

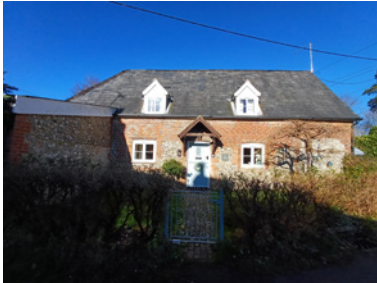
Building Name/ Number	Status	Reason for Inclusion (Positive Contributors)	List Entry (Where Applicable)	Photo/Brief Description
Guys Cottages	Positive Contributor	Historic proportions and architectural details including characteristic use of knapped flint and exposed red brick, timber window units, slate roof coverings and surviving chimney stacks enhance the historic character of the conservation area.	N/A

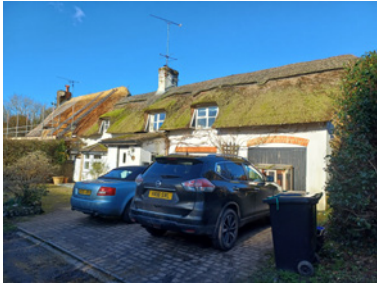
Building Name/ Number	Status	Reason for Inclusion (Positive Contributors)	List Entry (Where Applicable)	Photo/Brief Description
Rosa Cottage	Positive Contributor	Historic proportions and traditional thatched roof finish enhance the rural vernacular character of the conservation area.	N/A

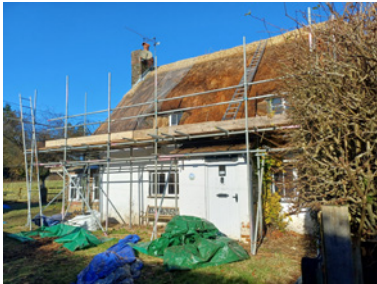
Elm Cottage	Positive Contributor	Historic proportions and traditional thatched roof finish enhance the rural vernacular character of the conservation area.	N/A
