UPPER FROYLE CONSERVATION AREA
CONSERVATION AREA APPRAISAL AND MANAGEMENT PLAN: CONSULTATION DRAFT
ISSUE 02
APRIL 2025

UPPER FROYLE: CONSERVATION AREA APPRAISAL AND MANAGEMENT PLAN

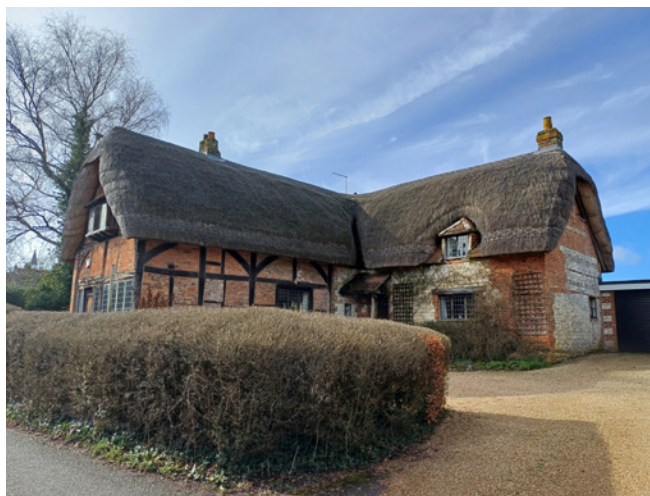
Post Office Cottage, which dates from the late 16th century with 18th-century additions, is typical of the local vernacular style. It uses a combination of local materials including timber framing with brick infill panels, malmstone, clay tiles and thatch.

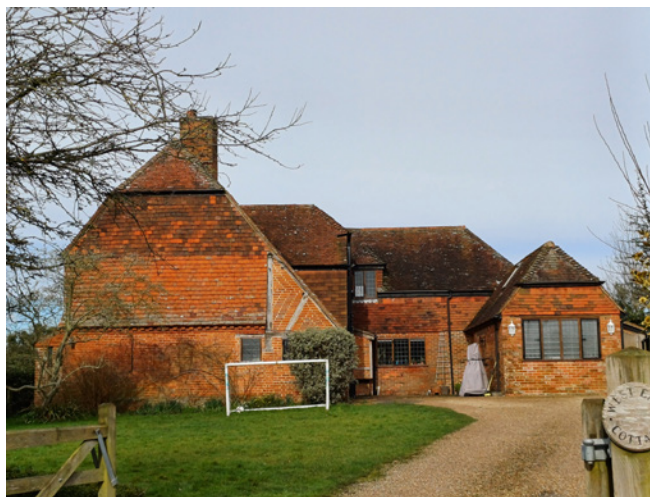
West End Cottage, a 17th-century vernacular dwelling. The materials used (clay tiles, red brick, timber), the evidence of multiple additions over time and the different sizes of window openings help to identify this as a vernacular structure.

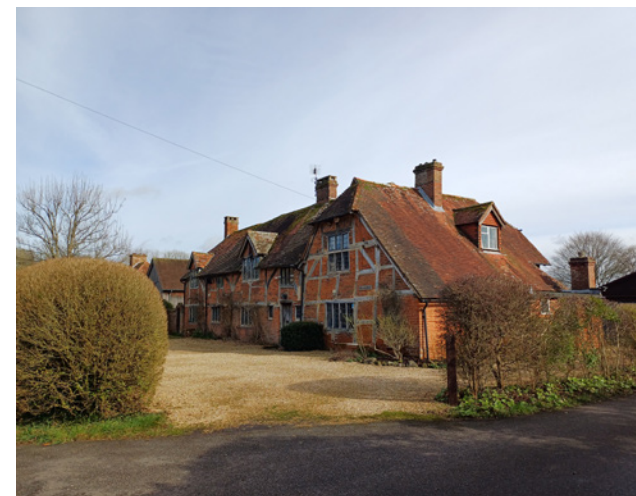
Blunden's House, which originated as a late-medieval hall house, incorporates the timber framing and steeply-pitched roof slopes characteristic of vernacular architecture in this region.

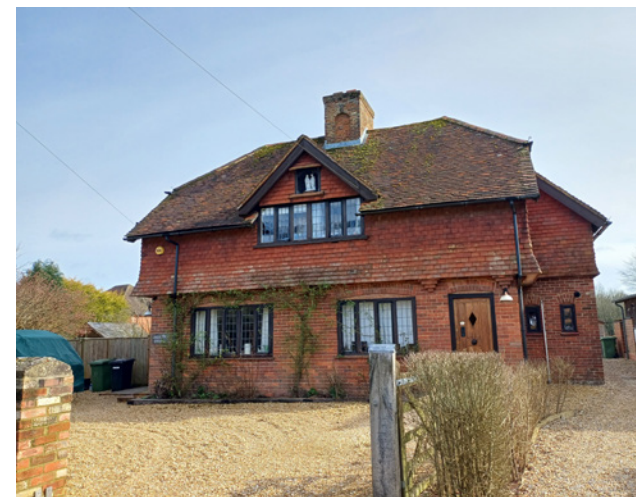
Jasmine Cottage, constructed between 1896 and 1910, showcases the fashion for vernacular architecture which was popular at this time through the use of clay hung tiles, a traditional half-hipped roof and large Tudor-Gothic style windows.

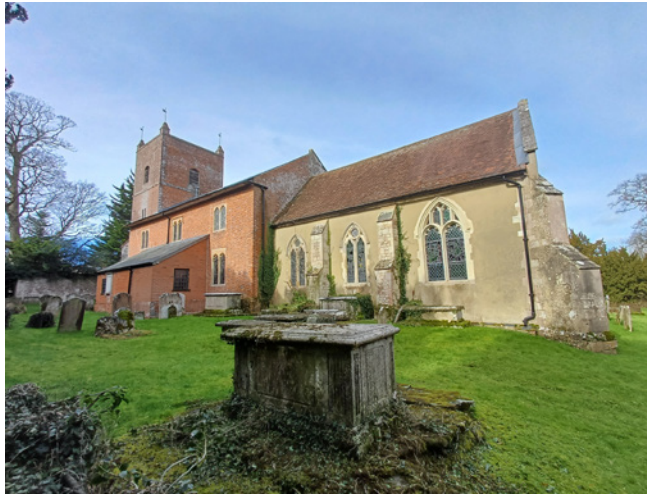
The Gothic style St Mary's Church, incorporating fabric dating from the 14th century with an early 18th-century tower.

Gothic Buildings: Gothic architecture, characterised by the use of pointed arches, tracery and stained glass, was the mainstay of religious and royal architecture in England until the 17th century. The Gothic style is illustrated at St Mary's Church – built on the site of an older church during the early 14th century with later additions and extensions.

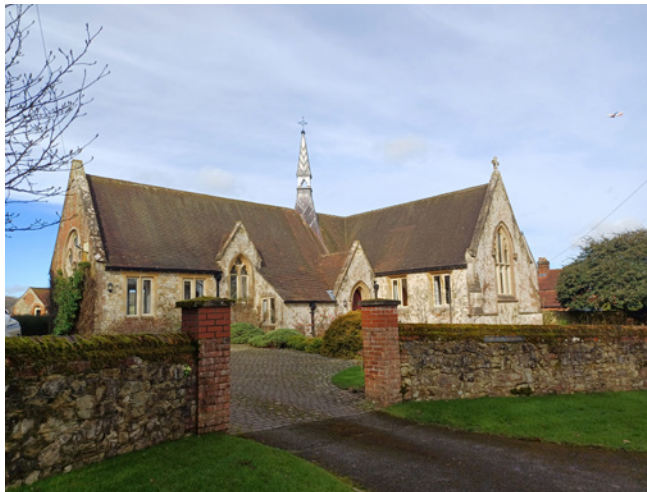
The mid-19th-century former National School on the north side of Ryebriidge Lane. With its lavish use of pointed arches, mouldings and tracery this building draws strongly on medieval ecclesiastical architecture.

Gothic experienced a substantial revival in the 19th century when it was used for civic and domestic buildings as well as religious and royal ones. The mid-19th-century National School on the west side of Ryebriidge Lane illustrates the Victorian admiration for medieval Gothic architecture. Gothic Cottage, to the west of the conservation area, demonstrates the characteristic sense of verticality found in Gothic architecture through its steeply pitched roof slopes.

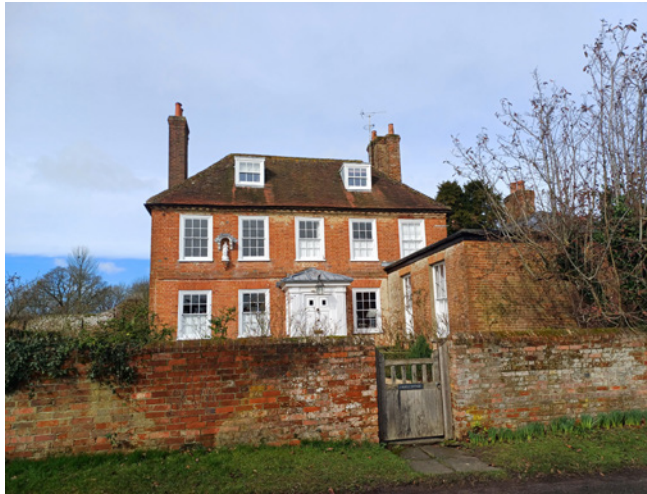
Froyle Cottage, an 18th-century Georgian building, easily identifiable as such through its highly symmetrical façade, shallow hipped roof and regularly arranged sash windows.

Georgian Neo-Classicism: Neo-Classicism was the dominant architectural style during the 18th and early 19th centuries. Neo-Classical buildings are deliberately designed to be symmetrical with regular windows and features such as columns, pilasters, pediments and keystones. Several buildings within the conservation area demonstrate the Georgian Neo-Classical style. Froyle Cottage (18th century) and Froyle House (early 19th century) incorporated Neo-Classical features from the outset. Both display characteristic Georgian features including regularly arranged sash windows and shallow hipped roofs (in the case of Froyle House hidden behind a parapet).

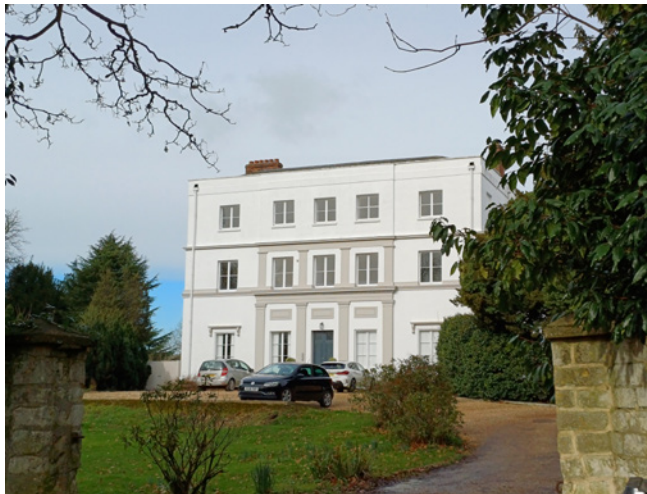
Froyle House, a substantial late-Georgian residence constructed on Ryebriidge Lane around 1820. Typical Neo-Classical features include the regular sash windows, pilasters, projecting cornices, egg-and-dart mouldings and pale stucco finish.

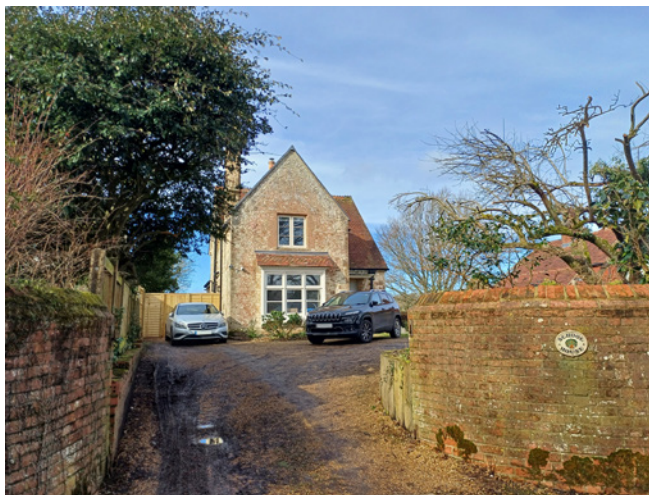
The steeply-pitched roof and street-fronting gable to the School House are characteristic of Victorian domestic architecture.

Victorian and Edwardian Domestic Style. The influence of the Gothic tradition in Victorian architecture was most often expressed in large civic and commercial buildings, purpose-built urban terraces and substantial houses. The more modest residences, such as those found within Upper Froyle, used a style less dependent upon medieval Gothic features. They often incorporated square (rather than arched) window openings, bay windows and pitched roofs with large street-fronting gables. The use of brick detailing to decorate external facades was common. Home Farm Cottages at the western end of the conservation area and School House due east of the former National School are good examples of this Victorian architectural style.

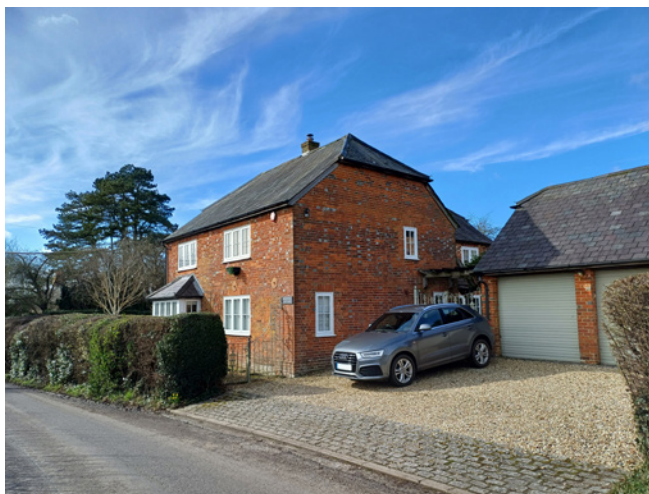
Whiteway Cottage at the eastern edge of the conservation area. The projecting bay window is a typical Edwardian feature.

Similarly, whilst large Edwardian houses, purpose-built urban terraces and civic/commercial structures from the early 20th century were often highly decorative, smaller dwellings such as those found within the conservation area were comparatively simple. The influence of the Neo-Georgian style in Edwardian architecture can be seen in the use of sash windows and hipped roofs. As with Victorian properties, bay windows were also common. St Joseph's Cottages and Whiteway Cottage are late 19th or early 20th-century structures which incorporate some of these features.

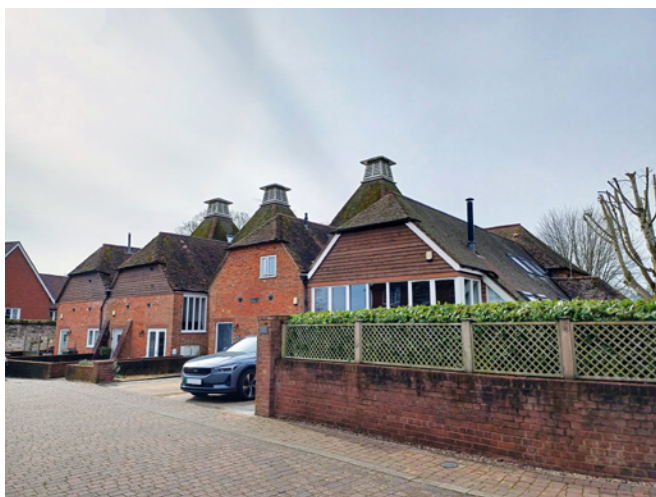
Former stables and malshouses, since converted to residential use, denote the former location of Home Farm, to the south-west of Froyle Park.

Historic Agricultural/Service Buildings: Throughout the conservation area there are examples of historic barns, stables and malshouses which enhance the rural character of the conservation area and illustrate its origins as an agricultural settlement. These buildings are generally single storey structures (some with additional storeys inserted in modern times) with a functional character and are often clad with timber. Although many have since been adapted to serve other uses, their functional agricultural character is still appreciable.

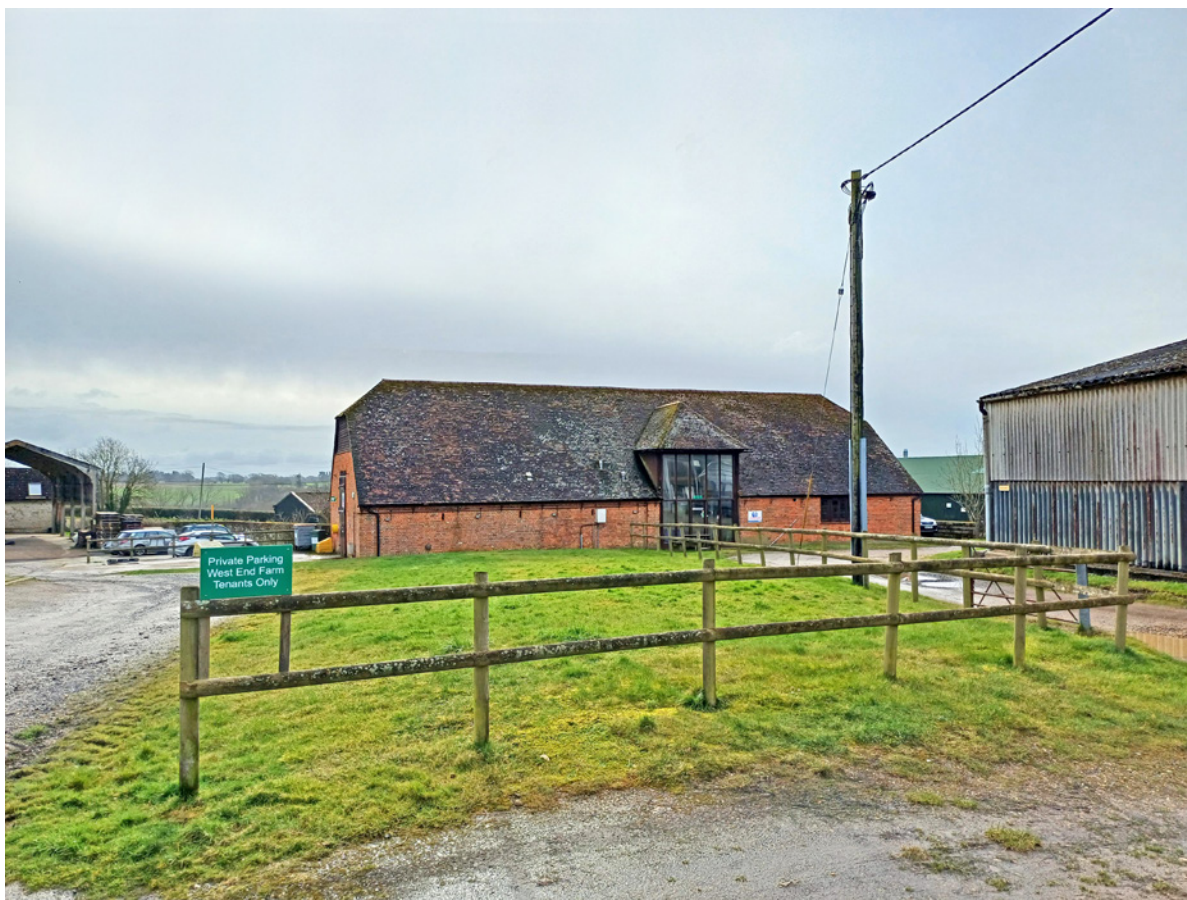
A substantial early 19th-century barn at West End Farm. Many such buildings survive throughout the conservation area, often in groups, illustrating the agricultural origins of the settlement.

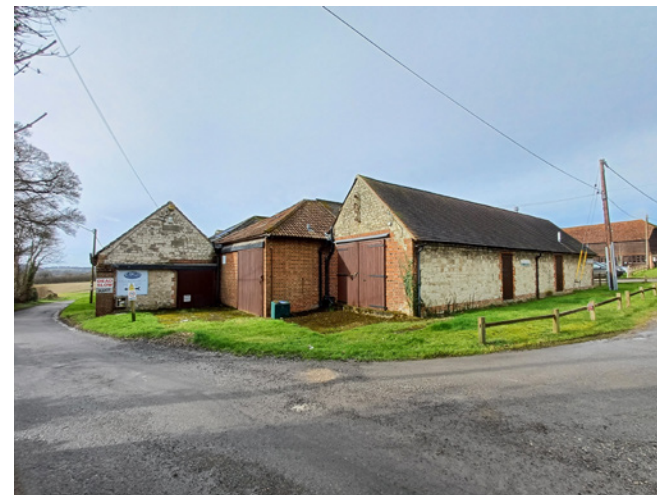
A combination of malmstone and red brick to a historic agricultural structure to the west of the conservation area.

Malmstone, a local chalky sandstone, is also found in multiple buildings including the highly-prominent Froyle Park as well as boundary walls and historic agricultural structures.

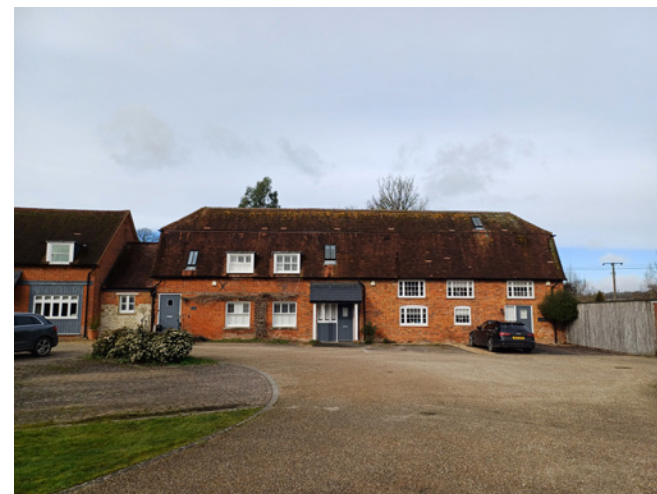
This historic agricultural structure adjacent to Froyle Park utilises a characteristic materiality of exposed red brick with clay roof tiles.

Exposed red brick is the most visually prominent material within the conservation area. Painted/ rendered buildings (Thatch Cottage, Froyle House, St Katherine's Cottage) are in the minority. Brick is a common construction material for all building types within the conservation area, and is also found in boundary walls and chimney stacks.

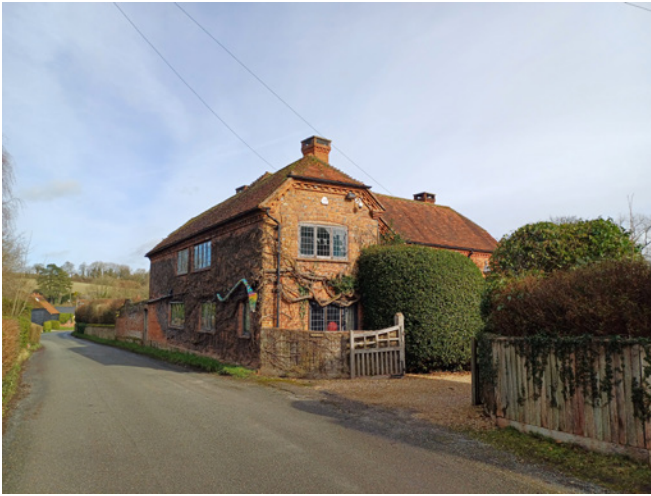
Park Edge, towards the eastern end of the conservation area, incorporates red brick, clay tiles and timber windows. The rear range is timber framed.

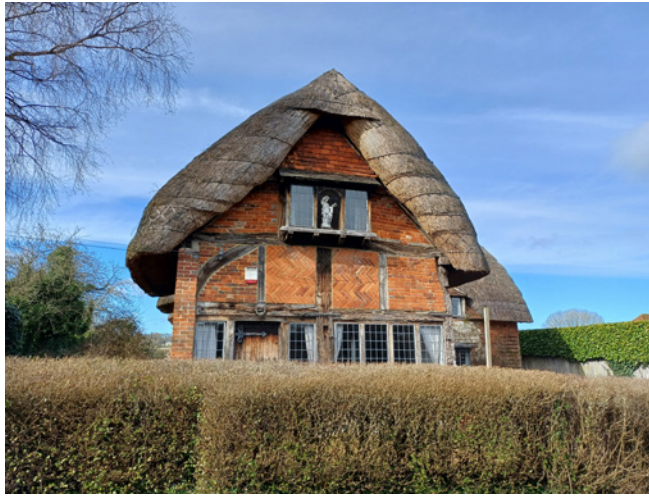
Post Office Cottage, a timber-framed, thatched building with red-brick infill panels, timber windows and dark red hung tiles. Note the statuette of the saint in the niche at high level.

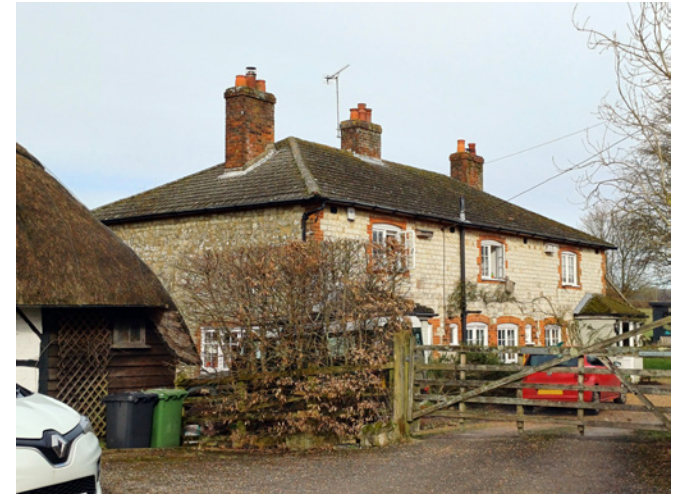
Malmstone is a common building material across the conservation area, as seen at this small Victorian terrace.

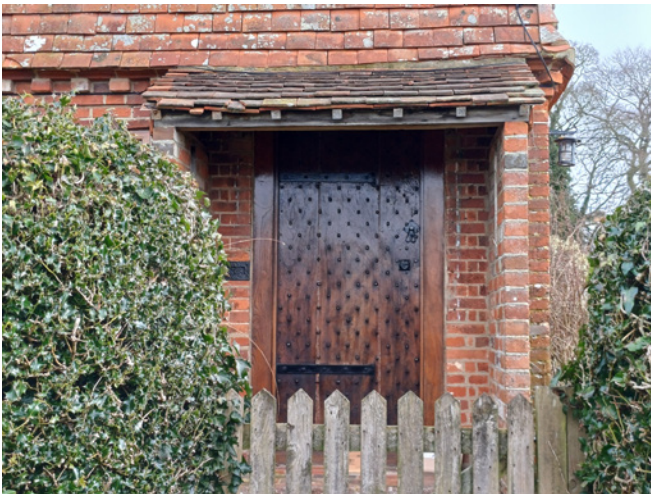
A historic plank and batten door to the 17th-century West End Cottage, which lends a high degree of visual and historic interest.

Doors are largely timber and are a mixed of historic and traditionally styled modern doors. Some are solid whilst others are partially glazed.

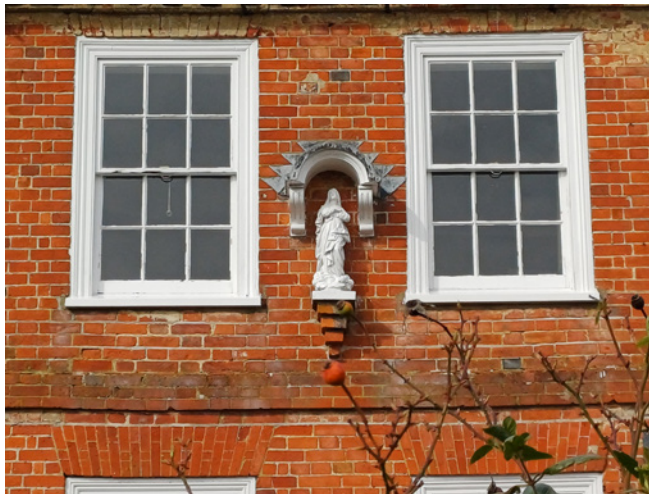
The statuettes of saints positioned at high level on many buildings across the village is a unique feature of the conservation area.

Of particular interest within Upper Froyle are the multitude of small statues of saints, which were brought back from Italy by the last Lord of the Manor during the early 20th century and installed on various properties across the estate.

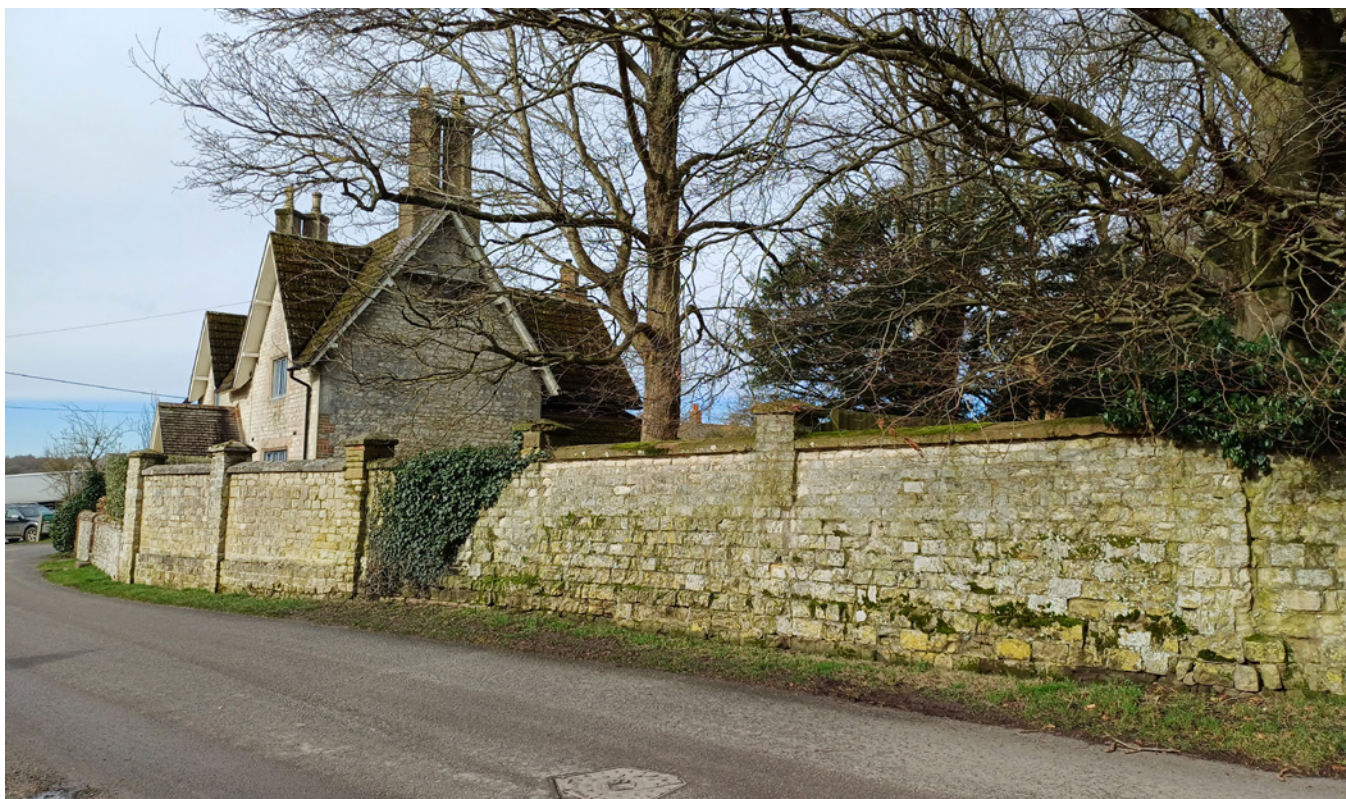
The malmstone boundary wall enclosing Froyle House.

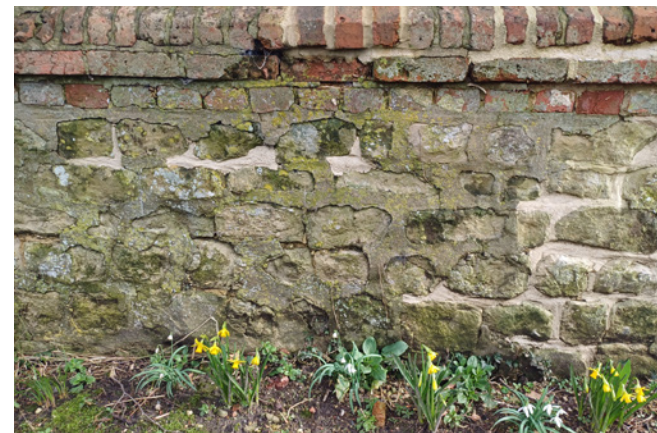
This section of malmstone boundary wall off Ryebidge Lane has been subject to inappropriate repairs with cement-based mortar. As moisture cannot escape through the mortar, it instead moves through the masonry, causing it to degrade over time.

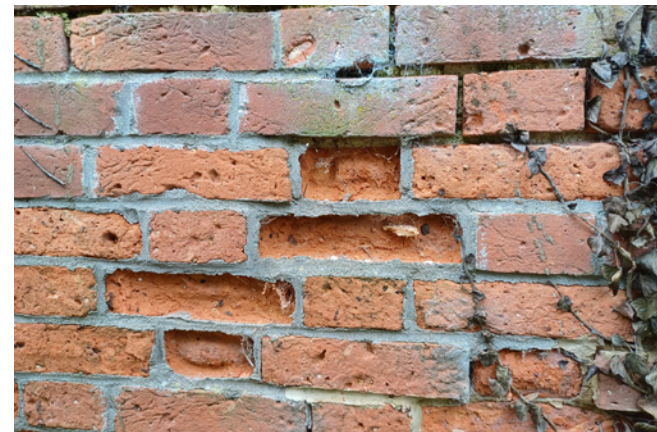
A section of boundary wall to the Old Dairy off Ryebidge Lane. This illustrates the damage caused to fabric through the use of cementitious mortar to re-point historic brickwork.

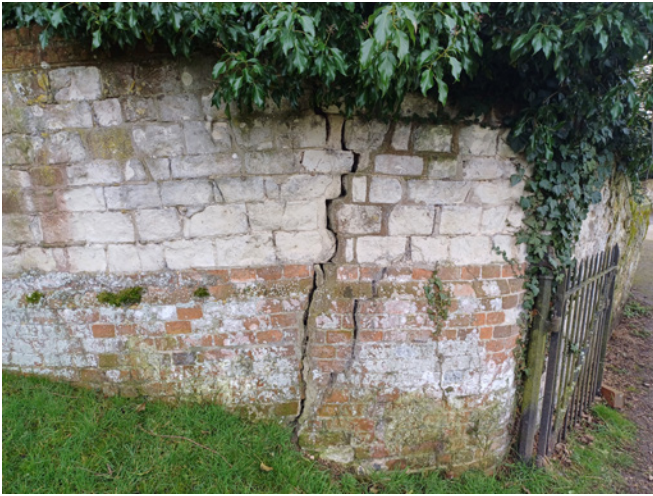
A section of historic boundary wall between Froyle Park and the churchyard, which is in need of repair.

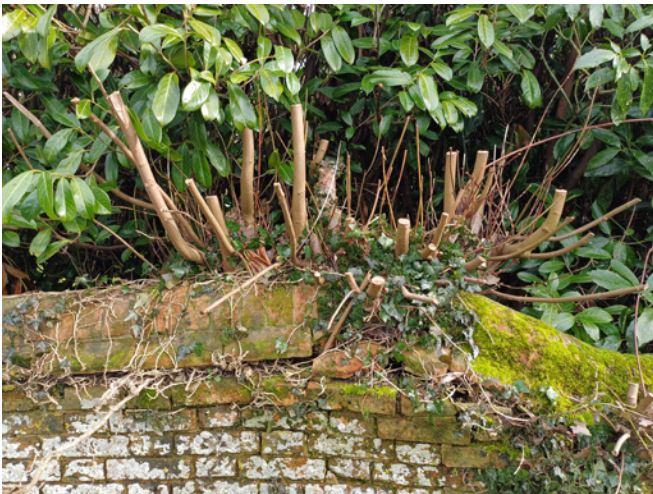
When left unmanaged, vegetation can take root in historic joints and push fabric out of place as it grows.

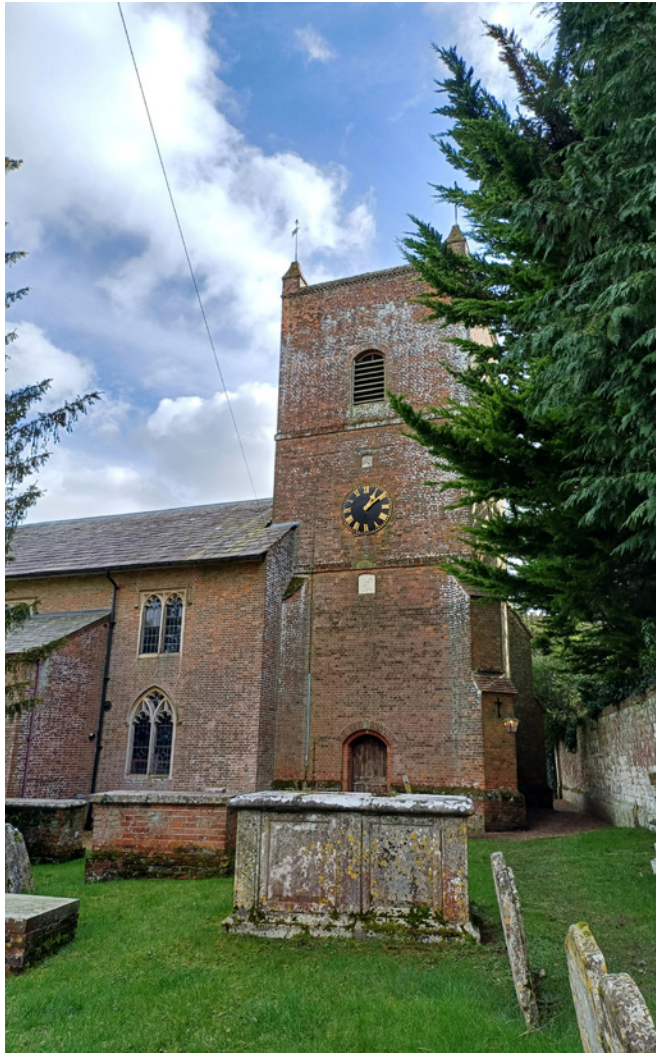
Heavy efflorescence (salt staining) across the brickwork on the church tower, which is particularly vulnerable to repeated cycles of wetting and drying due to its exposed position.

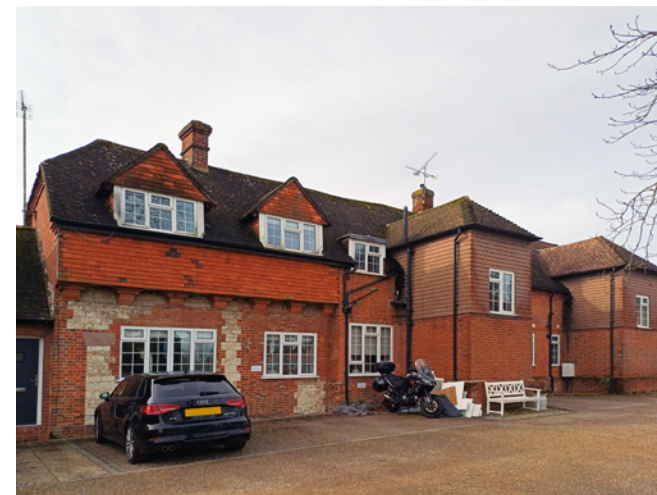
The proportions and materiality of the modern uPVC windows to this historic agricultural structure (since converted to residential use) depreciate the historic character of the conservation area.

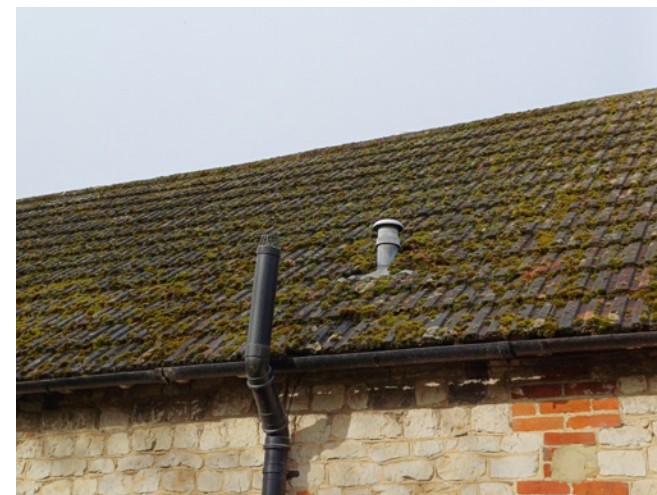
The uPVC downpipe and interlocking concrete roof tiles to this historic agricultural structure at West End Farm detracts from the historic character of the building and the wider conservation area.

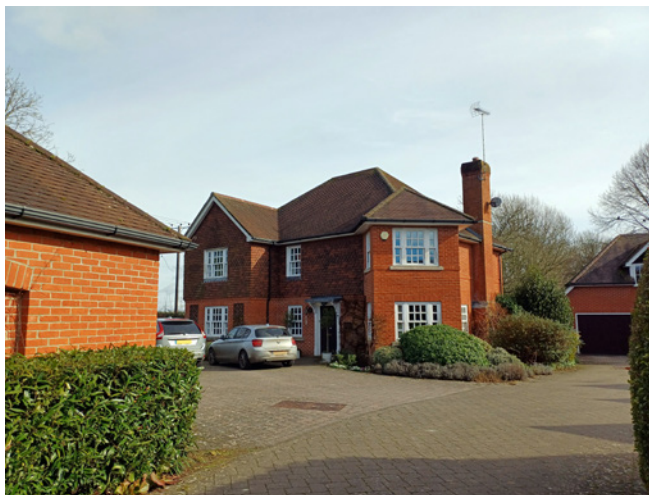
No.3 Beech Grove, constructed c.2003. In its incorporation of both hipped and pitched roof forms, rich red brick, hung clay tiles and timber sash windows this building responds effectively to the established character of the conservation area.

Future development within or in the setting of the conservation area has the potential to contribute positively to its established character. No. 3 Beech Grove for example, which lies just outside the boundary of the conservation area within a small early 21st-century development, is a modern building sympathetic in scale, style and materiality to the special character of the historic settlement.

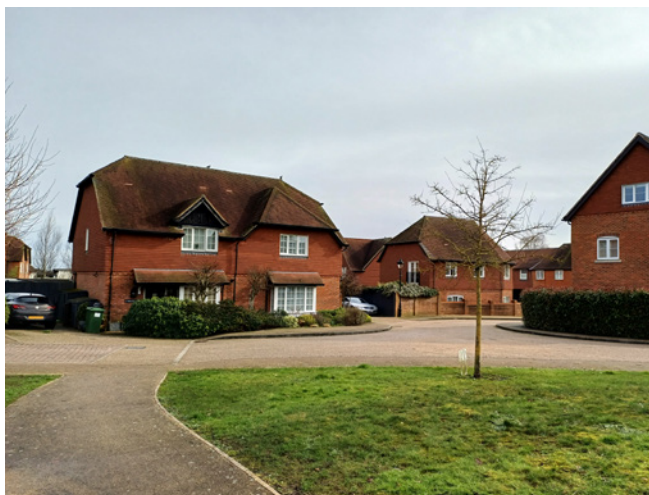
The modern development on the former Treloar School site responds to the established character of the historic settlement, incorporating a mixture of pitched and half-hipped roofs, red brick and hung tiles. Brick detailing is used effectively in places to enliven facades and add visual interest.

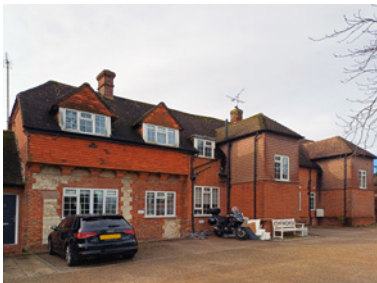
Froyle Green				
Froyle Place Cottages	Positive Contributor	Despite its conversion to residential use, the functional proportions of this former agricultural building are still legible, and reflect the former agricultural use of this area prior to the establishment of Treloar's School and the later residential estate.	N/A

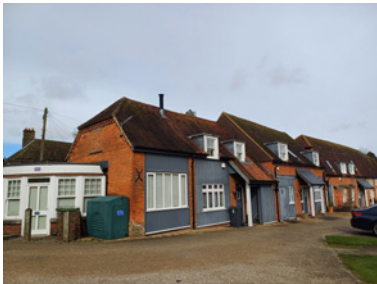
4 & 5 Jephson House	Positive Contributor	Despite its conversion to residential use, the functional proportions of this former agricultural building are still legible, and reflect the former agricultural use of this area prior to the establishment of Treloar's School and the later residential estate.	N/A

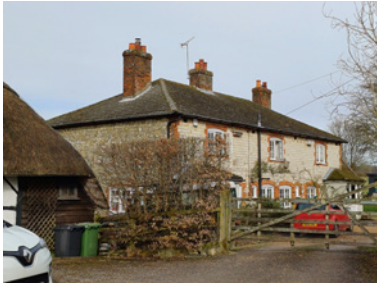
Building Name/ Number	Status	Reason for Inclusion (Positive Contributors)	List Entry (Where Applicable)	Photo/Brief Description
White Grounds	Positive Contributor	Historic proportions, characteristic materiality (malmstone) and architectural details including timber casement windows, red-brick dressings and historic chimney stacks enhance the historic character of the conservation area.	N/A

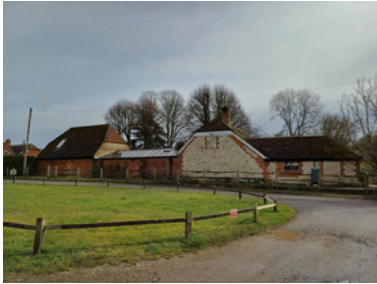
Building Name/ Number	Status	Reason for Inclusion (Positive Contributors)	List Entry (Where Applicable)	Photo/Brief Description
Old Dairy	Positive Contributor	Historic proportions, characteristic materiality (malmstone with red brick) and architectural details including half-hipped roofs and historic chimney stacks enhance the historic character of the conservation area.	N/A

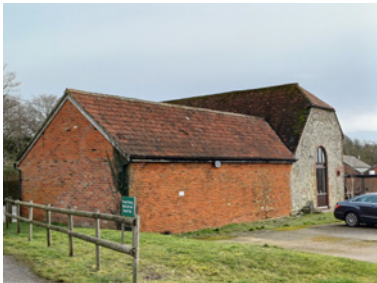
Agricultural Structures 15m West of West End Cottage	Positive Contributor	A historic agricultural structure of at least two historic phases, which has important group value with other historic agricultural buildings at West End Farm.	N/A

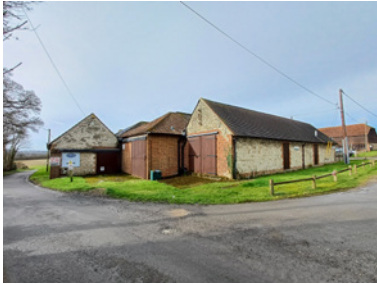
Building Name/ Number	Status	Reason for Inclusion (Positive Contributors)	List Entry (Where Applicable)	Photo/Brief Description
Agricultural Structures 30m South East of West End Cottage (excludes 20th-century additions)	Positive Contributor	A complex of historic agricultural structures with traditional proportions and materiality, which have important group value with other historic agricultural buildings at West End Farm.	N/A

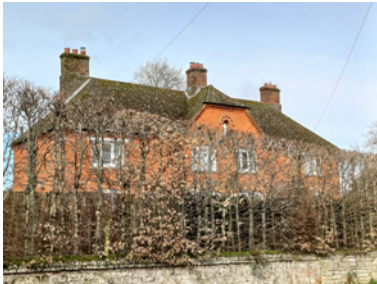
St Joseph's	Positive Contributor	Boundary treatments, historic proportions, characteristic materiality (red brick) and architectural details including timber window units, red-brick dentils at eaves level, statuette of saint in central niche and chimney stack enhance the historic character of the streetscape.	N/A

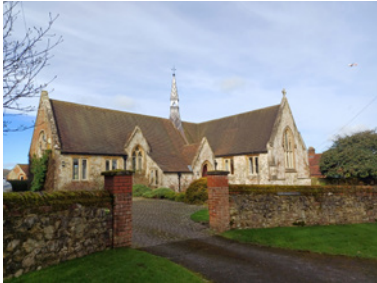
Building Name/ Number	Status	Reason for Inclusion (Positive Contributors)	List Entry (Where Applicable)	Photo/Brief Description
The Old School	Positive Contributor	Boundary treatments, materiality and architectural details enhance the historic character of the streetscape. An attractive example of Victorian Gothic Revival architecture.	N/A

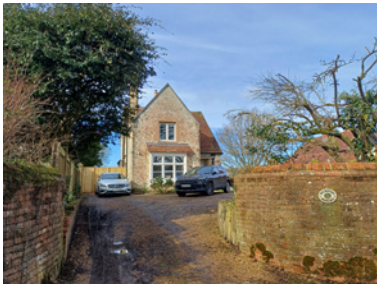
School House	Positive Contributor	Boundary treatments, materiality and architectural details including scalloped roof tiles, ridge tiles and prominent chimney stack enhance the historic character of the streetscape.	N/A

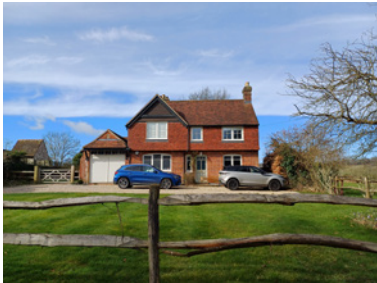
The Chestnuts	Positive Contributor	Historic proportions and characteristic materiality (red brick with clay tiles to upper storey and roof) enhance the historic character of the streetscape.	N/A

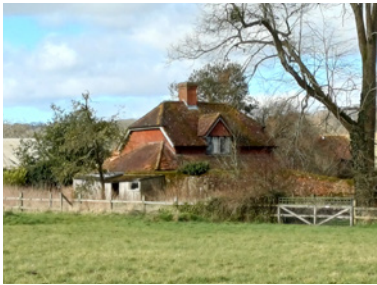
Heath Farm	Positive Contributor	Boundary treatments, historic proportions and characteristic materiality (red brick with hung tiles) enhance the historic rural character of the conservation area.	N/A

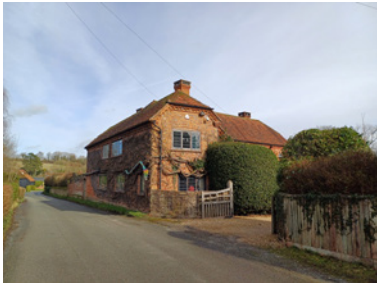
Park Edge	Positive Contributor	Boundary treatments, historic proportions, characteristic materiality (red brick with clay roof tiles and timber-framed range to rear) and architectural details included timber windows with leaded lights and brick dentils below eaves enhance the historic character of the streetscape.	N/A

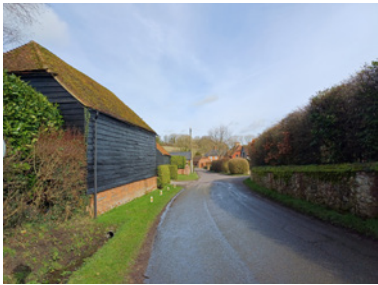
Barns 30m West of Blundens House	Positive Contributor	Characteristic materiality (brick with clay tiles and timber weatherboarding) enhances the historic rural character of the streetscape. These historic agricultural buildings have strong group value with the adjacent Grade II listed barn.	N/A

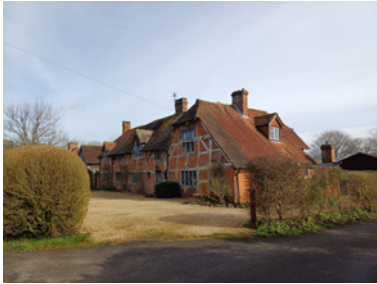
A photograph of Blunden's House, a large, multi-story timber-framed house with a steep gabled roof and multiple chimneys, surrounded by mature hedges and trees.
Blunden's Farm	Grade II Listed Building	N/A	https://historicengland.org.uk/listing/the-list/list-entry/1094091

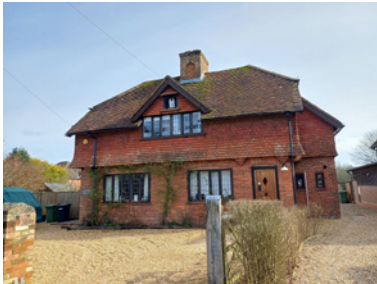
A photograph of Jasmine Cottage, a two-story red brick house with a gabled roof, a central chimney stack, and a dormer window with leaded lights.

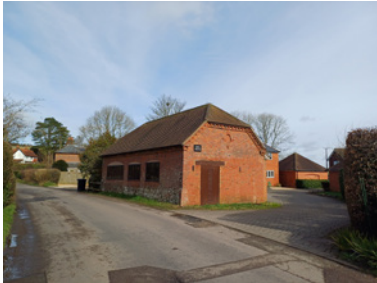
Building Name/ Number	Status	Reason for Inclusion (Positive Contributors)	List Entry (Where Applicable)	Photo/Brief Description
Beech Grange	Positive Contributor	The characteristic materiality and traditional proportions of this former agricultural building enhance the historic rural character of the conservation area. Brick detailing adds visual interest.	N/A

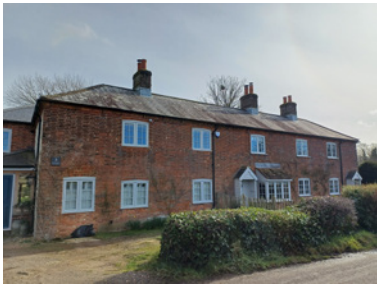
Rye Bridge Cottages	Positive Contributor	Characteristic materiality (red brick) and traditional proportions enhance the historic character of the streetscape.	N/A

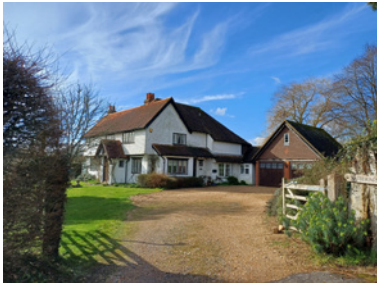
St Katherine's	Positive Contributor	Characteristic materiality (brick with hung tiles to upper storey), traditional proportions and architectural features including timber window units and historic chimney stacks enhance the historic character of the streetscape.	N/A

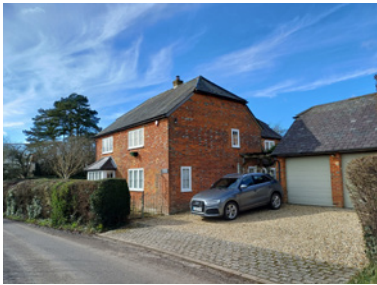
Whiteway Cottage	Positive Contributor	Traditional materiality (red brick with slate roof coverings) and historic proportions enhance the character of the streetscape.	N/A
