LOWER FROYLE CONSERVATION AREA
CONSERVATION AREA APPRAISAL AND MANAGEMENT PLAN: CONSULTATION DRAFT
ISSUE 02
APRIL 2025

LOWER FROYLE: CONSERVATION AREA APPRAISAL AND MANAGEMENT PLAN

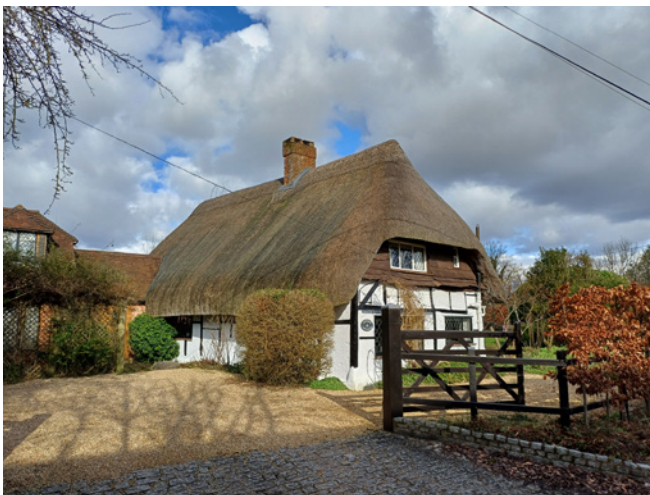
Church Cottage, a 17th-century vernacular building constructed with a timber frame, brick infill panels and a steeply pitched thatched roof. The irregularly-arranged windows and functional timber weatherboarding to the upper storey are also typical vernacular features.

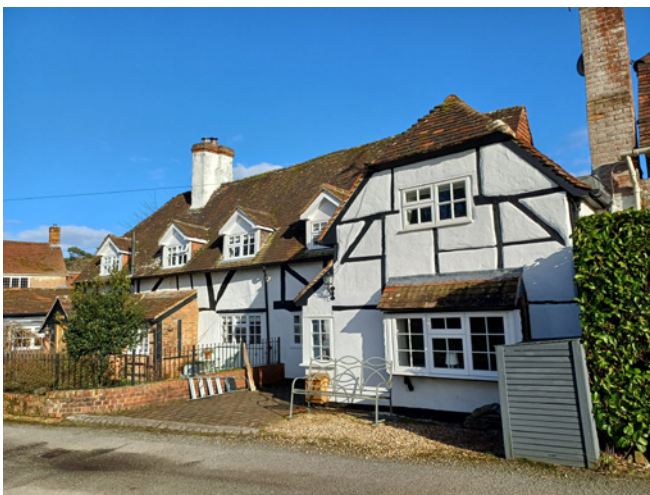
Apple Tree and Pond Cottages, two 17th-century vernacular structures featuring timber framing and the traditional half-hipped roofs characteristic of the local area.

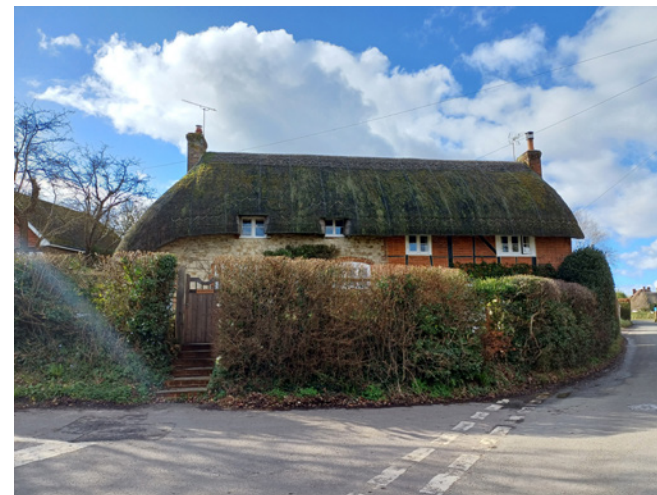
Ewelme, a pair of cottages which evolved over time from a 16th-century hall house with additions and extensions in the 17th and 18th centuries. The combination of materials (including malmstone, brick, timber and thatch) is typical of the local vernacular.

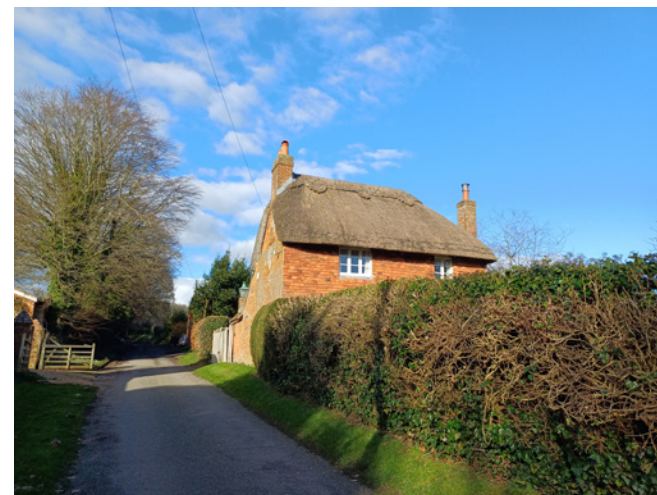
Ford Cottage, an 18th-century vernacular building of brick construction with a thatched roof and irregular window openings.

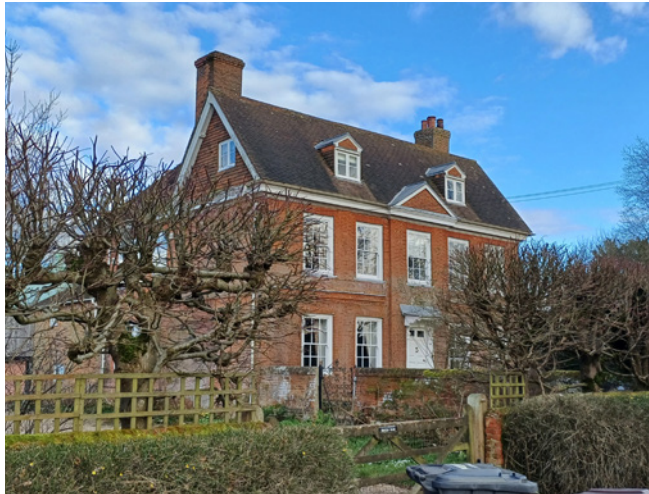
Brocas Farmhouse is an early Georgian house with typical 18th-century proportions.

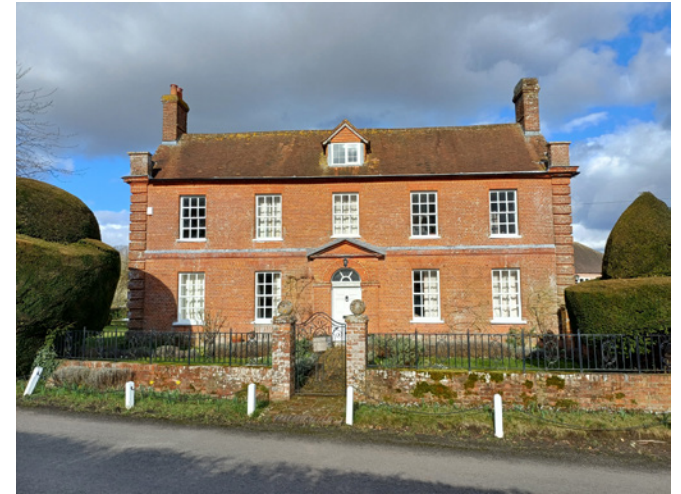
Hodges Farmhouse, a 17th-century timber-framed house which was re-faced in the 1760s to accord with the architectural fashions of the time.

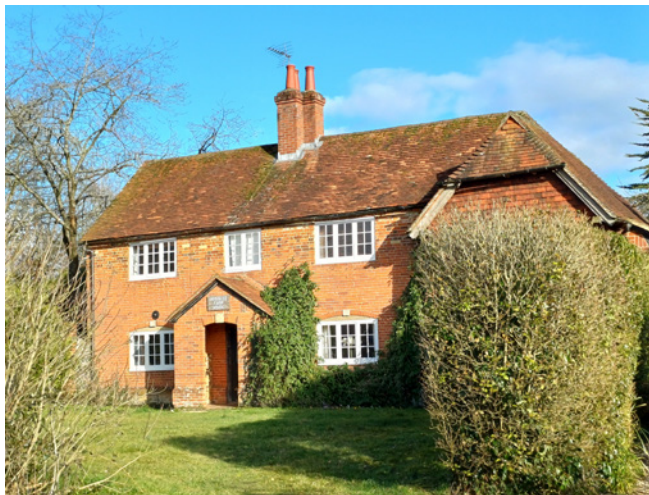
Hussey's Farmhouse, which appears from the highway as a Georgian building, has a 15th-century core.

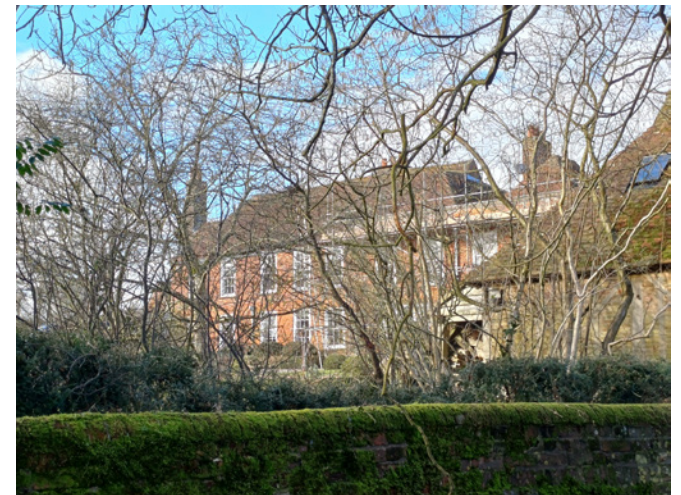
Hussey's, a substantial 16th-century house extended and partially re-clad in the 18th century in the fashionable Neo-Classical style.

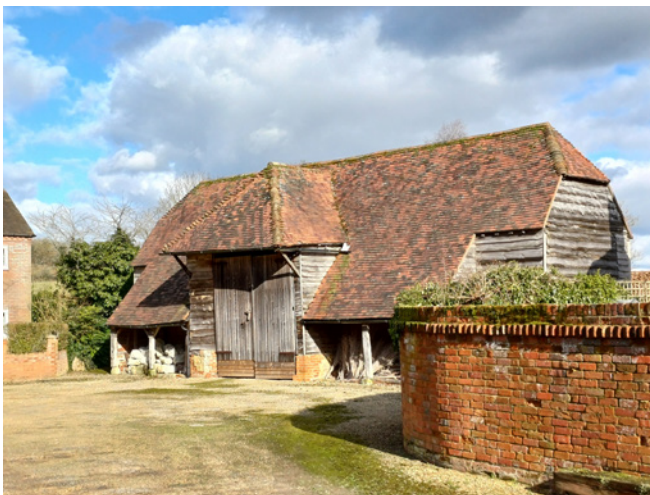
One of several substantial 18th-century barns within Lower Froyle. It is a single-storey structure with a half-hipped roof and is clad with timber, as is typical of similar structures in the village and the wider area.

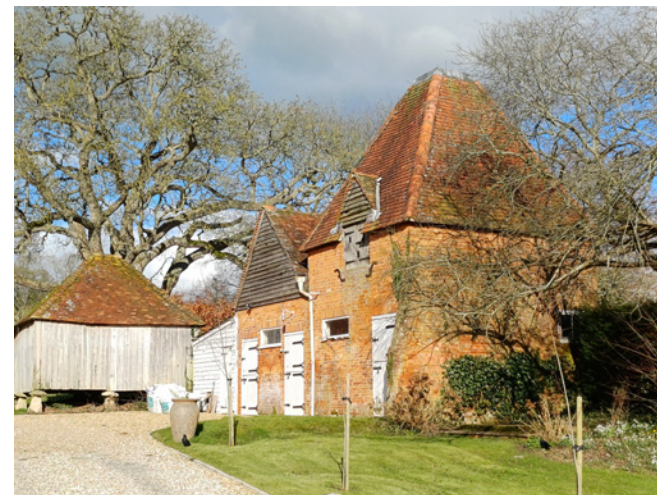
A stable block and hop kiln dating from the mid-19th century on the former site of Rockhouse Farm. Hop kilns, also known as oast houses, can be identified by their steeply pitched pyramidal or conical roofs. They were utilised to dry hops grown on the surrounding land.¹⁰

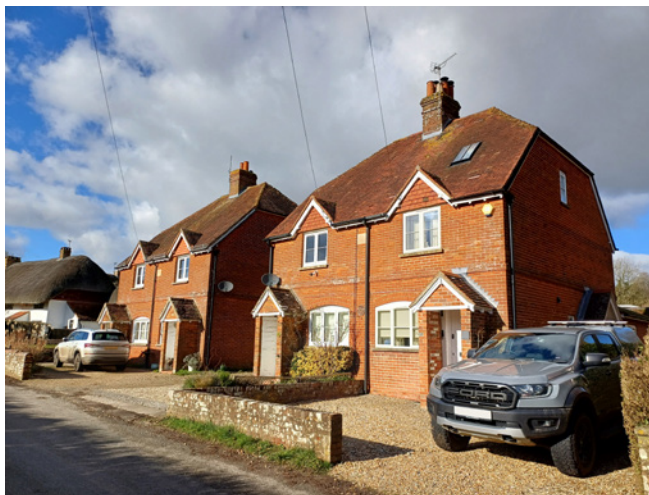
Rose Cottages, at the western edge of the conservation area, reflect the fashion for symmetry which typified much domestic architecture during the Victorian and Edwardian eras. The low-centred brick arches over the ground-floor windows are another feature common during this time period.

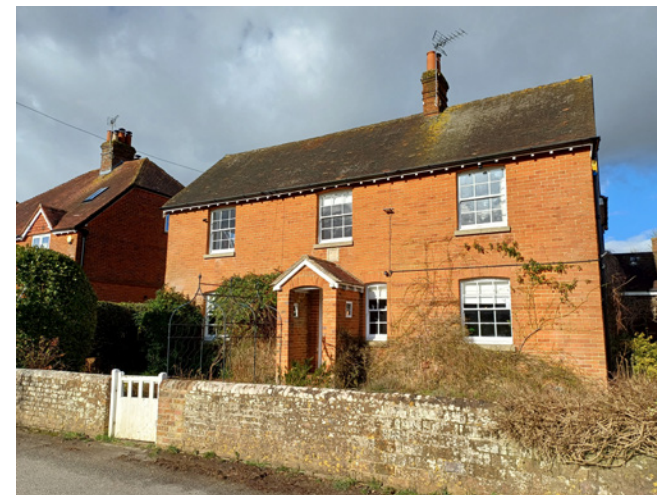
Rock Cottage, which is contemporary with the adjacent Rose Cottages, reflects the Edwardian interest in Georgian architecture. The arrangement of the building across three bays and the incorporation of regularly arranged sash windows self-consciously emulates the Georgian style (seen for instance at Box House slightly further west).

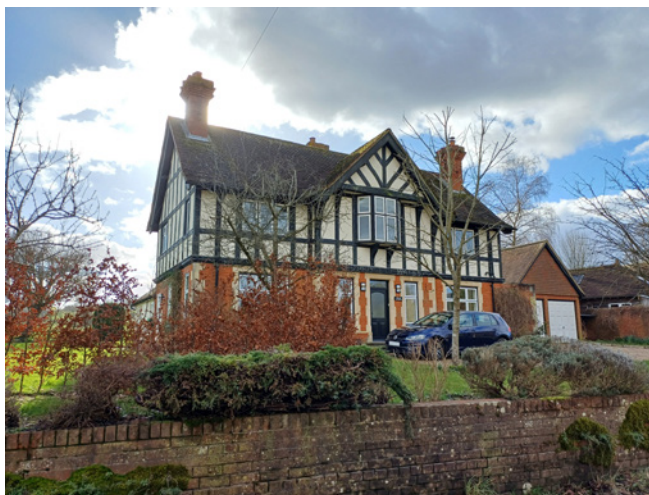
The former Prince of Wales pub, built c.1912 at the bottom of Well Lane, illustrates the influence of vernacular architecture on Edwardian design – note the mock timber framing to the upper storey.

Late 19th and early 20th-century architecture was also heavily influenced by vernacular traditions, and as a result often incorporated traditional features such as tile hanging and mock timber framing. The former Prince of Wales pub on Froyle Road, built c.1912, is a good example of this style.

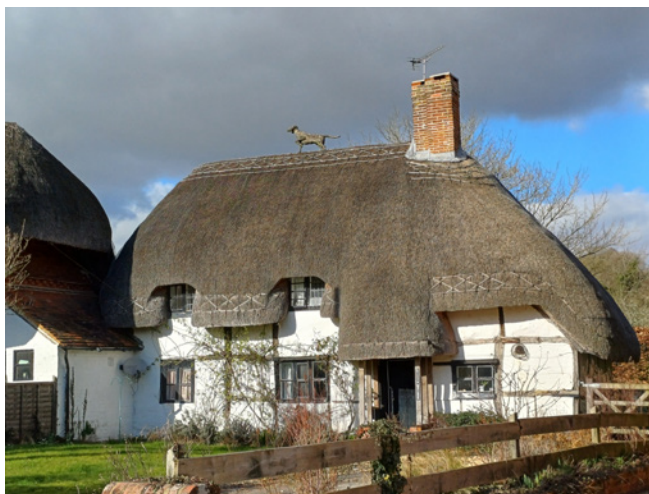
The exposed timber frame with rendered and white-painted brick infill panels, thatched roof covering and brick chimney stack are characteristic of the conservation area. The timber window units enhance the historic character of the building and the wider streetscape.

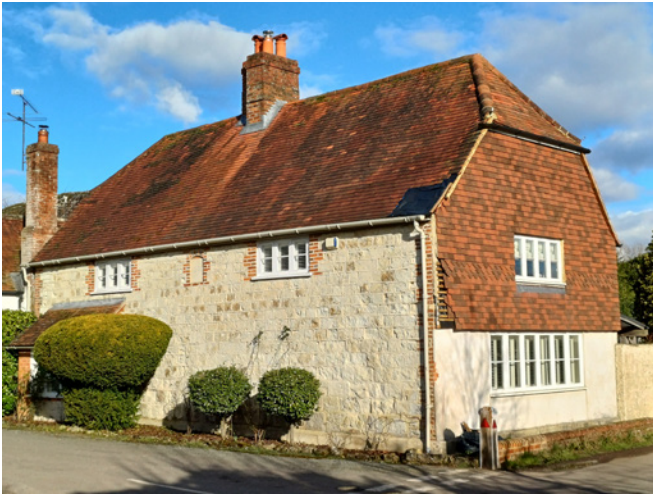
The combination of malmstone, red brick and clay tiles at Bridge House illustrates the use of various local materials in combination.

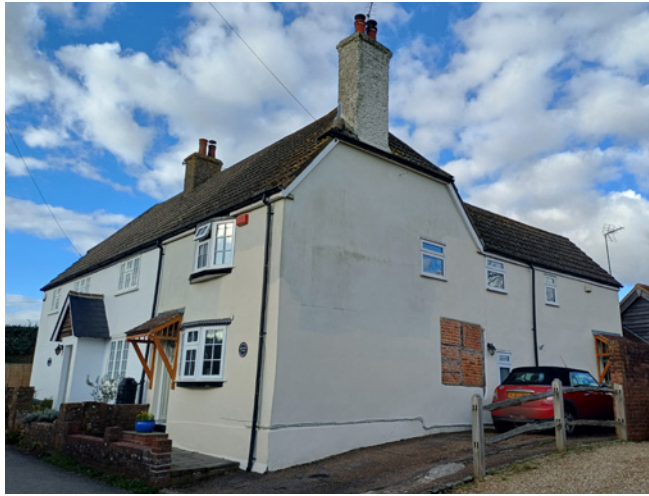
The side elevation on Greenfields Cottage on Froyle Road, illustrating the timber framed core which survives behind a modern render.

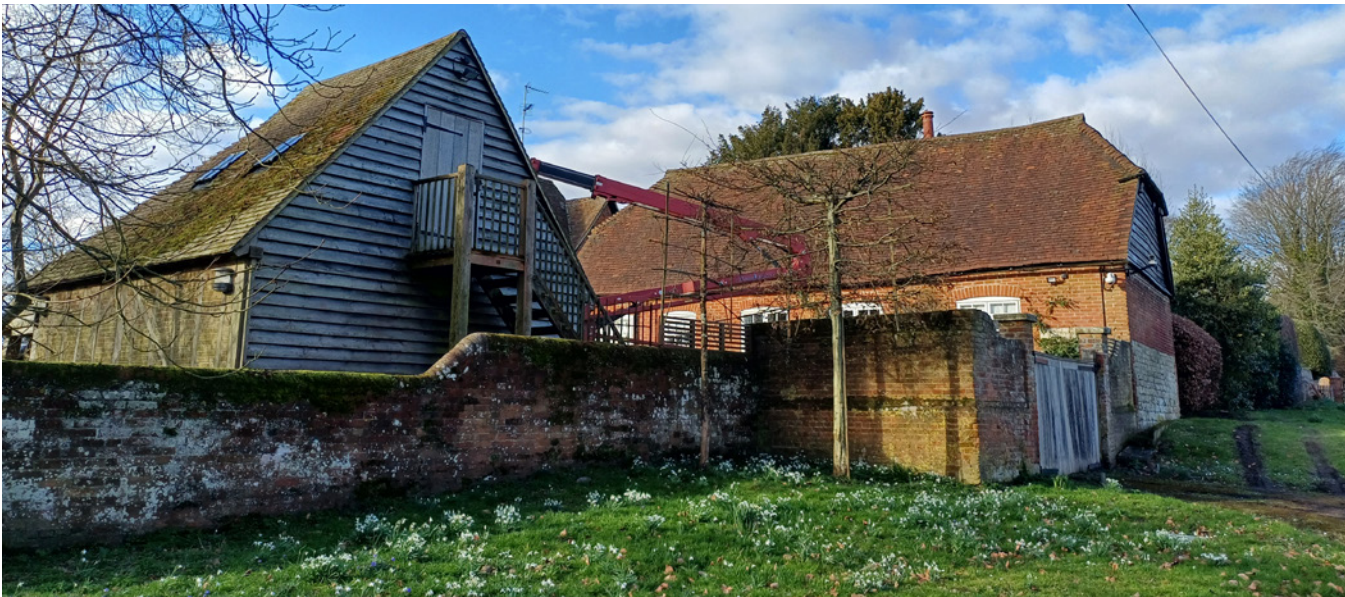
This view of the service/agricultural buildings and boundary wall at Hussey's Farm illustrates the characteristic materials palette found across the conservation area – including brick, malmstone, clay and timber.

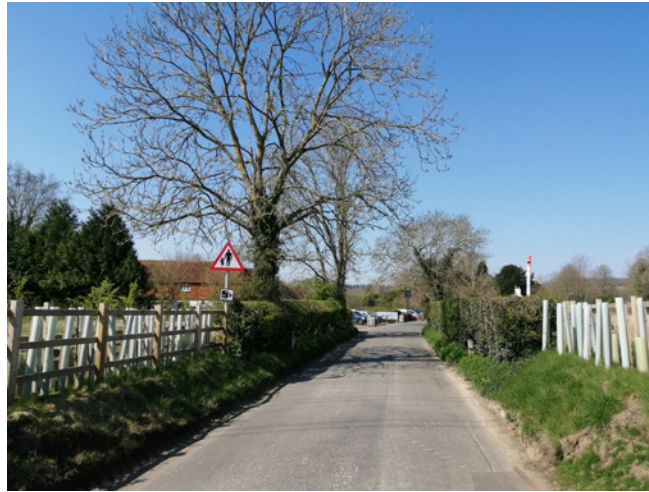
View 11: The Anchor Inn announces the edge of the historic settlement on the approach from the east. The gentle curve of Froyle Road north-eastwards towards Brocas Farm, combined with the density of intervening vegetation, means the Anchor Inn is seen against a distinctly rural backdrop.

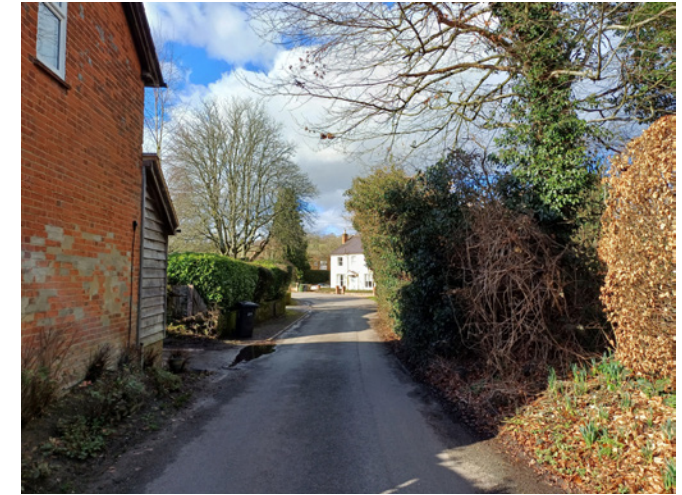
View 12: The pale façade of Box House is prominent in streetscape views looking north-westwards along Froyle Road. The cottage is orientated to address the bend in Froyle Road as it turns westwards to lead out of the village.

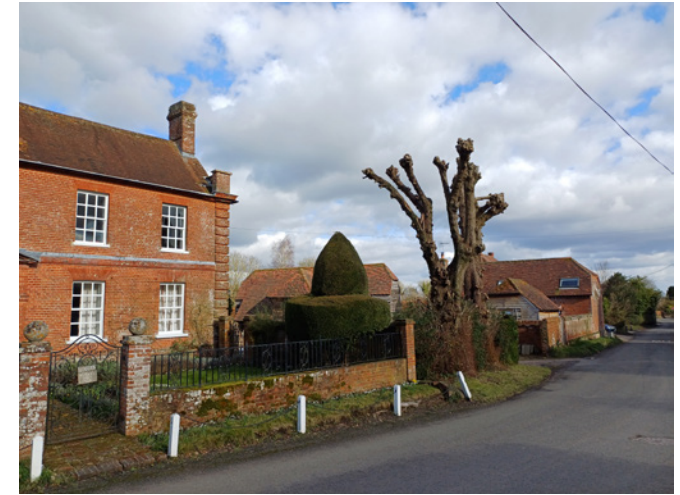
View 15: Groups of historic agricultural structures such as these outbuildings on the former site of Hodges Farm feature in streetscape views throughout the village. The historic courtyard configuration of the former farmyard can be appreciated in kinetic streetscape views, which greatly enhances the historic interest and rural character of the settlement.

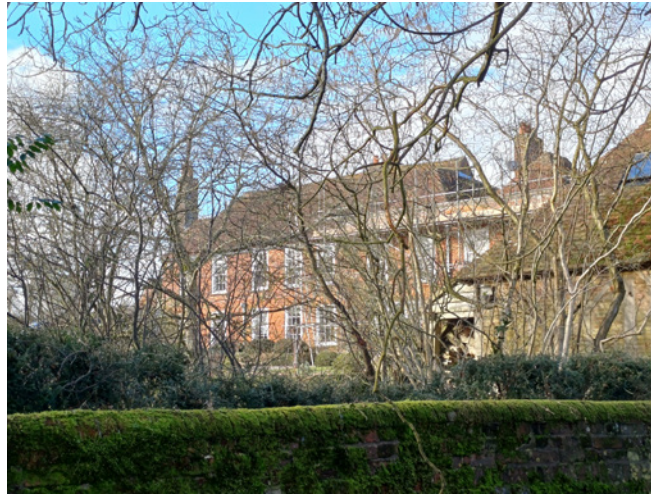
View 20: The south elevation of Hussey's, re-faced during the 18th century in the Georgian fashion, can be appreciated in winter views from Husseys Lane. The distance of the building from the public highway and the density of intervening boundary treatments reflects its historic status.

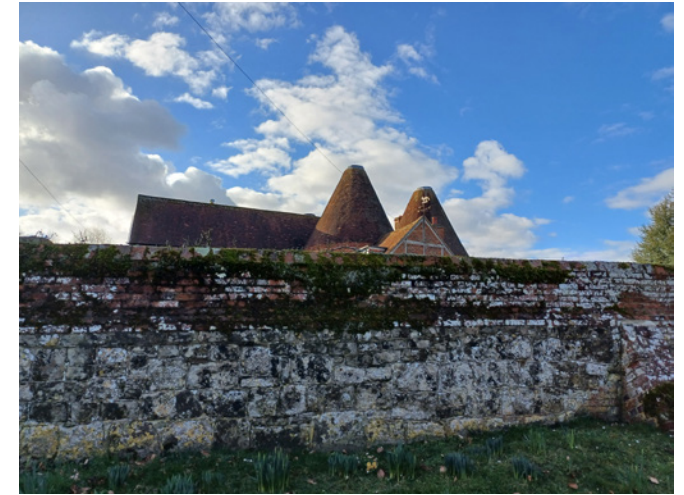
View 21: Hop kilns are a common sight throughout the conservation area, lending a strong rural character and illustrating the historic importance of hop production to the local economy. The tall, conical roofs give them particular visual prominence and allow the structures to be appreciated over intervening boundary treatments, as at Hussey's pictured here.

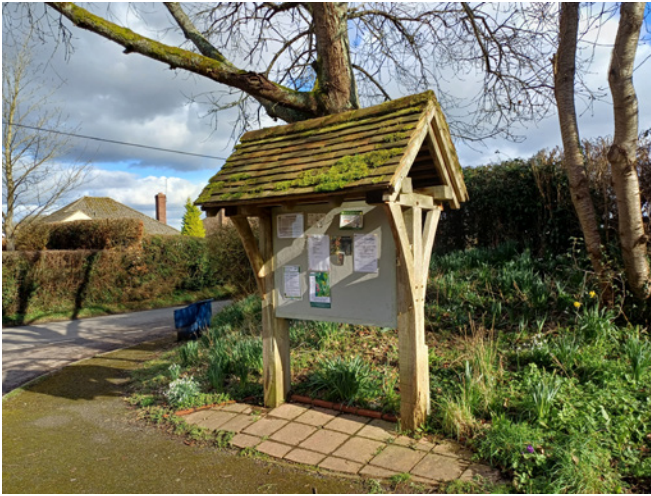
The traditionally styled timber framed roof over the public notice board at the bottom of Ryebriidge Lane is sympathetic to the historic rural character of the streetscape.

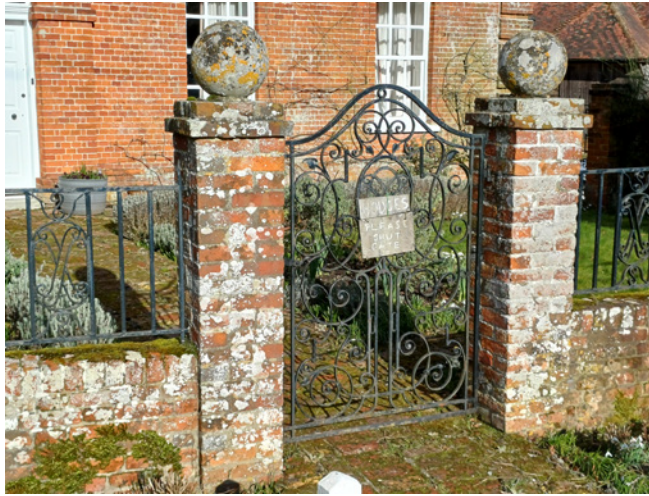
Historic brick gate piers announce the entrance to Hodges Farmhouse, which was the dwelling of a wealthy yeoman farmer during the 18th century.

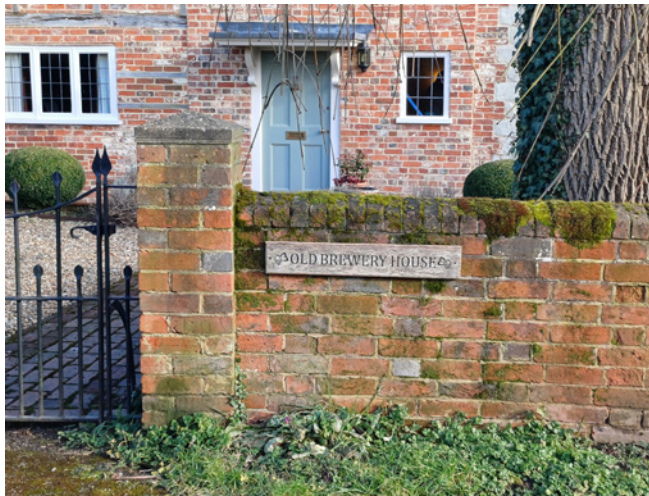
The brick boundary wall and traditionally styled iron gate outside Old Brewery House on Husseys Lane enhance the historic character of the streetscape.

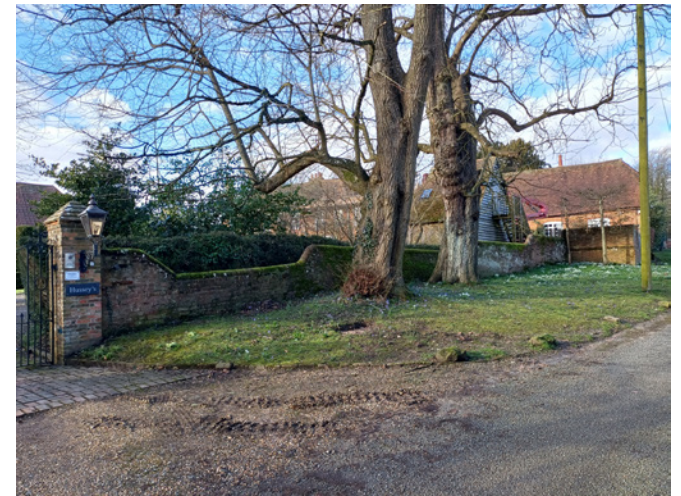
A section of historic boundary wall to Hussey's, which is separated from the lane by a deep grass verge.

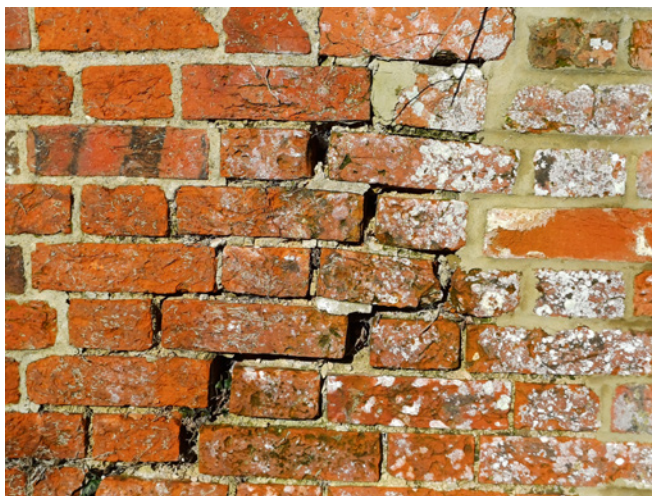
Maintenance of boundary walls. There are several instances throughout the conservation area where boundary walls are suffering from a lack of maintenance which manifests in missing joints, vegetation growth and spalling or crumbling brick and masonry. This could be remedied through the replacement of sections of brick/flint and lime mortar repairs.

Lack of maintenance/repair to this section of boundary wall on Froyle Road has resulted in large open joints, which encourage water ingress and plant growth and can hasten the deterioration of built fabric.

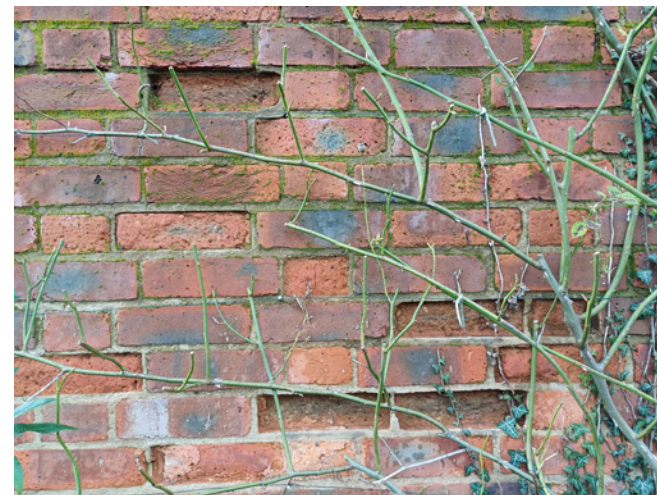
Inappropriate repairs. Issues with condition are often initiated or exacerbated with the use of modern non-breathable materials such as cementitious mortar/ render and plastic-based paints, and there are some examples of this within the conservation area. Traditional buildings (generally those built before 1919) utilised 'breathable' materials which facilitate the free passage of moisture through a structure. Although older buildings absorb more moisture than modern structures, this moisture should be able to evaporate in dry conditions. Modern cement-based renders and mortars are not breathable and prevent the evaporation of moisture from a traditional building, thereby causing issues with damp and deterioration. Non-breathable paint applied over historic solid walls and timber windows can have a similar impact.

This photograph illustrates the damage caused to fabric through the use of cementitious mortar to re-point historic brickwork.

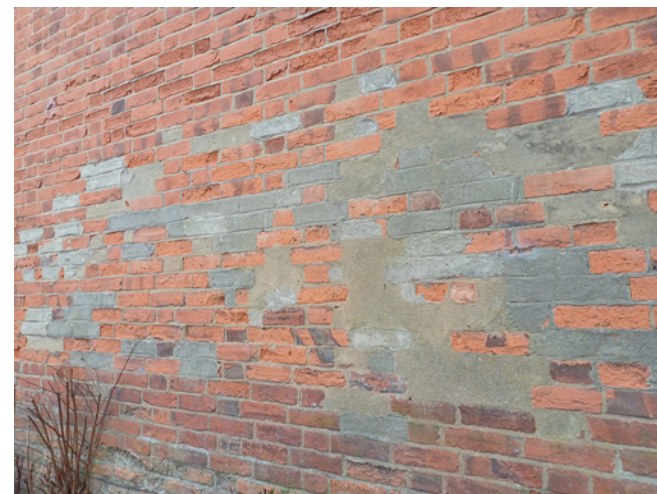
Large amounts of cementitious mortar have been applied to the wall of this historic building on Froyle Road. This will eventually have the effect of forcing moisture into surrounding historic bricks thereby causing further deterioration.

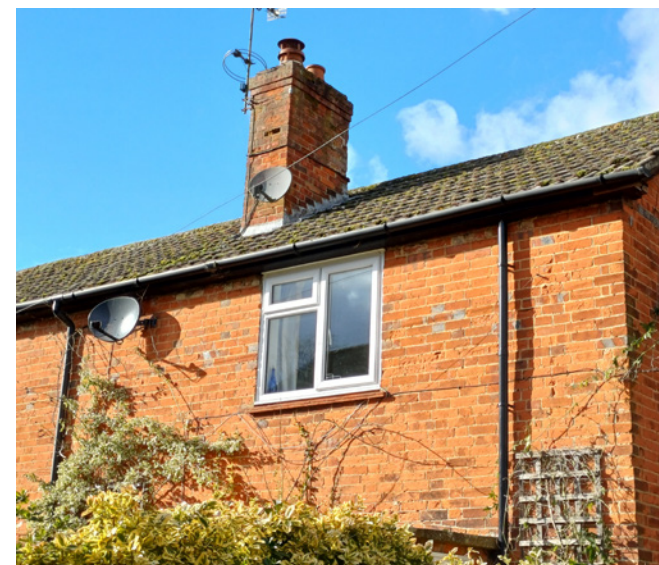
uPVC windows. Whilst the majority of windows within the conservation area are either historic or modern timber sash/casement units, some traditional units have been replaced with uPVC. The materials, style and position within the window reveal (i.e. flush with the elevation, rather than set back) of the uPVC replacements are detrimental to the character of historic elevations and collectively detract from the special interest of the conservation area. Although they are often perceived to offer environmental benefits, the lifespan of uPVC windows is also considerably shorter than that of well-maintained timber windows and the units cannot be easily recycled. The introduction of slim-profile double glazing or secondary glazing can offer improved thermal performance within older buildings, whilst retaining the appearance of traditional window units.⁰¹

uPVC windows/rainwater goods and the accretion of satellite dishes and TV aerials detract from the historic character of this building and the wider streetscape.

Although many of the uPVC windows which have already been installed are unlikely to require replacement in the near future, there is scope for any further replacement windows and doors to be carried out using styles, materials and methods that are better suited to enhancing the special interest of the conservation area. It would be especially beneficial for first-generation uPVC double-glazing, which is generally coming to the end of its life cycle, to be replaced with more suitable alternatives.

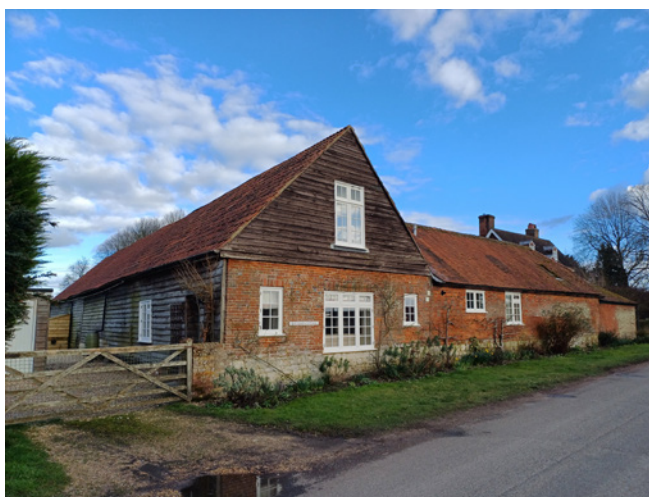
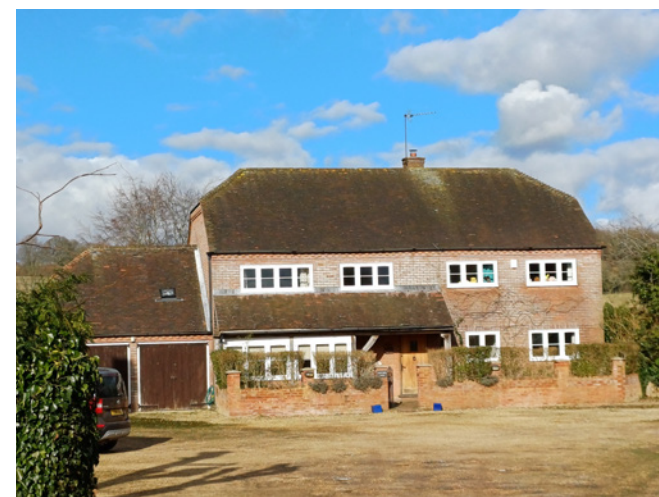
Above are two contrasting examples of historic agricultural structures in Lower Froyle which have been converted to residential use. The use of pale brown/orange bricks to the 1980s barn conversion (on the right) contrasts with the dark red and orange bricks which are characteristic of the conservation area. The proportions of the window openings are also out of keeping and do not draw on historic precedent. The development on the left is more successful; it has retained/incorporated traditional materials and is lit with traditionally styled timber window units.

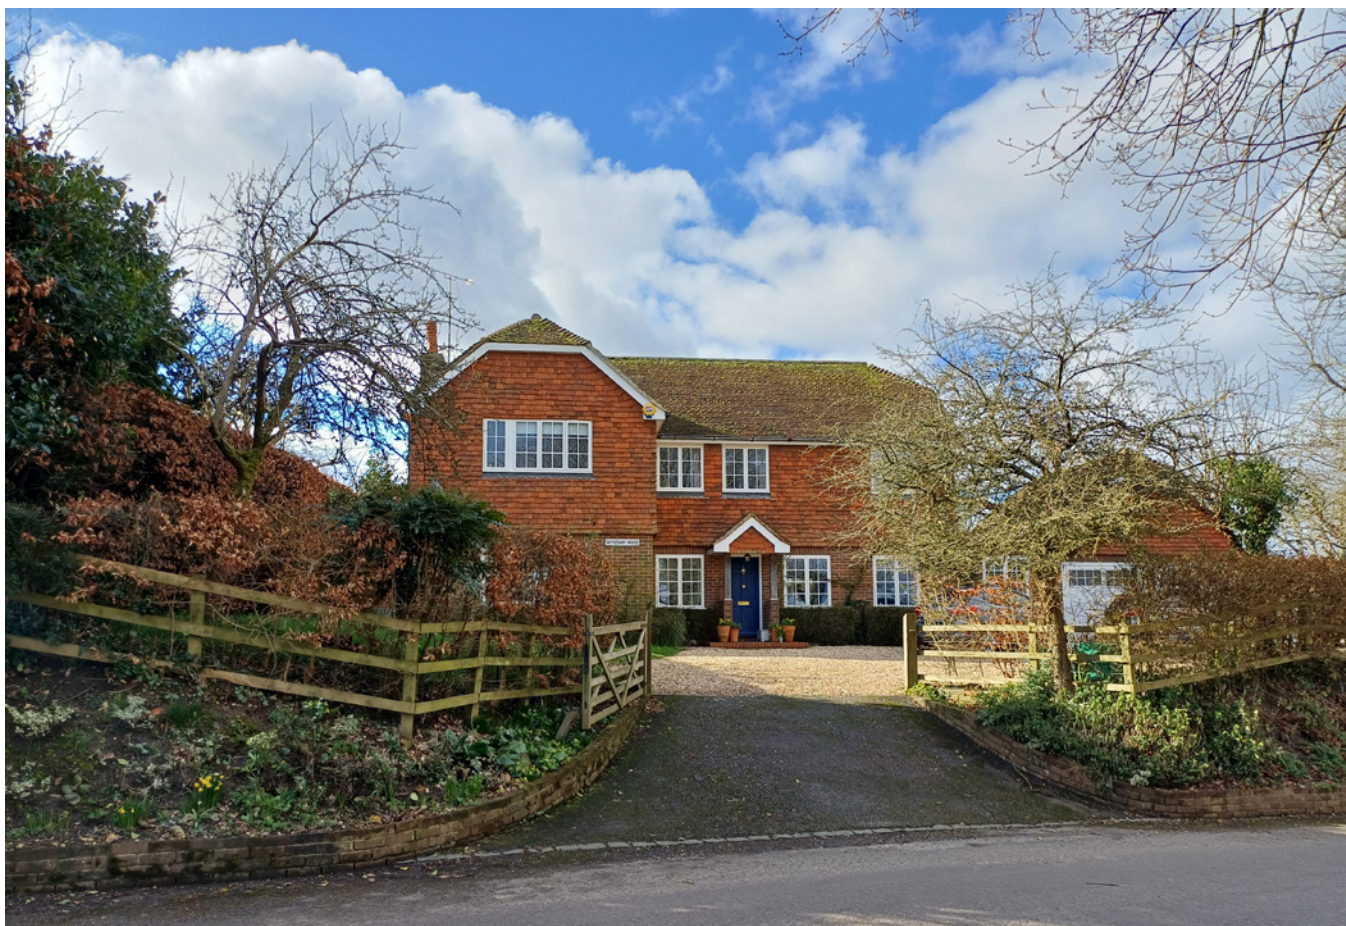
Wykeham House, on Ryebriidge Lane, is an example of well-designed modern development which responds to the established character of the conservation area and enhances its setting.

Future development within or in the setting of the conservation area has the potential to contribute positively to its established character. There are already several examples of this – for example the timber-clad outbuildings at Blue Cottage and the thatched garage at Church Cottage. Cox's Meadow and Semley House, at the far western edge of the conservation area, are modern buildings sympathetic in scale, style and materiality to the character of the historic settlement. Wykeham House, just south of the conservation boundary, is another example of a successful modern development which complements the established character of the area.

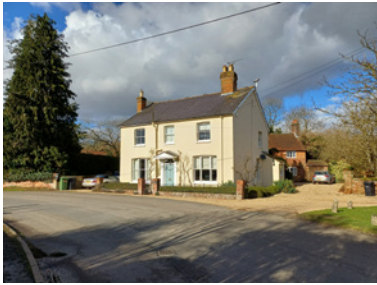
Homestead Cottage	Positive Contributor	Historic proportions, surviving chimney stacks and characteristic materiality (red brick with clay roof tiles) enhance the historic character of the streetscape.	N/A

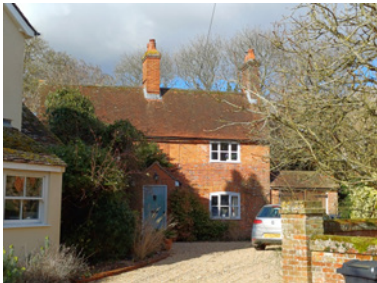
Building Name/ Number	Status	Reason for Inclusion (Positive Contributors)	List Entry (Where Applicable)	Photo/Brief Description
Little Rock	Positive Contributor	Incorporates a timber-framed building. Historic proportions, surviving chimney stack, timber window units and characteristic materiality (red brick with clay tiles to roof and facades) enhance the historic character of the streetscape.	N/A

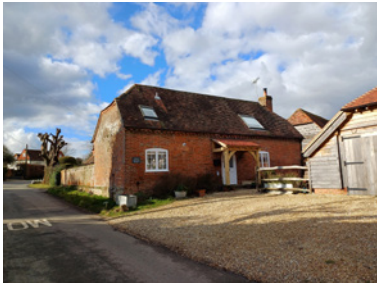
Old Stable Barn	Positive Contributor	The historic proportions of this former barn or stable block and its characteristic vernacular materiality enhance the rural character of the streetscape. The brick dentils at eaves level add further architectural interest.	N/A

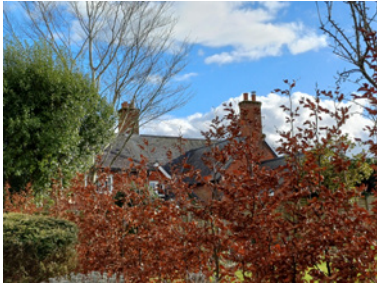
Building Name/ Number	Status	Reason for Inclusion (Positive Contributors)	List Entry (Where Applicable)	Photo/Brief Description
Warren Cottage	Positive Contributor	Historic proportions and traditional materiality (red brick, clay hung tiles, slate roof coverings) enhance the character of the streetscape.	N/A

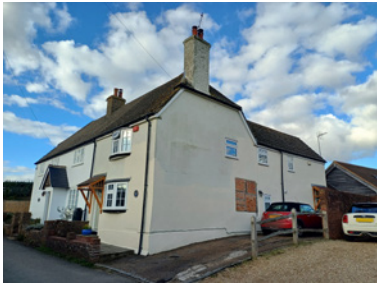
Porch Cottage & Greenfields Cottage	Positive Contributor	Boundary treatments and historic proportions enhance the character of the streetscape. Small area of exposed timber framing to east elevation of Greenfields Cottage demonstrates the historic core of the building is far older than it appears when viewed externally, due to the impact of modern interventions.	N/A

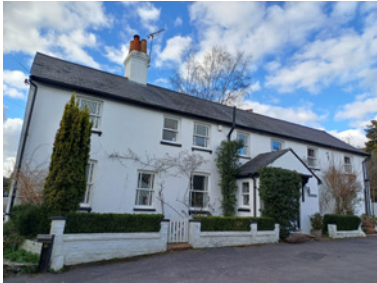
Building Name/ Number	Status	Reason for Inclusion (Positive Contributors)	List Entry (Where Applicable)	Photo/Brief Description
Glebe Cottage	Positive Contributor	Boundary treatments, historic proportions, traditional slate roof covering, surviving chimney stacks with brick detailing and sash windows enhance the historic character of the streetscape.	N/A

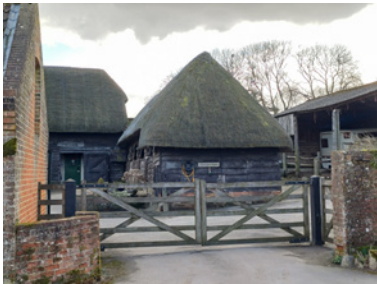
Barn 24 Metres West of Silvester's Farmhouse	Positive Contributor	Proportions and materiality contribute to the historic rural character of the conservation area and enhance the setting of the adjacent listed buildings at Silvester's Farm.	N/A

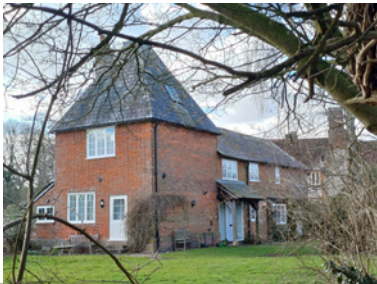
Silvester's Farm Cottages	Positive Contributor	Although converted to residential use, this building is still legible as agricultural infrastructure (incorporating a hop kiln) which enhances the rural character of the conservation area and illustrates the historic usage of Silvester's Farm.	N/A

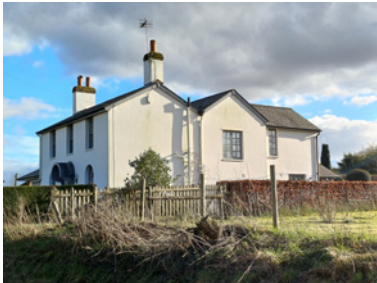
Leecot	Positive Contributor	Historic proportions and architectural details including brick chimney stacks and sash windows enhance the historic character of the conservation area.	N/A

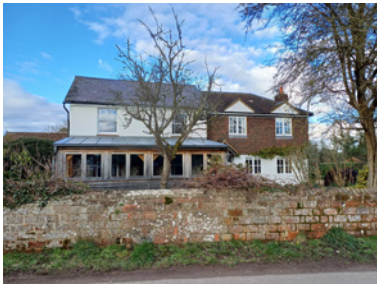
Elm Croft (excludes later extensions)	Positive Contributor	Boundary wall and historic proportions / sash windows to upper storeys of 19th-century house enhance the historic character of the streetscape.	N/A

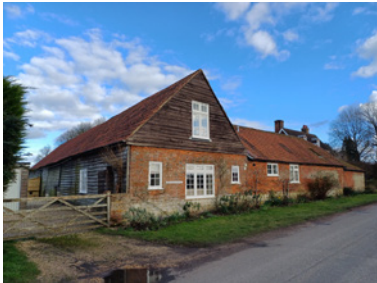
Brocas Farm Cottage	Positive Contributor	Although converted to residential use, this building is still legible as agricultural infrastructure which enhances the rural character of the conservation area and illustrates the historic usage of Brocas Farm. Utilises a characteristic vernacular materiality including brick, malmstone, clay and timber weatherboarding.	N/A

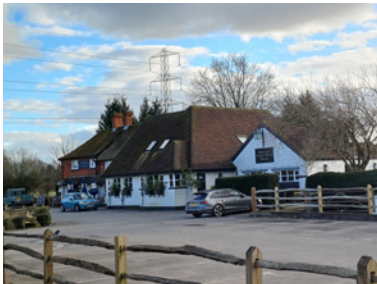
The Anchor Inn	Positive Contributor	Historic proportions and characteristic materiality (including clay tiles and timber weatherboarding) enhance the character of the conservation area. Where timber window units survive these confer historic interest. The building is also an important community facility.	N/A

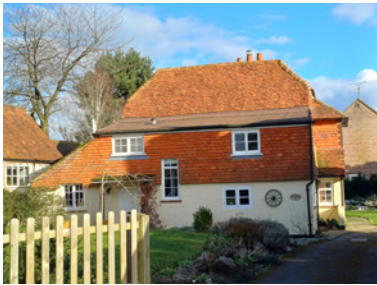
Wheelwrights	Positive Contributor	Appears to incorporate historic agricultural / service building. Characteristic materiality, timber window units and characteristic half-hipped roof enhance the historic character of the streetscape.	N/A

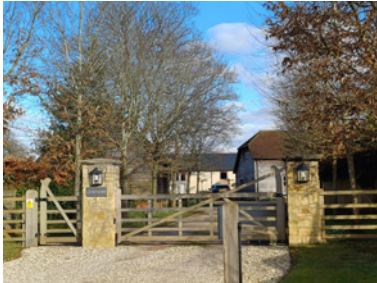
Building Name/ Number	Status	Reason for Inclusion (Positive Contributors)	List Entry (Where Applicable)	Photo/Brief Description
Goschens (includes former barn to west)	Positive Contributor	Despite later adaptation to residential use, the configuration and proportions of these former agricultural buildings are still appreciable and enhance the rural character of the conservation area.	N/A

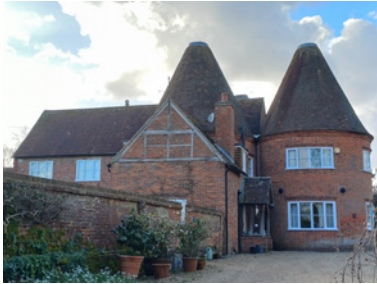
Building Name/ Number	Status	Reason for Inclusion (Positive Contributors)	List Entry (Where Applicable)	Photo/Brief Description
The Oast House	Positive Contributor	Former hop kilns are prominent in the streetscape and views from further afield (e.g. recreation ground), illustrating the historic use of Hussey's Farm and enhancing the rural character of the conservation area.	N/A

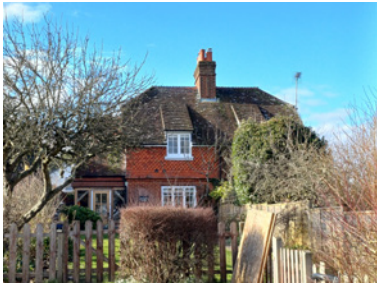
Park Lane				
No. 1 and Elm Cottage	Positive Contributor	Historic proportions, retention of designed symmetry to pair and architectural details including ridge tiles, brick detailing to chimney stack, timber window units and decorative hung tiles enhance the historic character of the conservation area.	N/A

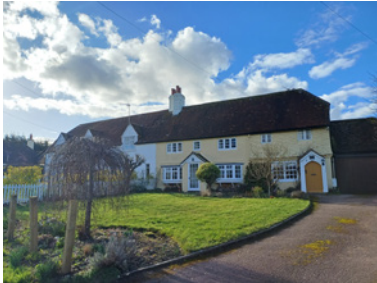
2 to 4	Positive Contributor	Despite insertion of large garage doors to No. 4, the historic proportions of the terrace confers historic character. Hung tiles to No. 2 add further visual interest.	N/A

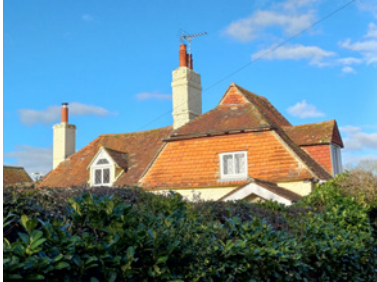
Building Name/ Number	Status	Reason for Inclusion (Positive Contributors)	List Entry (Where Applicable)	Photo/Brief Description
Sunnyside	Positive Contributor	Use of clay tiles to upper storey, dormers and roof are characteristic of the conservation area. Variegated roof form enhances visual interest of the roofscape.	N/A
